## CONDITION REPORT

Report No:  
2017305215  
DATE  
30/09/2026

MFC Auction House  
M57 Pretoria Rd, Glenmarais, KEMPTON PARK  
Gauteng

| Manufacturer | TATA CARS | Registration Number | HYG076MP |

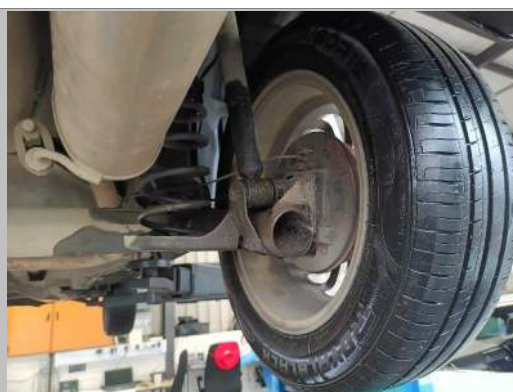
RR TYRE TREAD

| | Size | Load/Speed Index | Manufacture | Model | Type* | Production Date | Tread Depth (mm) |
|---|---|---|---|---|---|---|---|
| Rear Right | 185/60R15 | 84H | Royal black | Mile | V | 0224 | 3 mm |

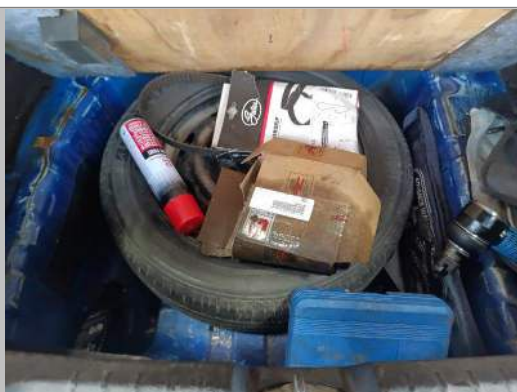
Sparewheel

| | Size | Load/Speed Index | Manufacture | Model | Type* | Production Date | Tread Depth (mm) |
|---|---|---|---|---|---|---|---|
| Spare | 185/60R15 | 84T | Bridgestone | B260 | V | 0000 | 1 mm |

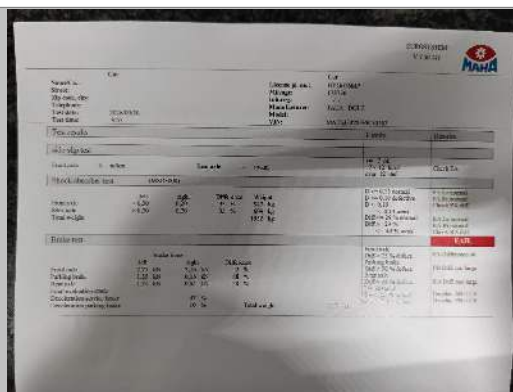
Shock and brake report

| Parking Brake Performance Left / Right Difference out of legal range | Repair |

| Brake test | | | |
|---|---|---|---|
| Parking brake | 1,35 kN | 0,16 kN | 88 % |

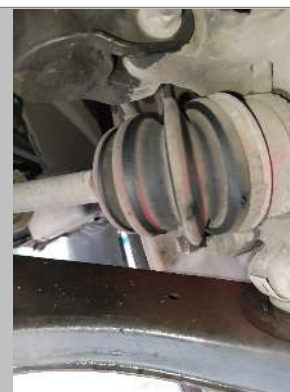
| CV Joint(s) Boot(s) Front Right (inner/outer) Damaged | Replace |

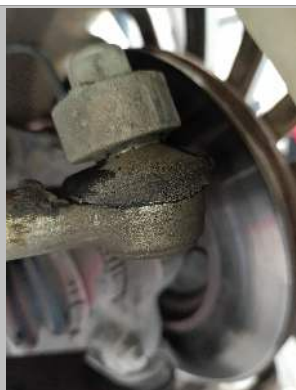
| Tie Rod End right Damaged | Replace |

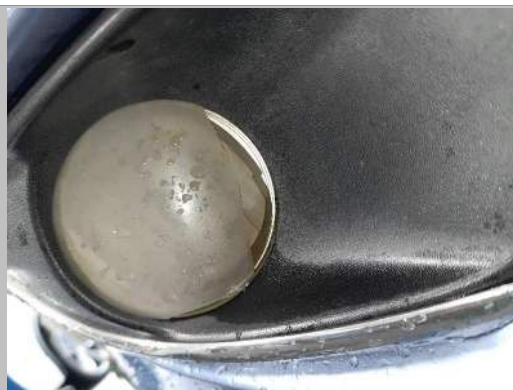
| Fog Light Front Right Damaged | Replace |

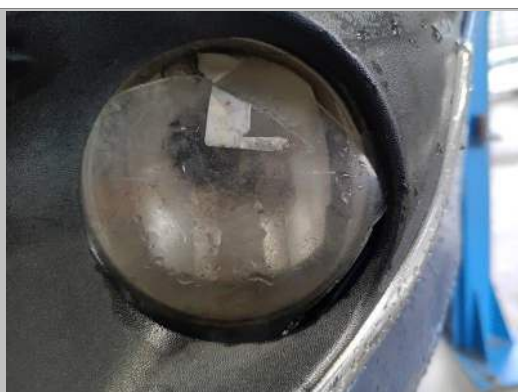
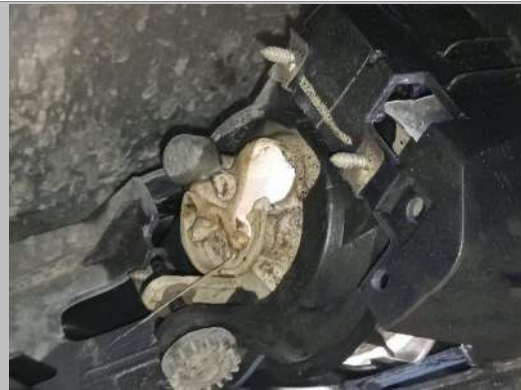
| Fog Light Front Left Damaged | Replace |

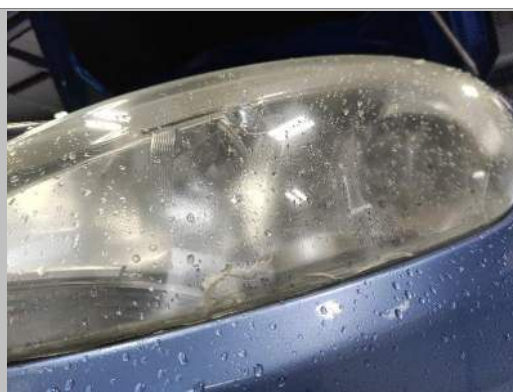
| Headlight Left Cracked | Replace |

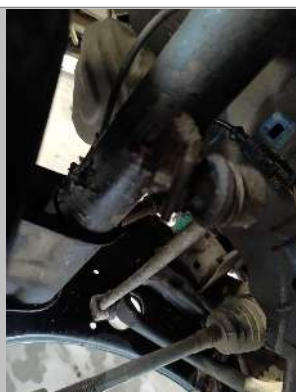
| Stabilizer Mounting Front Left Damaged | Replace |

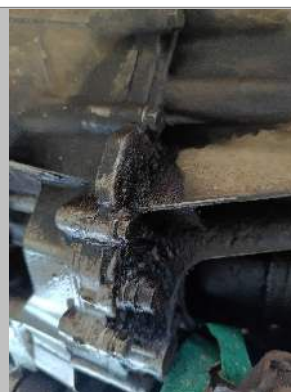
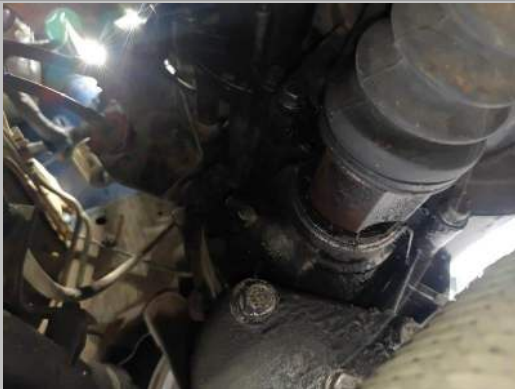
| Gearbox Oil Leak | Repair |

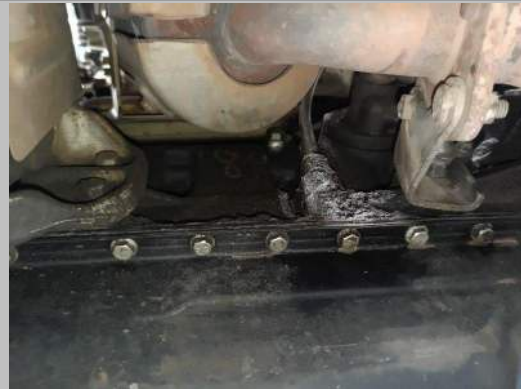
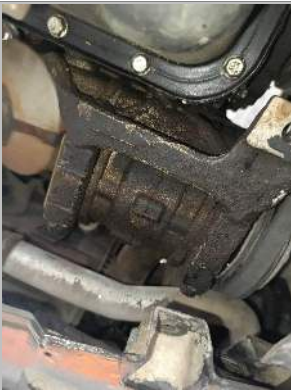
| Engine Oil Sweat | Repair |

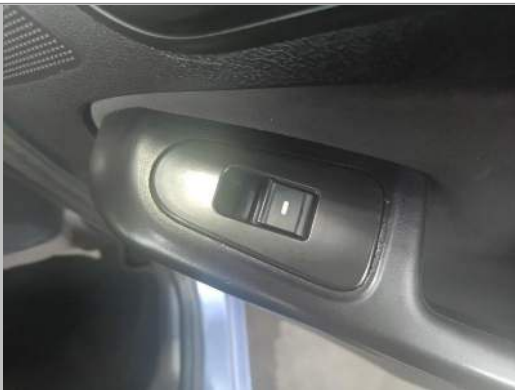
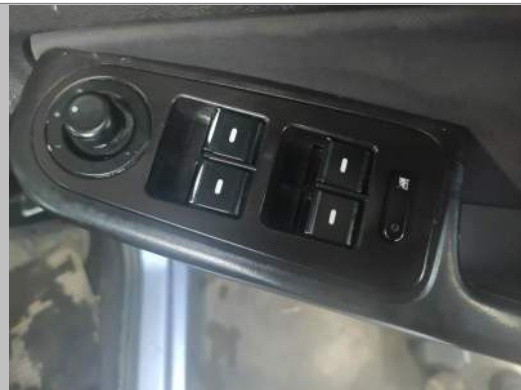
| Switch Electrical Window Winder rear right Defective | Repair |
| Both rear electric windows not working | Repair |

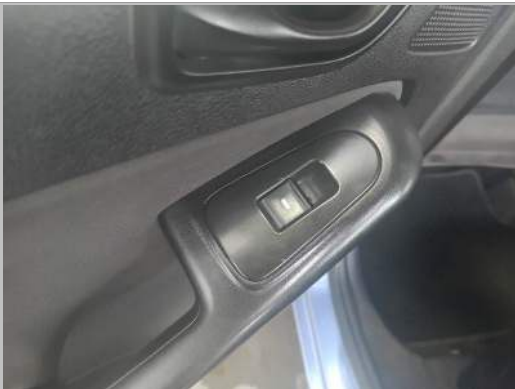
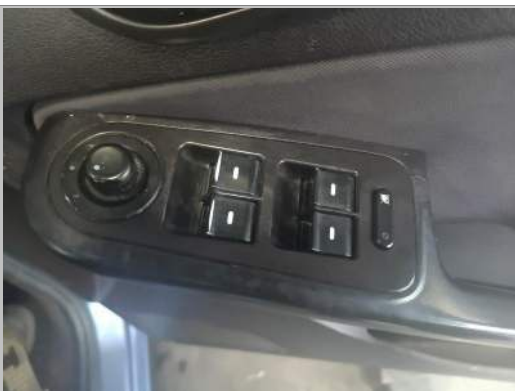
| Switch Electrical Window Winder rear left Defective | Repair |

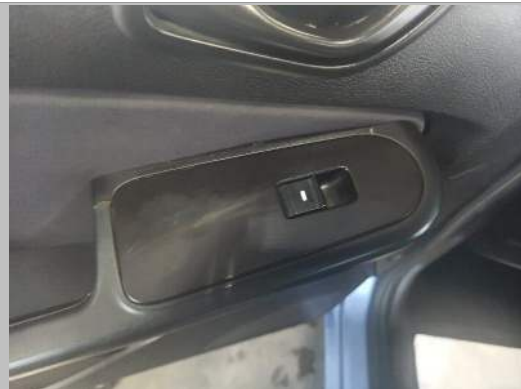
| Switch Electrical Window Winder front left Defective | Repair |

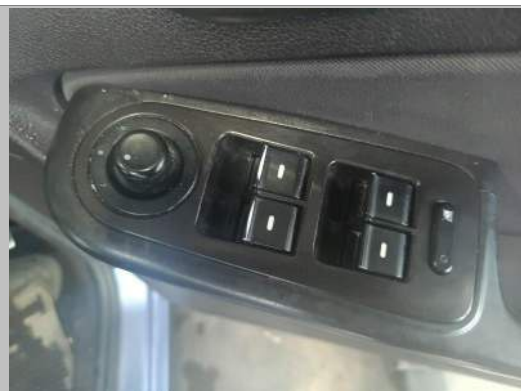
| Switch Electrical Window Winder front right Damaged | Repair |
| Driver electric window not closing | Repair |
