## CONDITION REPORT

Report No: 2016866280

DATE  
06/05/2025

| Manufacturer | SUZUKI | Registration Number | LN48KGGP |

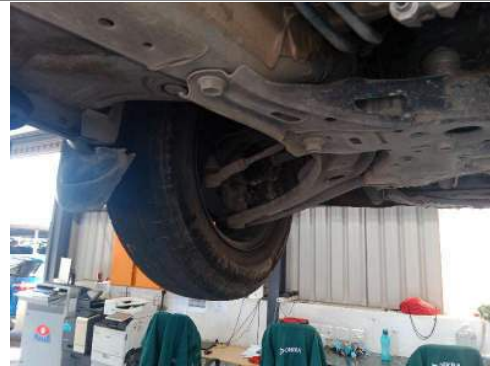
LF TYRE TREAD

Front tyres size differs

| | Size | Load/Speed Index | Manufacture | Model | Type* | Production Date | Tread Depth (mm) |
|---|---|---|---|---|---|---|---|
| Front Left | 165/80R14 | 85T | Apollo | Amazer | V | 1322 | 3 mm |

Replace

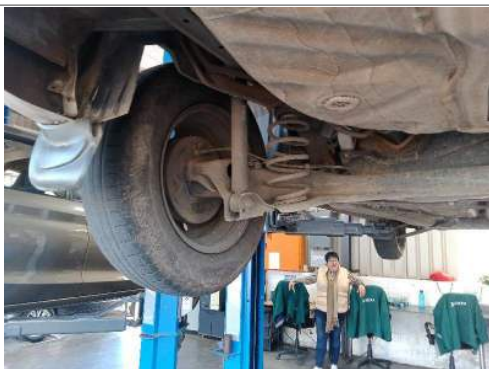
LR TYRE TREAD

| | Size | Load/Speed Index | Manufacture | Model | Type* | Production Date | Tread Depth (mm) |
|---|---|---|---|---|---|---|---|
| Rear Left | 165/80R14 | 85T | Apollo | Amazer | V | 3722 | 1 mm |

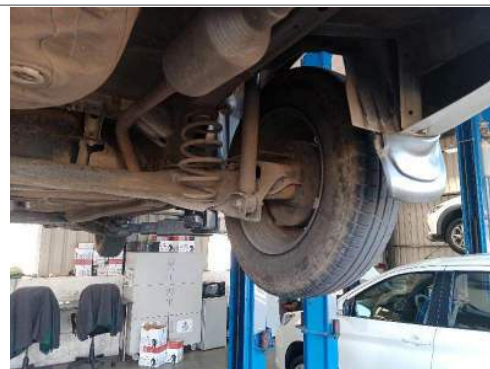
RR TYRE TREAD

| | Size | Load/Speed Index | Manufacture | Model | Type* | Production Date | Tread Depth (mm) |
|---|---|---|---|---|---|---|---|
| Rear Right | 165/80R14 | 85T | Apollo | Amazer | V | 1122 | 2 mm |

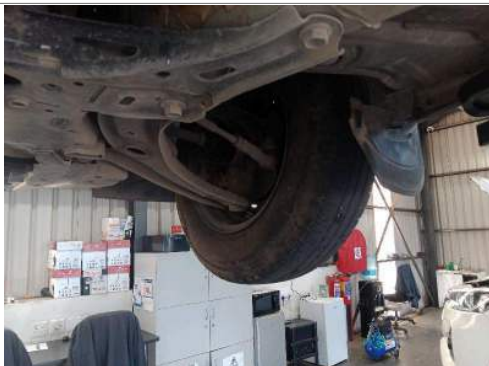
RF TYRE TREAD

| | Size | Load/Speed Index | Manufacture | Model | Type* | Production Date | Tread Depth (mm) |
|---|---|---|---|---|---|---|---|
| Front Right | 165/65R14 | 85T | Apollo | Amazer | V | 2723 | 3 mm |

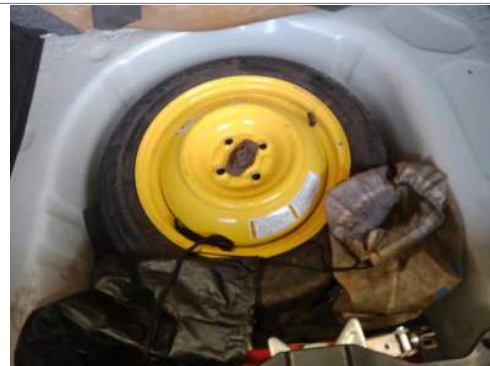
Spare wheel

| | Size | Load/Speed Index | Manufacture | Model | Type* | Production Date | Tread Depth (mm) |
|---|---|---|---|---|---|---|---|
| Spare | T135/70R15 | 99M | Jk tyre | Temporary | V | 5226 | 3 mm |

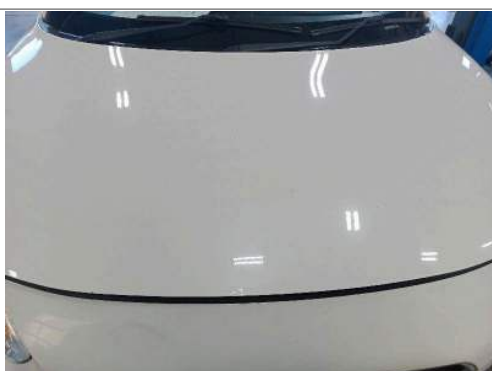
| Damage | Repair Way |
|---|---|
| Bonnet Paintwork • Chipmarks | Repair |

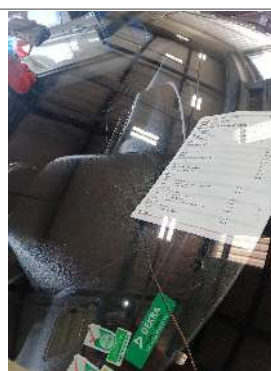
| Damage | Repair Way |
|---|---|
| Windscreen Cracked | Replace |

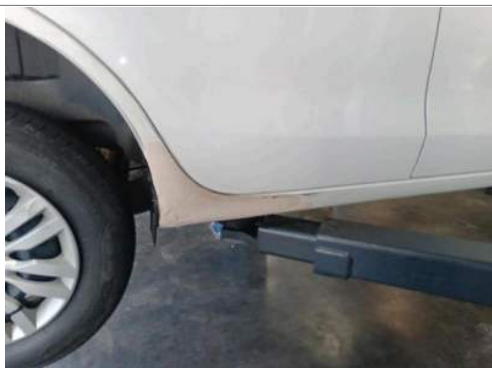
| Damage | Repair Way |
|---|---|
| Sill Panel Right Residual Traces of Repair | Repair |

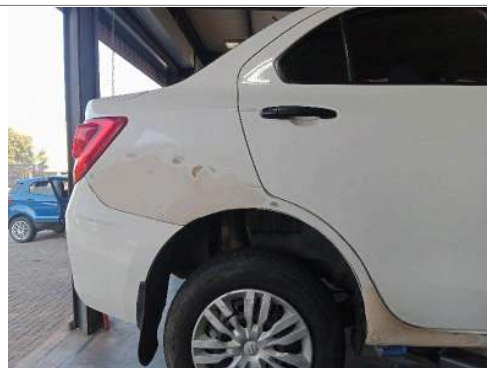
| Damage | Repair Way |
|---|---|
| Rear Fender Right Residual Traces of Repair | Repair |

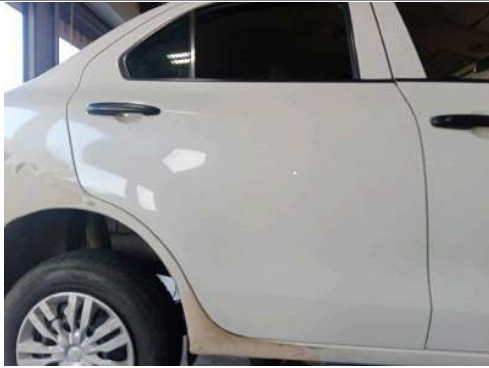
| Damage | Repair Way |
|---|---|
| Door Rear Right Paintwork • Scratched | Repair |

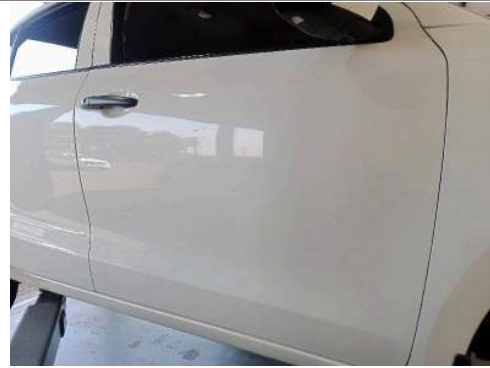
| Damage | Repair Way |
|---|---|
| Door Front Right Paintwork • Scratched | Repair |

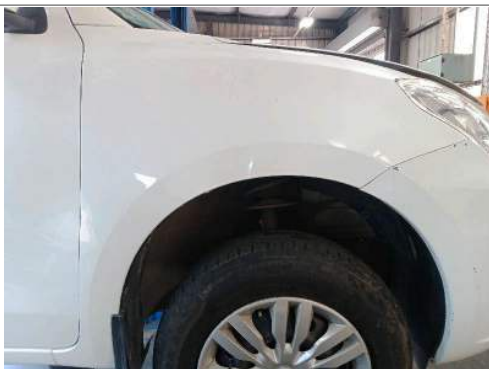
| Damage | Repair Way |
|---|---|
| Front Fender Right Dented | Repair |

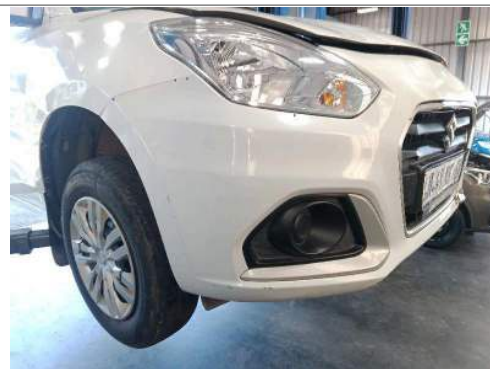
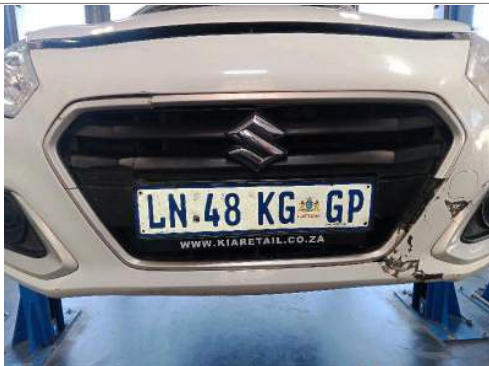
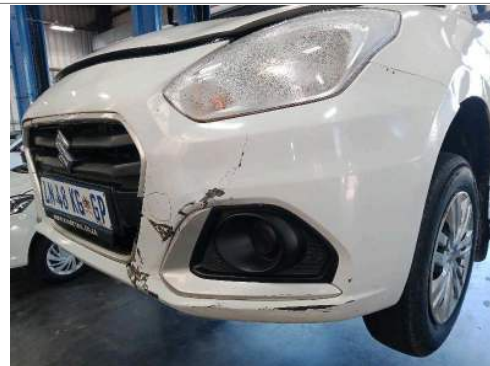
| Damage | Repair Way |
|---|---|
| Front Bumper Damaged | Repair |

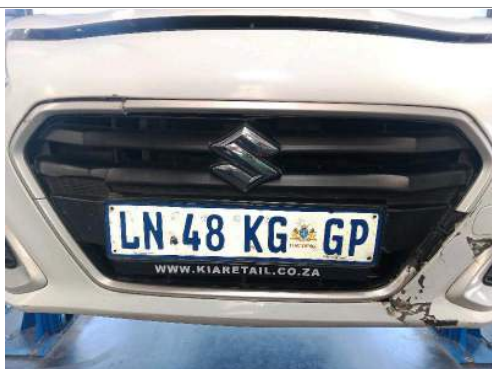
| Damage | Repair Way |
|---|---|
| Grill Damaged | Replace |

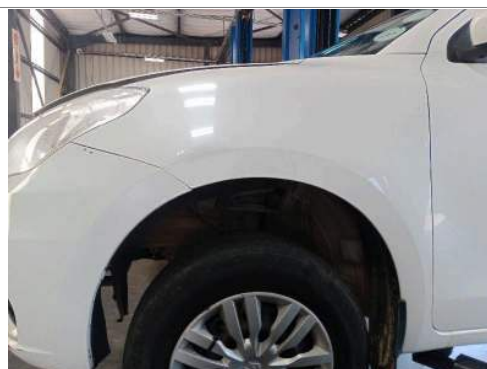
| Damage | Repair Way |
|---|---|
| Front Fender Left Dented | Repair |

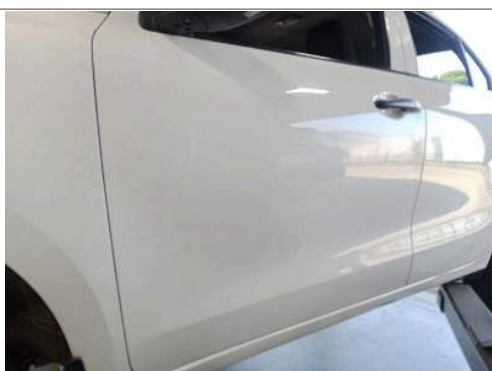
| Damage | Repair Way |
|---|---|
| Door Front Left Dented | Repair |

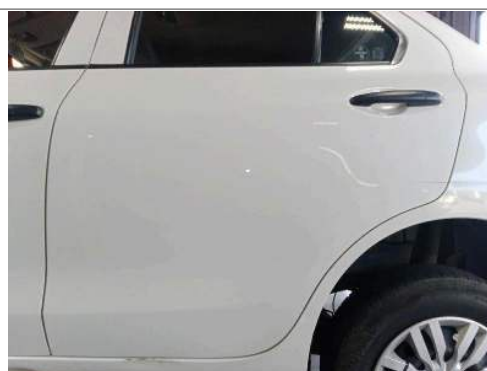
| Damage | Repair Way |
|---|---|
| Door Rear Left Paintwork • Scratched | Repair |

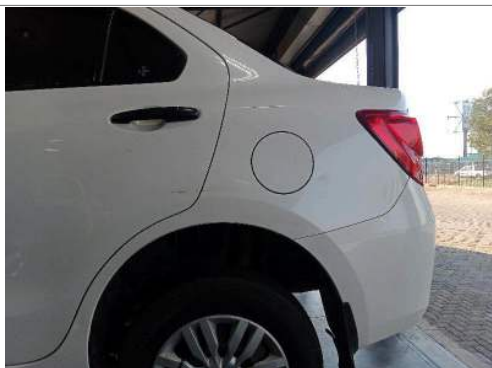
| Damage | Repair Way |
|---|---|
| Rear Fender Left Paintwork • Scratched | Repair |

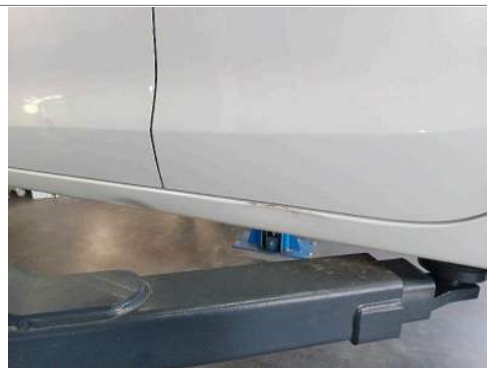
| Damage | Repair Way |
|---|---|
| Sill Panel Left Dented | Repair |

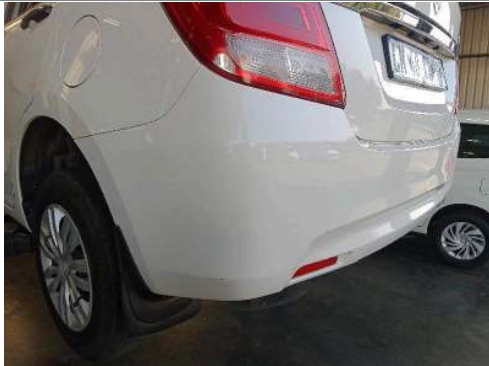
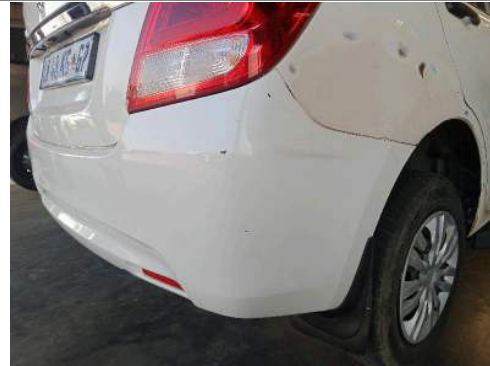
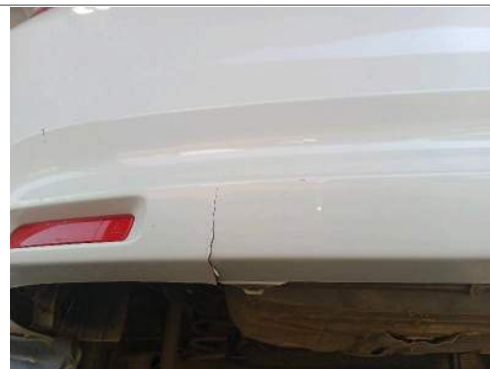
| Damage | Repair Way |
|---|---|
| Rear bumper Paintwork • Scratched | Repair |

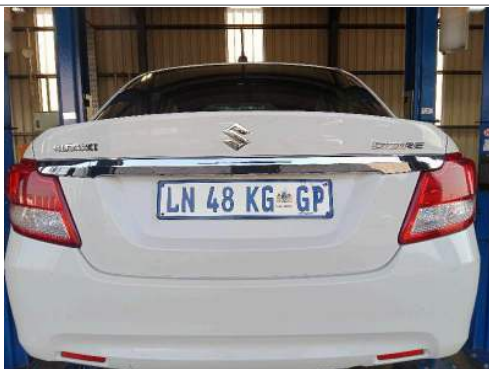
| Damage | Repair Way |
|---|---|
| Boot Lid / Hatch door Dented | Repair |

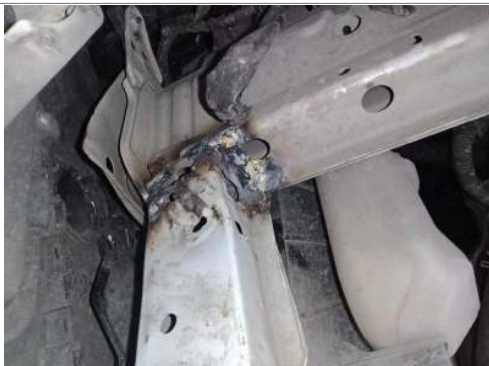
| Damage | Repair Way |
|---|---|
| Radiator Cradle Welded | Repair |
