## CONDITION REPORT

Report No:  
2017302476  
DATE  
23/09/2026

| Manufacturer | SUZUKI | Registration Number | LV42ZMGP |
| Model | FRONX | Register Number | |

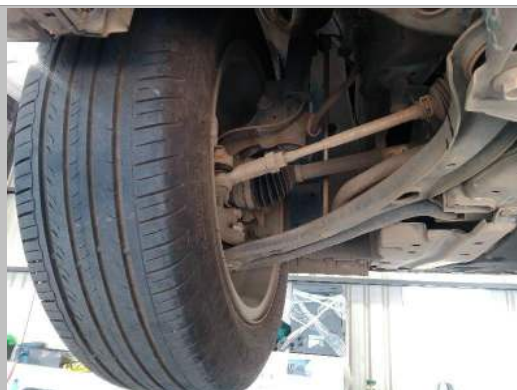
LF TYRE TREAD

| | Size | Load/Speed Index | Manufacture | Model | Type* | Production Date | Tread Depth (mm) |
|---|---|---|---|---|---|---|---|
| Front Left | 195/60 R16 | 89H | Goodyear | Assurance | V | 1124 | 2 mm |

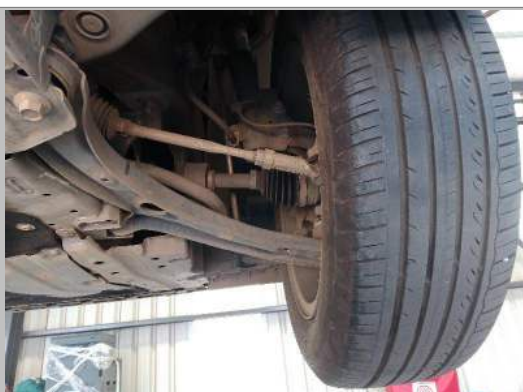
RF TYRE TREAD

| | Size | Load/Speed Index | Manufacture | Model | Type* | Production Date | Tread Depth (mm) |
|---|---|---|---|---|---|---|---|
| Front Right | 195/60 R16 | 89H | Goodyear | Assurance | V | 1124 | 3 mm |

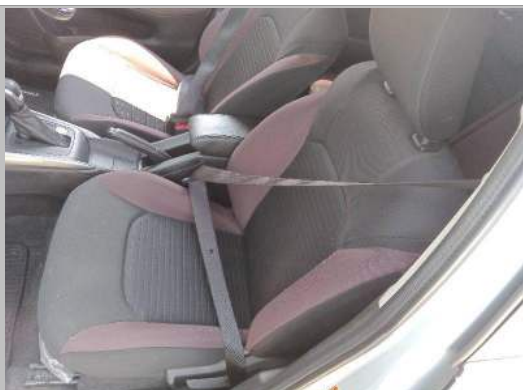
Seat Front Left Dirty  
 Front Bumper Paintwork • Chipmarks  
 Windscreen Chipped  
 Shock Absorber Rear Left Sweat  
 Shock Absorber Rear Right Sweat

Repair  
 Repair  
 Repair  
 Replace  
 Replace
