CONDITION REPORT

Report No:  
2017296016  
DATE  
08/09/2026

| Manufacturer | SUZUKI | Registration Number | MC59ZVGP |
| Model | SWIFT 1.2 GL 5-DR [2024-ON] | Register Number | |

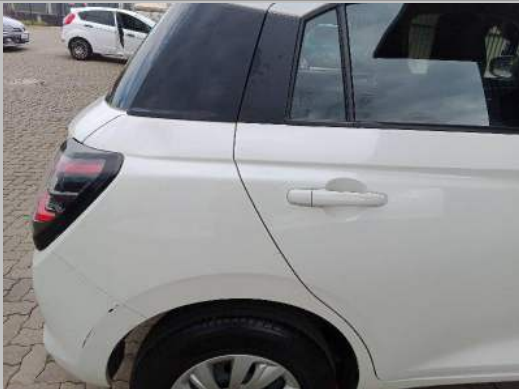
| Rear Fender Right Damaged | Repair |

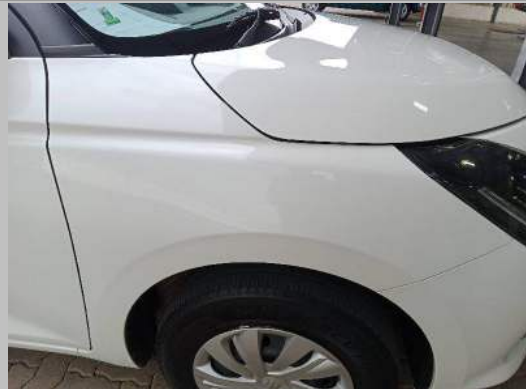
| Front Fender Right Residual Traces of Repair | Repair |

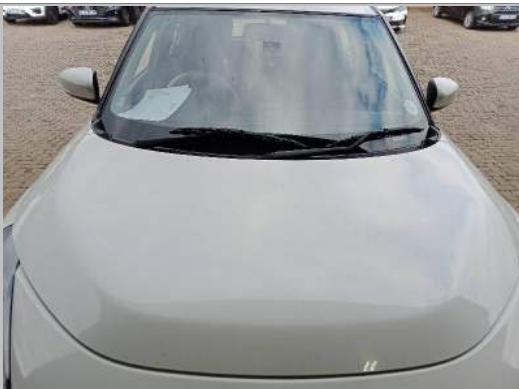
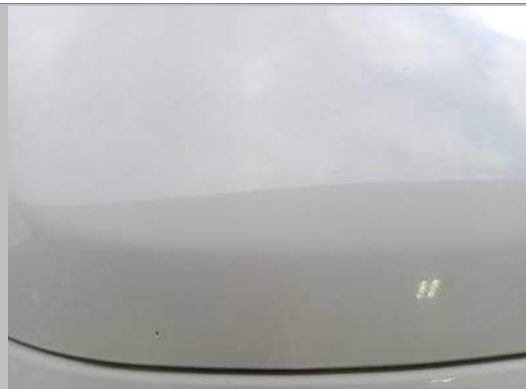
| Bonnet Paintwork • Chipmarks | Repair |

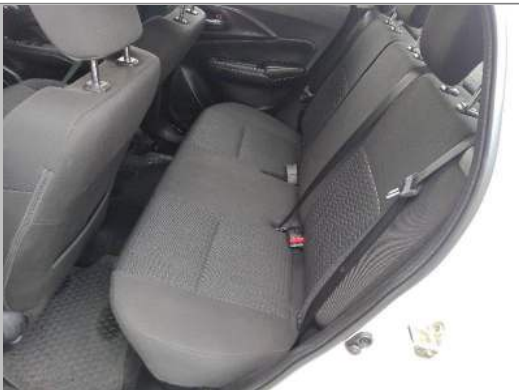
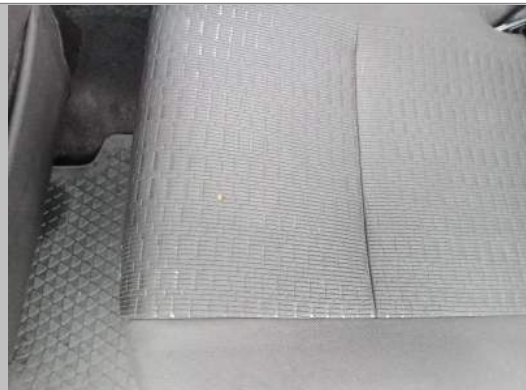
| Seat Rear Damaged | Repair |

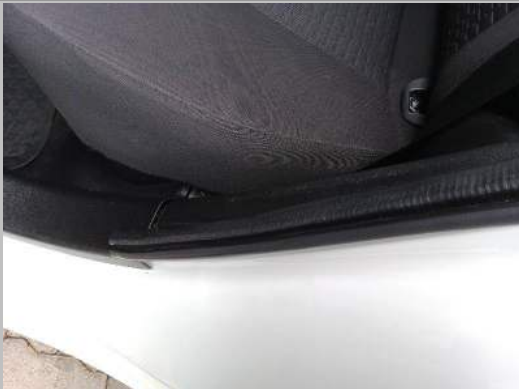
| Door Sealing Rubber Rear Left Defective | Repair |

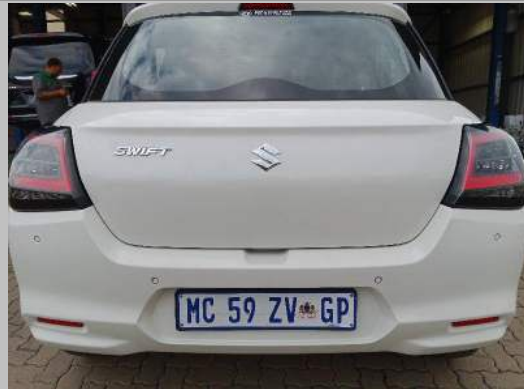
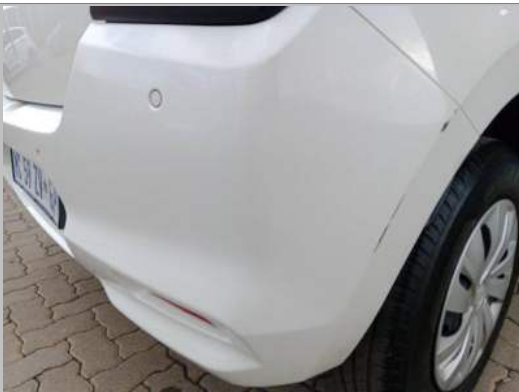
| Rear bumper Paintwork • Scratched | Repair |

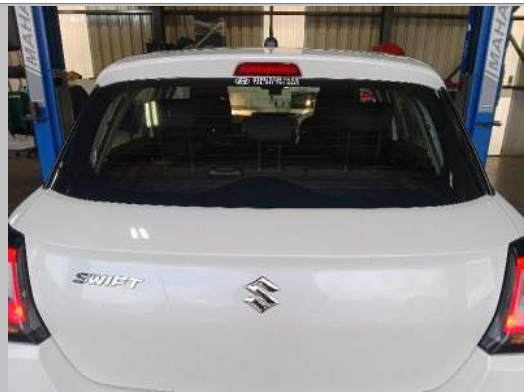
| Boot Lid / Hatch door Dented | Repair |

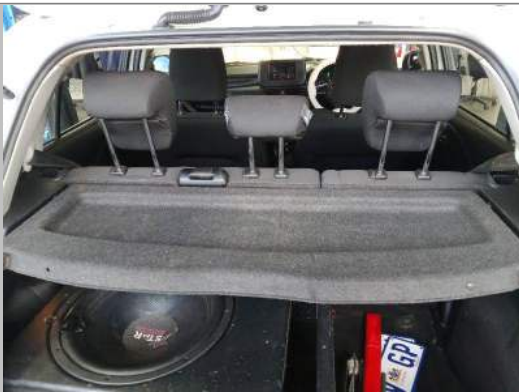
| Parcel Tray Damaged | Repair |

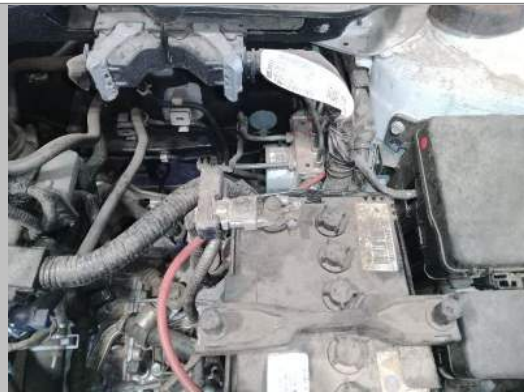
| Engine Wiring Defective | Repair |

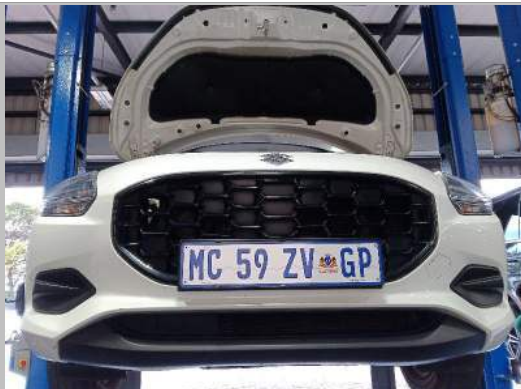
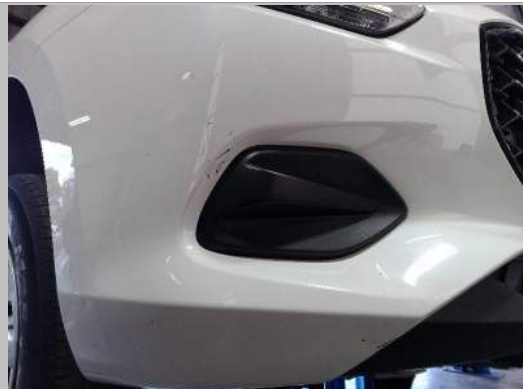
| Front Bumper Paintwork • Scratched | Repair |

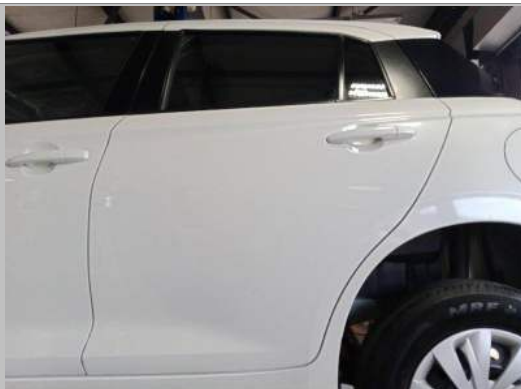
| Door Rear Left Paintwork • Scratched | Repair |

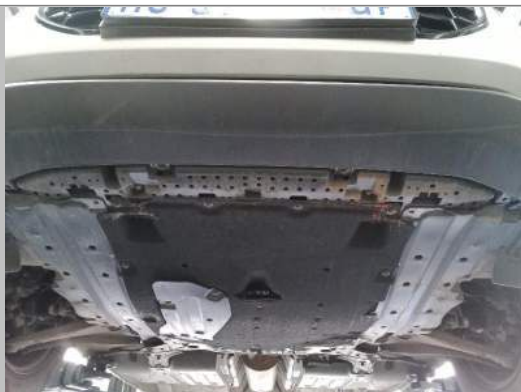
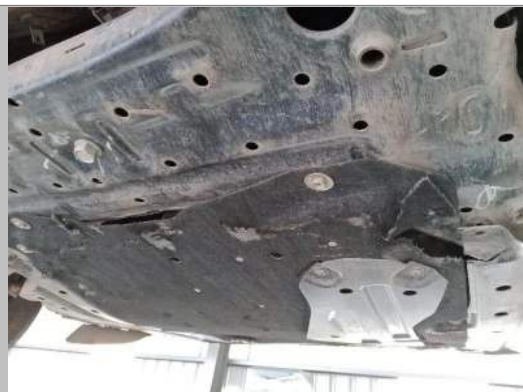
| Belly plates Damaged | Repair |

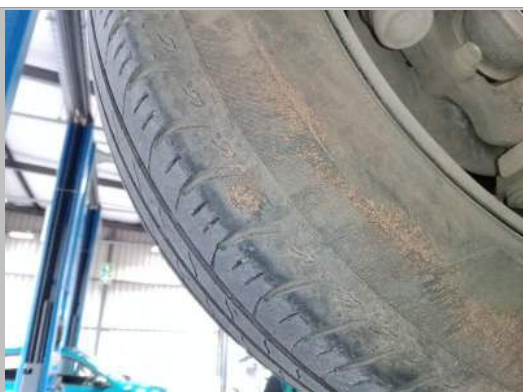
| Tyre Front Left Damaged | Replace |

| | Size | Load/Speed Index | Manufacture | Model | Type* | Production Date | Tread Depth (mm) |
|---|---|---|---|---|---|---|---|
| Front Left | 165/80 R14 | 85T | MRF | Ecotred | V | 2924 | 1 mm |

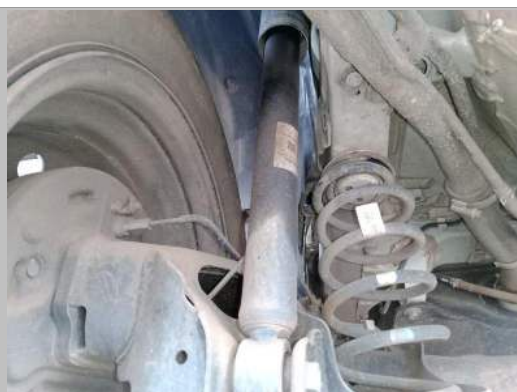
| Shock Absorber Rear Left Sweat | Replace |

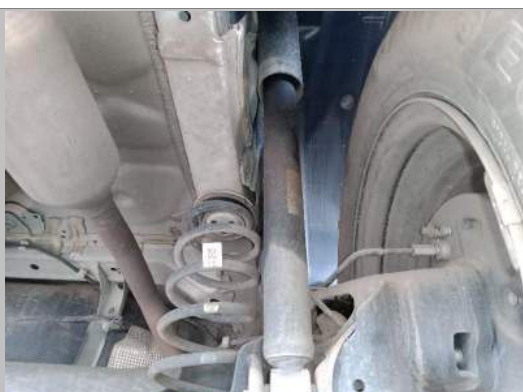
| Shock Absorber Rear Right Sweat | Replace |

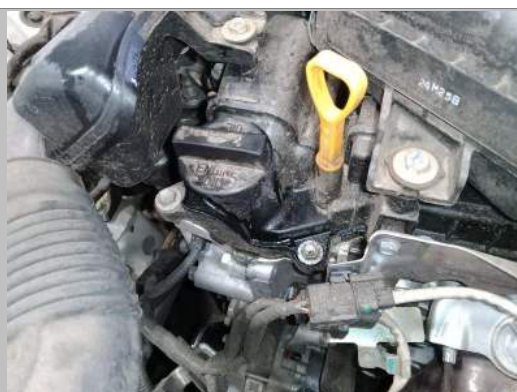
| Engine Oil Sweat | Repair |

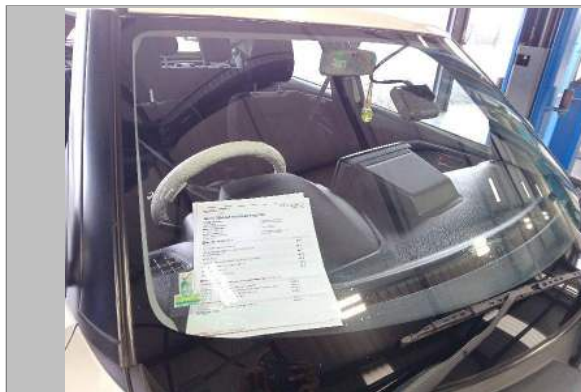
| Windscreen Chipped | Repair |

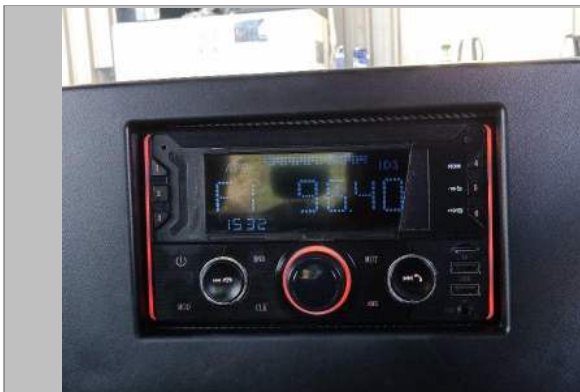
| Radio/CD/USB Defective | Repair |

General Comments: ACCORDING TO THE AGE AND MILEAGE OF THE VEHICLE, NORMAL WEAR AND TEAR MARKS ARE VISIBLE ON THE INTERIOR, EXTERIOR, ELECTRICAL AND MECHANICAL PARTS. Electrical Components and Instruments: Cluster faded. Non standard radio fitted to vehicle.

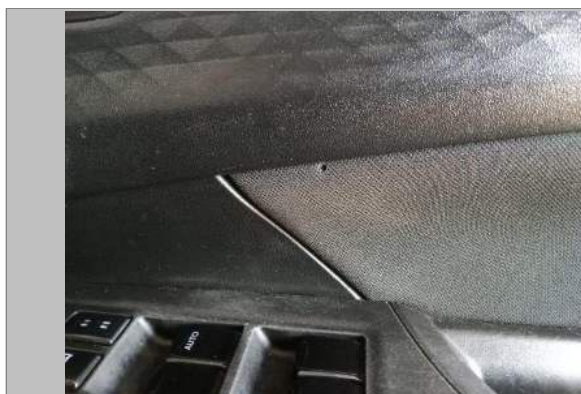
| Door Panel Front Right Damaged | Repair |
