## CONDITION REPORT

Report No:  
2016888250  
DATE  
23/05/2025

| Manufacturer | TOYOTA | Registration Number | KK83TWGP |
| Model | ETIOS 1.5 SPRINT [2019-2021] | Register Number | |

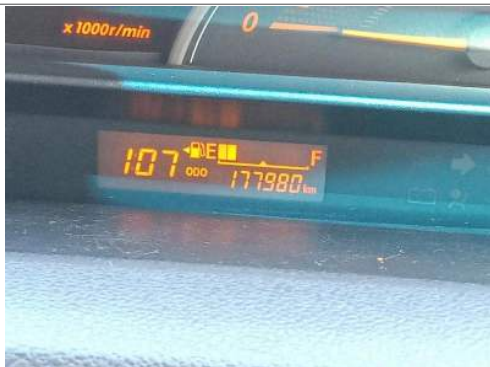
ODOMETER

| Damage | Repair Way |
|---|---|
| Vehicle electronics Faulty | Odometer and cluster lights malfunction |

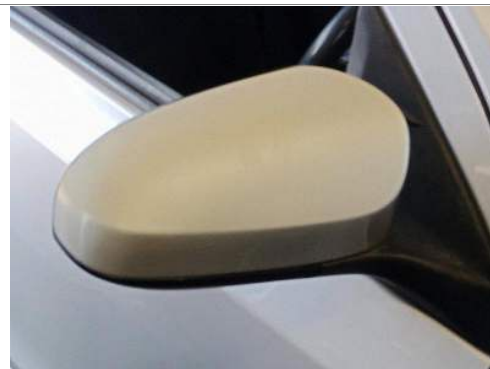
| Damage | Repair Way |
|---|---|
| Side Mirror Right Paintwork • Dull | Repair |

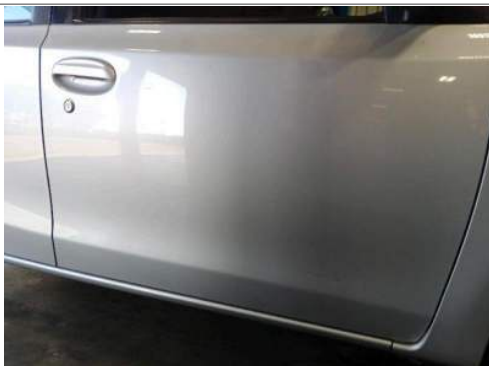
| Damage | Repair Way |
|---|---|
| Door Front Right Paintwork • Scratched | Repair |

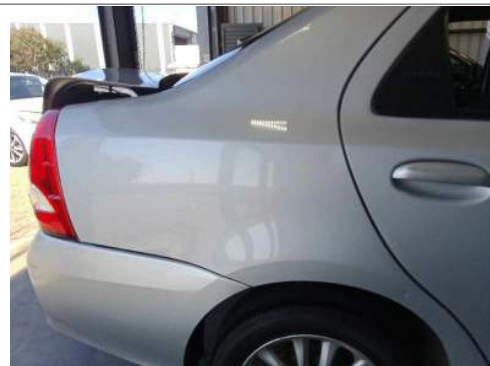
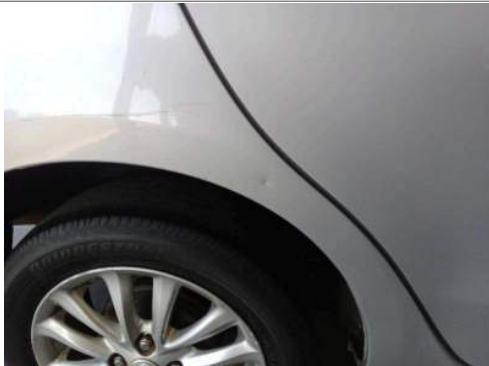
| Damage | Repair Way |
|---|---|
| Rear Fender Right Paintwork • Scratched | Repair |

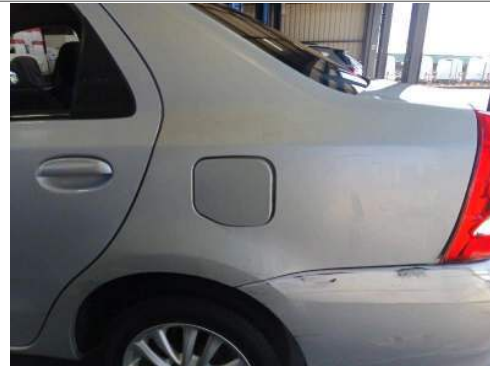
| Damage | Repair Way |
|---|---|
| Rear Fender Left Paintwork • Dull | Repair |

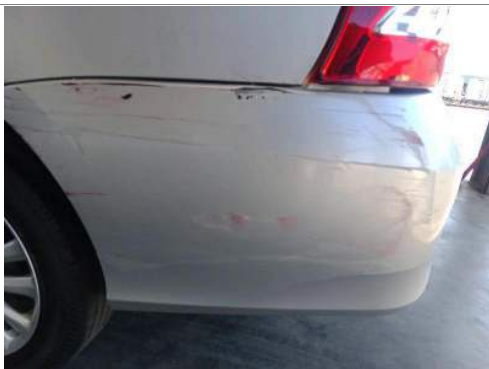
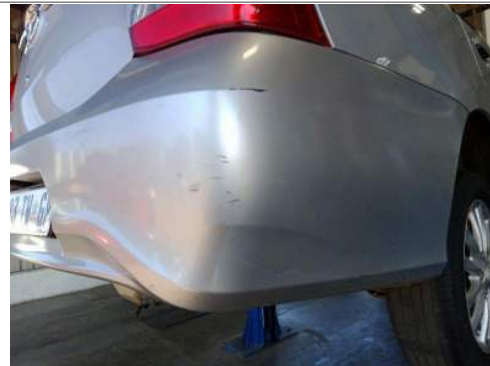
| Damage | Repair Way |
|---|---|
| Rear bumper Paintwork • Scratched | Repair |

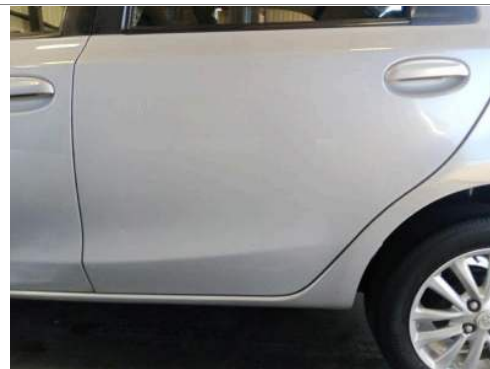
| Damage | Repair Way |
|---|---|
| Door Rear Left Paintwork • Scratched | Repair |

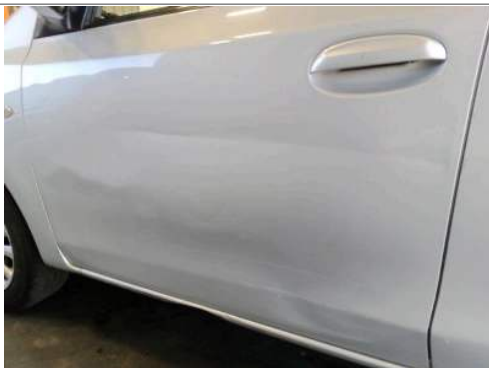
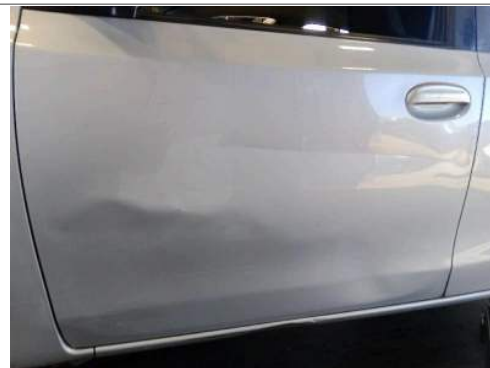
| Damage | Repair Way |
|---|---|
| Door Front Left Dented | Repair |

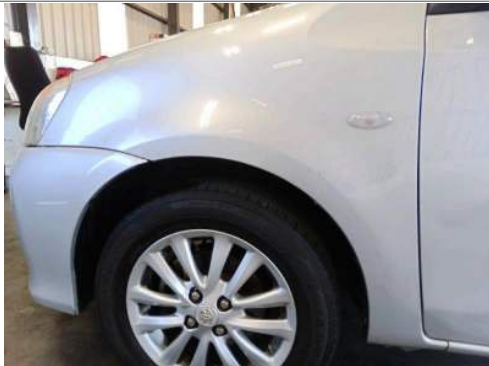
| Damage | Repair Way |
|---|---|
| Front Fender Left Paintwork • Scratched | Repair |

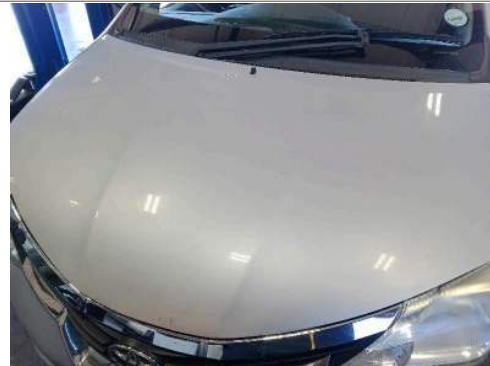
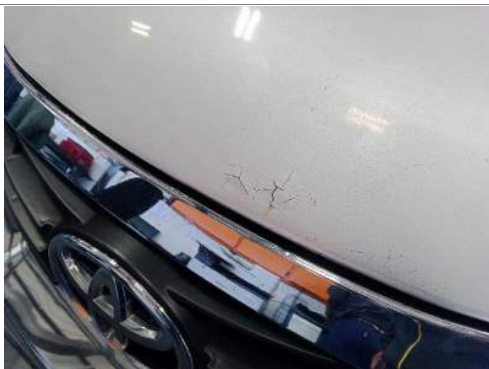
| Damage | Repair Way |
|---|---|
| Bonnet Paintwork • Dull | Repair |

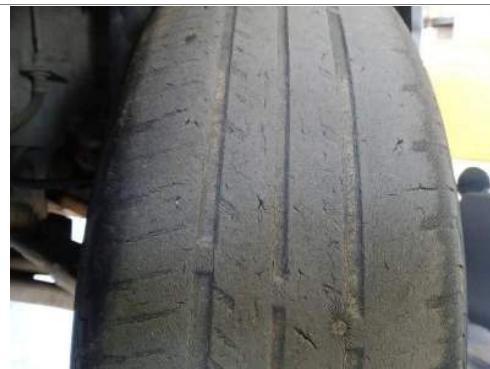
| Damage | Repair Way |
|---|---|
| Tyre Front Right Smooth | Replace |

| | Size | Load/Speed Index | Manufacture | Model | Type* | Production Date | Tread Depth (mm) |
|---|---|---|---|---|---|---|---|
| Front Right | 185/65R15 | 88H | Firestone | Touring | V | 0000 | 0 mm |

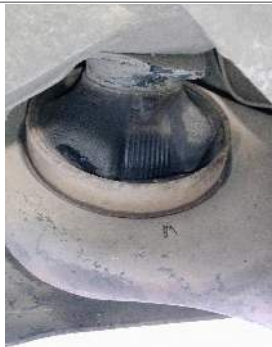
| Damage | Repair Way |
|---|---|
| Control Arm Bush(es) Front Axle Right Cracked | Replace |

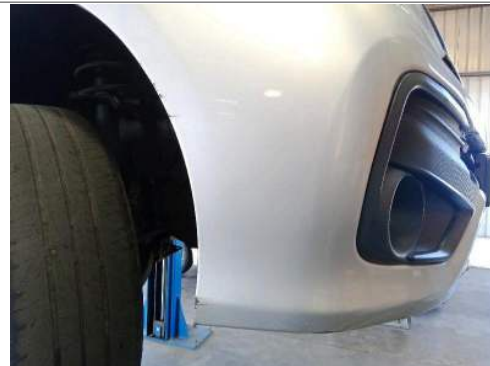
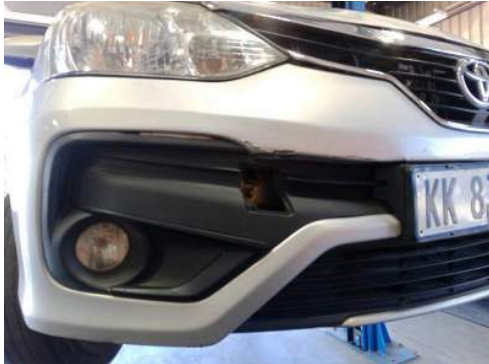
| Damage | Repair Way |
|---|---|
| Front Bumper Damaged | Repair |

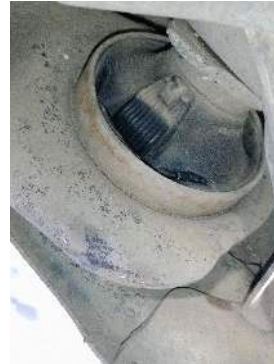
| Damage | Repair Way |
|---|---|
| Control Arm Bush(es) Front Axle Left Cracked | Replace |

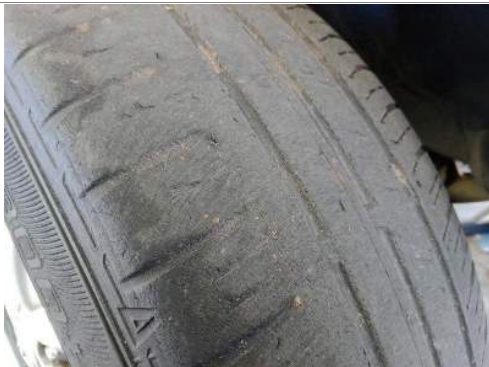
| Damage | Repair Way |
|---|---|
| Tyre Front Left Smooth | Replace |

| | Size | Load/Speed Index | Manufacture | Model | Type* | Production Date | Tread Depth (mm) |
|---|---|---|---|---|---|---|---|
| Front Left | 185/65R15 | 88T | Dunlop | Enasave | V | 3322 | 0 mm |

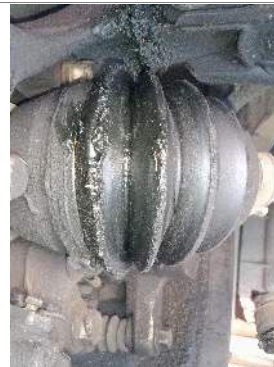
| Damage | Repair Way |
|---|---|
| CV Joint(s) Front Left (inner/outer) Damaged | Replace |

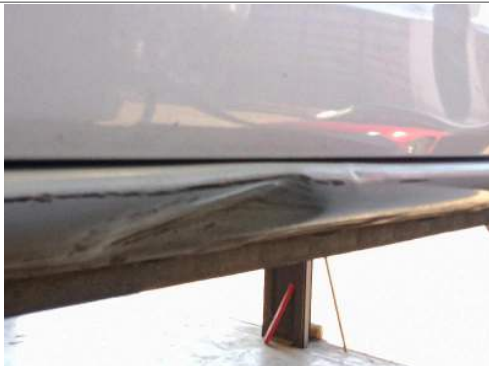
| Damage | Repair Way |
|---|---|
| Sill Panel Left Dented | Repair |

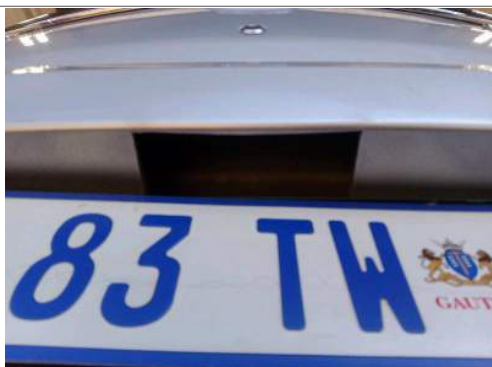
| Damage | Repair Way |
|---|---|
| Number Plate Light Right Missing | Replace |

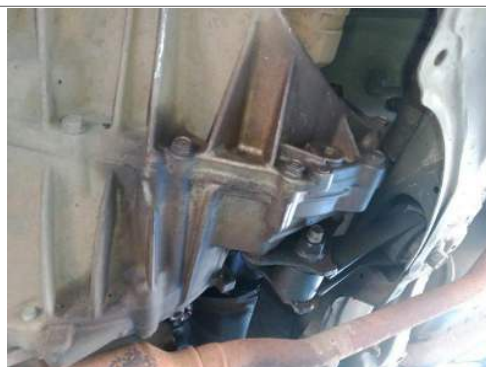
| Damage | Repair Way |
|---|---|
| Gearbox Oil Sweat | Repair |
