## CONDITION REPORT

Report No:  
2016960900  
DATE  
29/07/2025

| Manufacturer | TOYOTA | Registration Number | JM20GPGP |
| Model | ETIOS 1.5 SPRINT [2019-2021] | Register Number | |

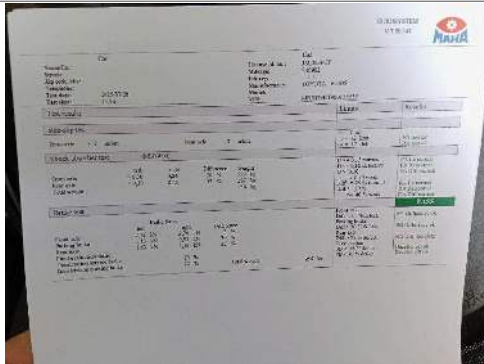
| | Left | Right | | |
|---|---|---|---|---|
| Rear | 1.63 | 1.18 | - | |
| Emergency / Parking | 1.13 | 0.91 | - | |

Brake test.

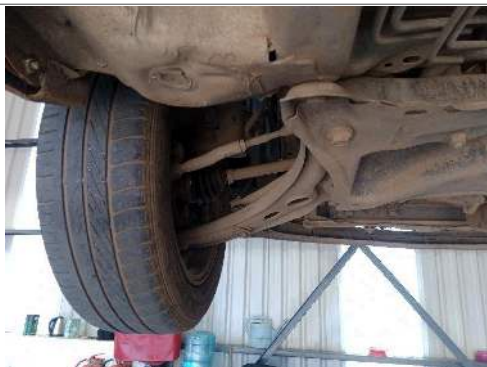
LF TYRE TREAD

| | Size | Load/Speed Index | Manufacture | Model | Type* | Production Date | Tread Depth (mm) |
|---|---|---|---|---|---|---|---|
| Front Left | 185/60R15 | 84T | Goodyear | Radial | V | 2921 | 1 mm |

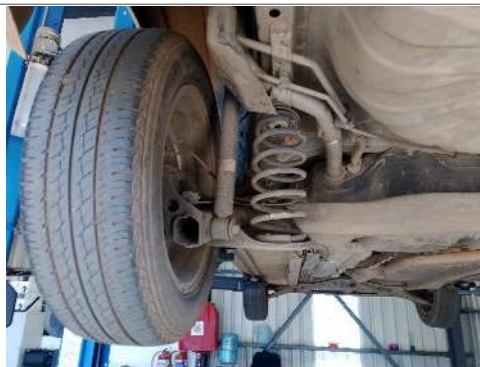
LR TYRE TREAD

| | Size | Load/Speed Index | Manufacture | Model | Type* | Production Date | Tread Depth (mm) |
|---|---|---|---|---|---|---|---|
| Rear Left | 185/65R15 | 88H | MRF | Radial | V | 4517 | 1 mm |

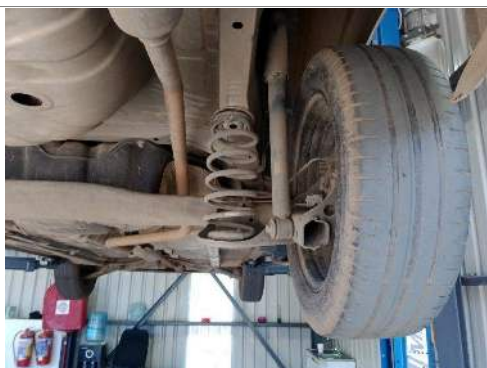
RR TYRE TREAD

| | Size | Load/Speed Index | Manufacture | Model | Type* | Production Date | Tread Depth (mm) |
|---|---|---|---|---|---|---|---|
| Rear Right | 185/60R15 | 84H | Dunlop | Sport | V | 1516 | 0 mm |

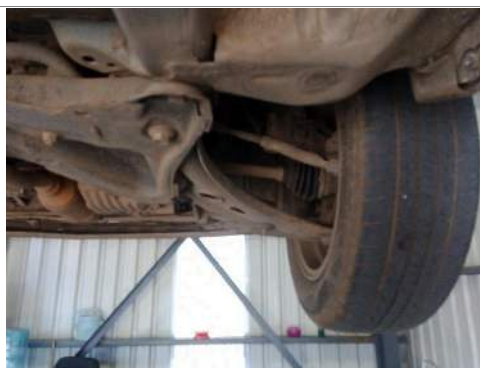
RF TYRE TREAD

| | Size | Load/Speed Index | Manufacture | Model | Type* | Production Date | Tread Depth (mm) |
|---|---|---|---|---|---|---|---|
| Front Right | 185/60R15 | 84H | Hilo | Radial | V | 1521 | 1 mm |

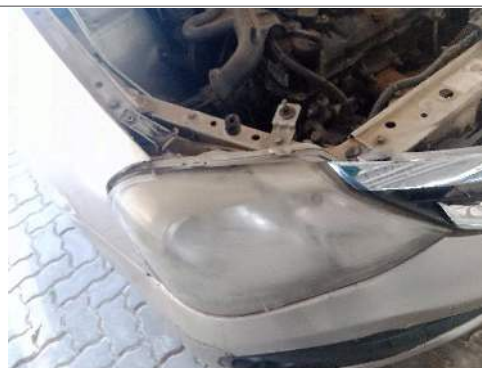
| Headlight Right Damaged | Repair |

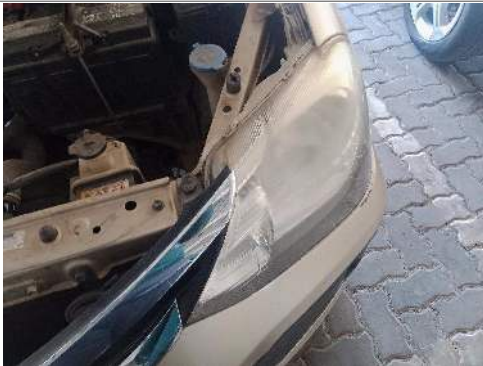
| Headlight Left Damaged | Repair |

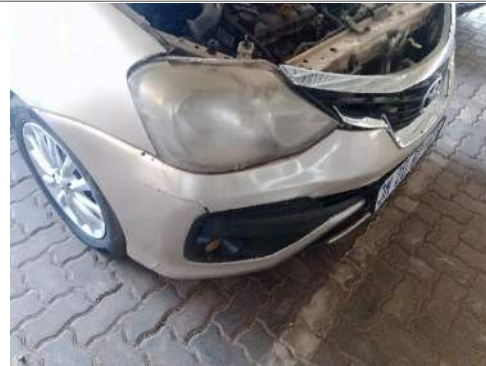
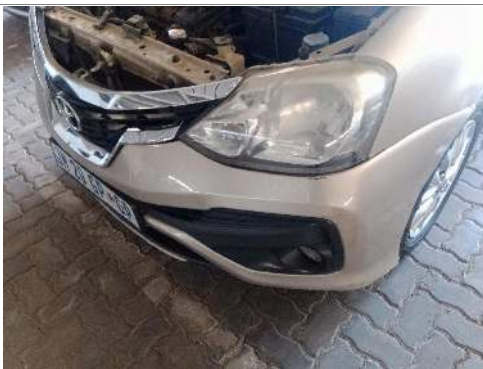
| Front Bumper Damaged | Repair |

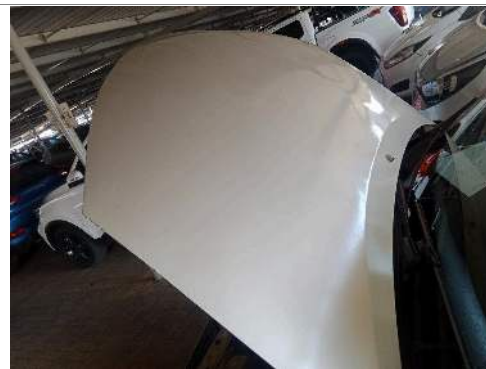
| Bonnet Damaged | Repair |

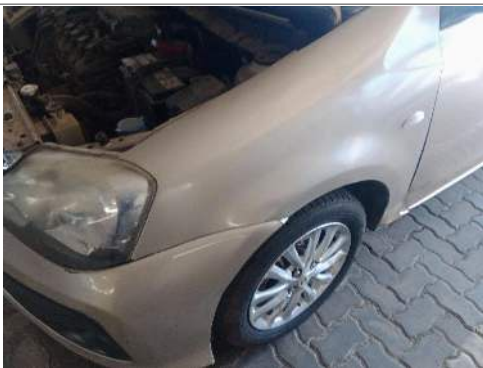
| Front Fender Left Damaged | Repair |

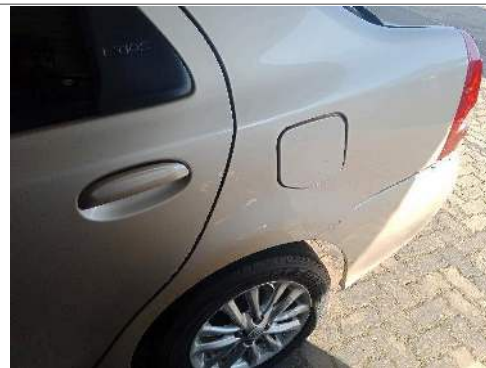
| Rear Fender Left Damaged | Repair |

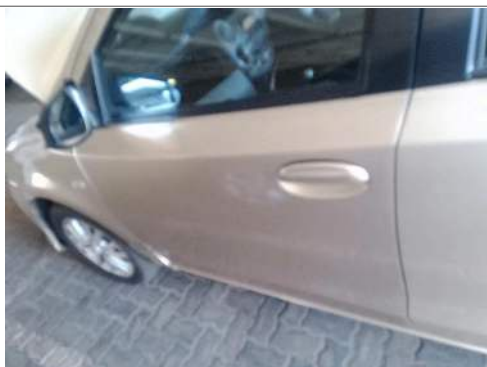
| Door Front Left Damaged | Repair |

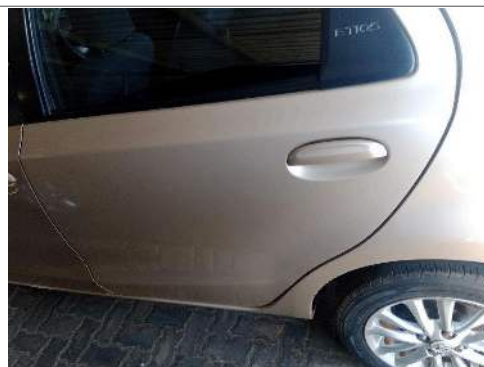
| Door Rear Left Damaged | Repair |

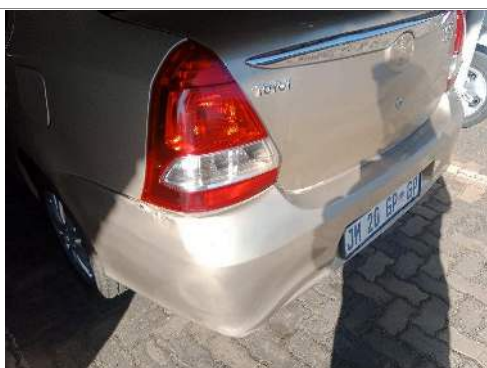
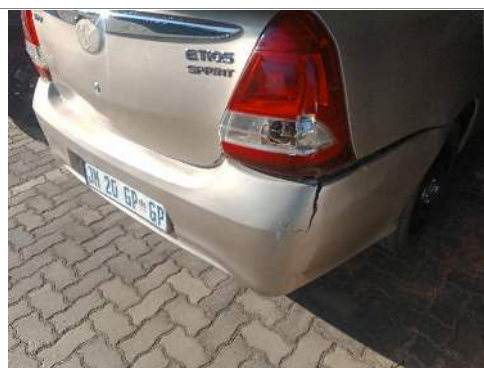
| Rear bumper Damaged | Repair |

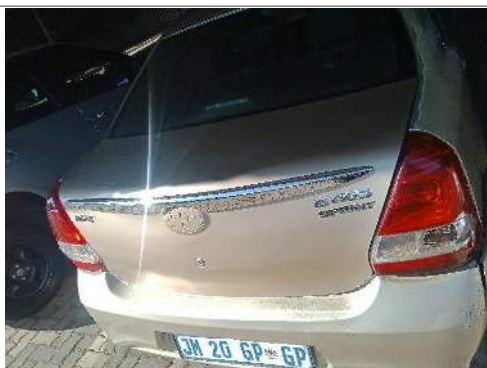
| Boot Lid / Hatch door Damaged | Repair |

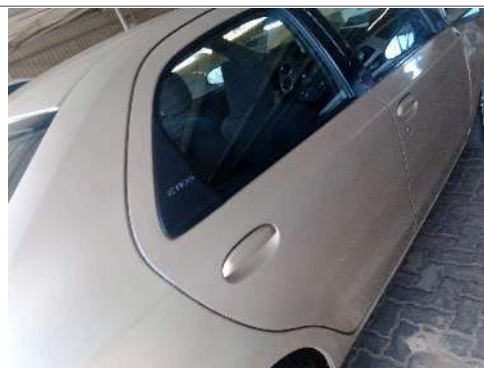
| Door Rear Right Damaged | Repair |

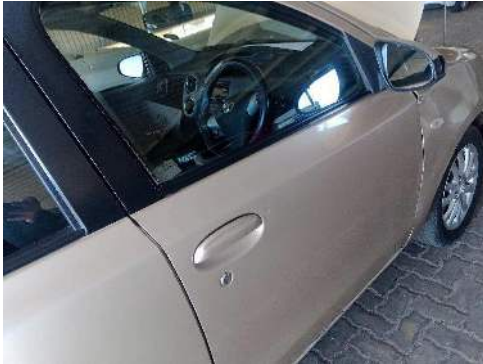
| Door Front Right Damaged | Repair |

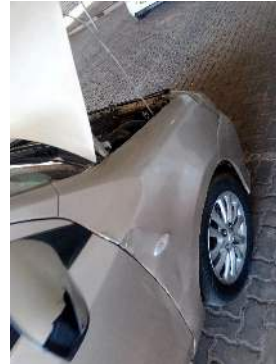
| Front Fender Right Damaged | Repair |

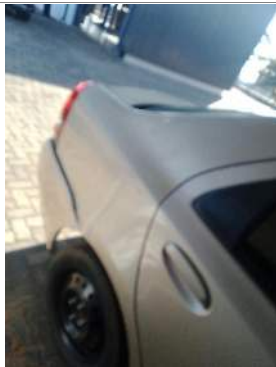
| Rear Fender Right Damaged | Repair |

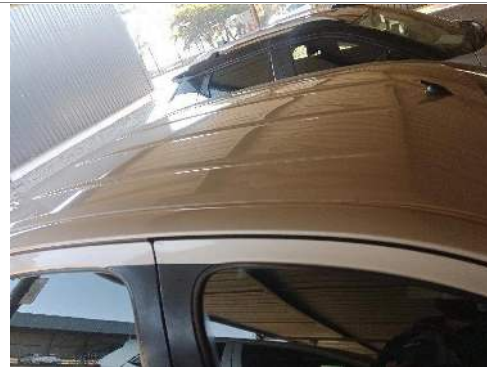
| Roof Damaged | Repair |

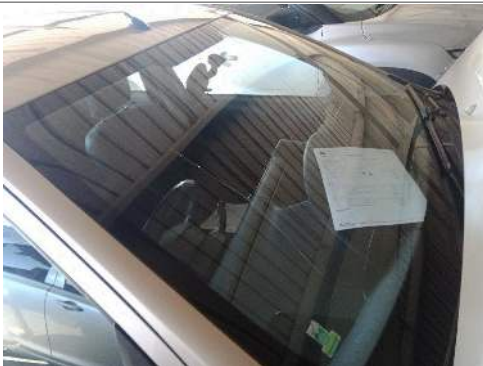
| Windscreen Damaged | Repair |

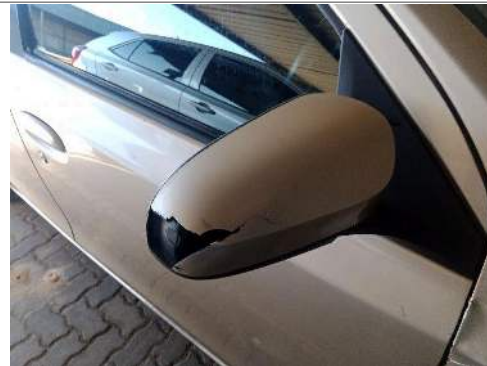
| Side Mirror Right Damaged | Replace |

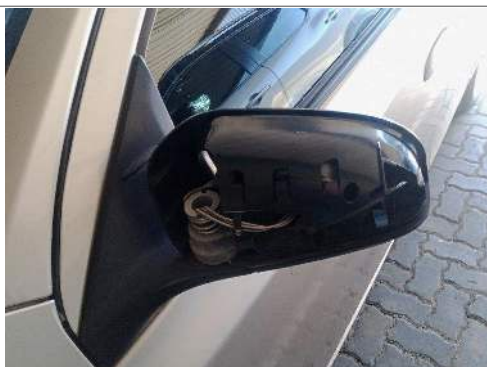
| Side Mirror Left Damaged | Replace |

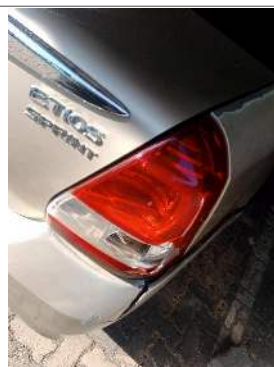
| Tail Light Right Damaged | Replace |

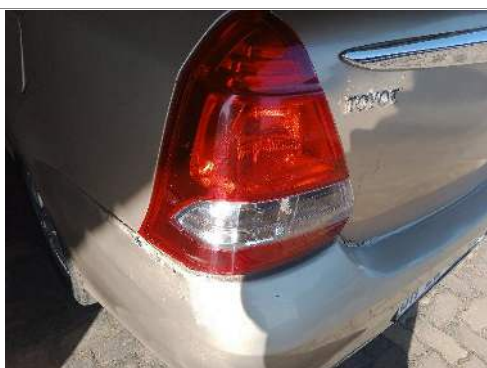
| Tail Light Left Damaged | Replace |

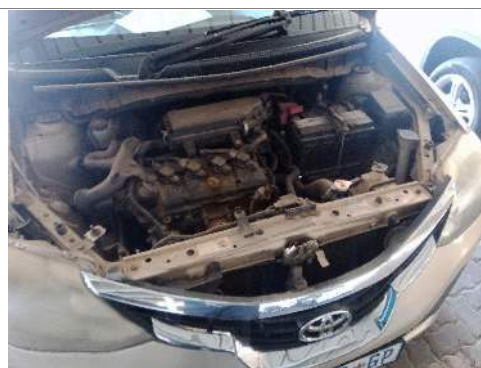
| Bonnet slam plate (Shock tower/ Inner tray) Damaged | Repair |

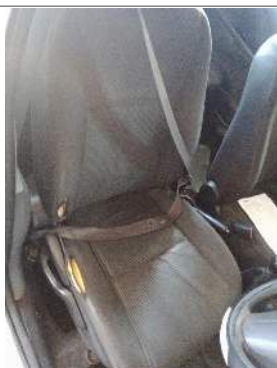
| Seat Front Right Damaged | Repair |

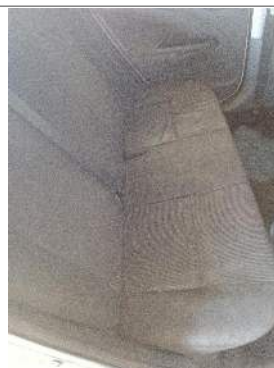
| Seat Rear Damaged | Repair |

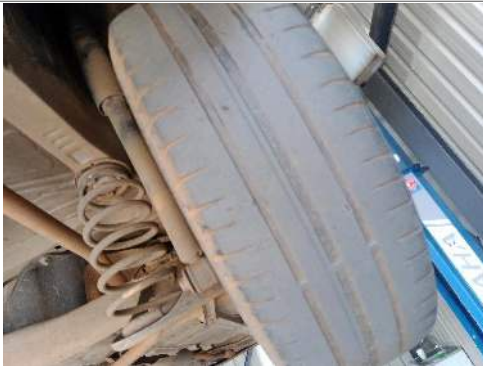
| Tyre Rear Right Worn | Replace |

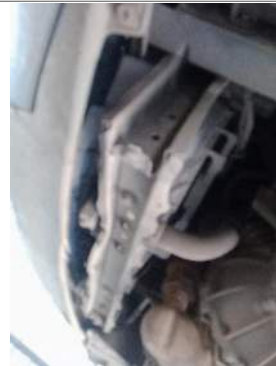
| Radiator Cross Member Damaged | Repair |

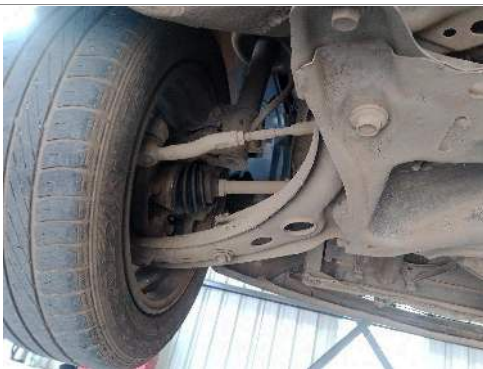
| Control Arm Bush(es) Front Axle Left Worn | Replace |

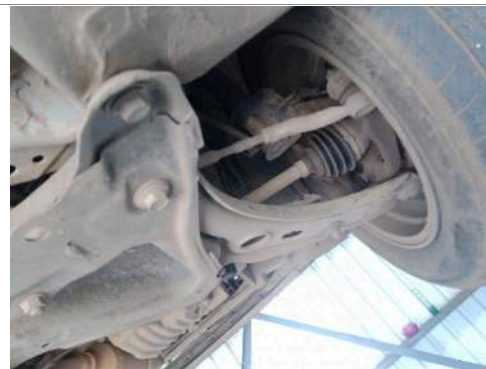
| Control Arm Bush(es) Front Axle Right Worn | Replace |
