CONDITION REPORT

Report No: 2016360916

MFC Auction House
M57 Pretoria Rd, Glenmarais, KEMPTON PARK
Gauteng

Vehicle Type	PASSENGER VEHICLE	Registered Owner	MFC AUCTION HOUSE
Manufacturer	TOYOTA	Registration Number	KN79XCGP
Model	ETIOS	Register Number	
VIN	MBJB29BTX00121092	Date Of First Licensing	
Engine Number		Last COR	
Doors	4	License Expiry Date	31/05/2023
Color	WHITE	Power / Displacement	
Year Model		Paint Finish	TWO COAT UNI
Km Reading	202,533 KM	Fuel	PETROL
Cab / Body Type	SEDAN	Transmission	MANUAL

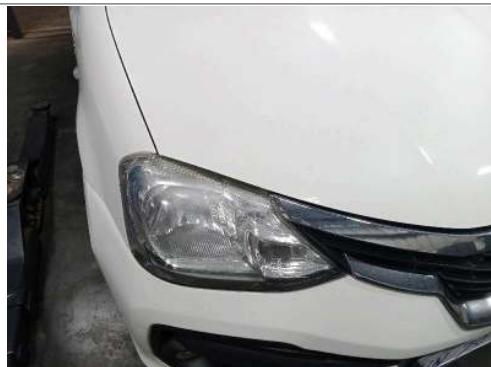
Damage	Repair Way
Fan Defective	Replace
Headlight Left Defective	Repair
Headlight Right Defective	Replace
Seat Front Right Damaged	Repair
Seat Rear Defective	Repair
Hood Lining Dirty	Repair
Door Sealing Rubber Front Right Damaged	Replace
Carpet Front Damaged	Repair
Steering Wheel Trim Defective	Repair
Side Mirror Left Paintwork • Scratched	Repair
Front Bumper Damaged	Repair
Bonnet Residual Traces of Repair	Repair
A • Pillar Right Dented	Repair
Front Fender Left Dented	Repair
Front Fender Right Dented	Repair
Rear Fender Left Damaged	Repair
Rear Fender Right Damaged	Repair
Door Front Left Residual Traces of Repair	Repair
Door Front Right Damaged	Repair
Door Rear Left Paintwork • Scratched	Repair
Door Rear Right Damaged	Repair
Doorstopper Front Right Defective	Replace
Doorstopper Rear Left Defective	Replace
Doorstopper Rear Right Defective	Replace
Boot Lid / Hatch door Dented	Repair
Rear bumper Damaged	Repair
Inner Boot Floor Pan and Spare Wheel Well Dented	Repair

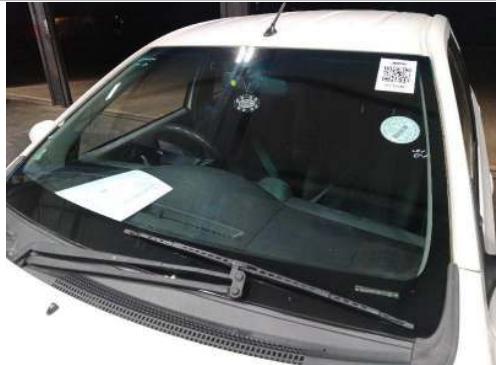
Damage	Repair Way
Rocker Panel Right Damaged	Repair
Roof Dented	Repair
Windscreen Chipped	Repair
Shock Absorber Front Left Sweat	Replace
Shock Absorber Front Right Sweat	Replace
Control Arm Bush(es) Front Axle Left Cracked	Replace
Control Arm Bush(es) Front Axle Right Cracked	Replace
Mounting Rubber(s) Rear Axle Left Cracked	Replace
Mounting Rubber(s) Rear Axle Right Cracked	Replace
Tyre Front Left Torn / Cut	Replace
Tyre Front Right Defective	Replace
Spare Tyre Damaged	Replace
Rim Front Left Scratched	Repair
Rim Front Right Scratched	Repair
Rim Rear Left Scratched	Repair
Rim Rear Right Scratched	Repair
Rim Spare Wheel Dented	Repair
Chassis Damaged	Repair
Cross Member Rear Right Scratched	Repair
Sub Frame Welded	Replace
Engine to silencer pipe Defective	Repair
Belly plates Damaged	Replace
Fuel Tank Defective	Repair
Radiator Cradle Damaged	Replace
Engine	Engine bay dirty
Body and Exterior	Dents and scratches on some body panels

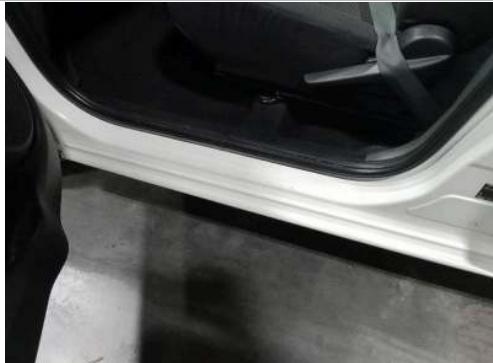
Sill Panel Left Paintwork • Scratched	Repair
Sill Panel Right Paintwork • Scratched	Repair

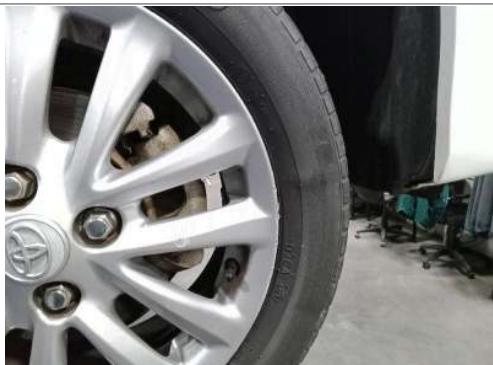
Tyre Front Right

Size	Load/Speed Index	Manufacture	Model	Type*	Production Date	Tread Depth (mm)
Front Left	185/60 R15	88H	Goodyear	Efficient	V	0719	0 mm
Front Right	185/60 R15	84H	Sumitomo	HTR H5	V	1921	0 mm
Rear Left	175/65 R15	88H	Zeta	Radial	V	3219	1 mm
Rear Right	175/65 R15	84H	Michelin	Energy	V	4116	1 mm
Spare	175/65 R15	84H	Hilo	HF201	V	0913	0 mm
