## CONDITION REPORT

Report No:  
2017302467  
DATE  
25/09/2026

MFC Auction House  
M57 Pretoria Rd, Glenmarais, KEMPTON PARK  
Gauteng

| Manufacturer | TOYOTA | Registration Number | JC11XYGP |

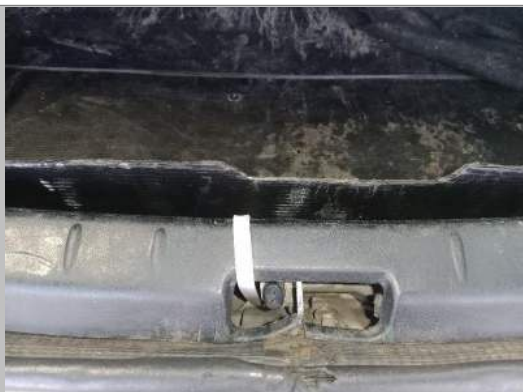
Interior boot lock plastic tri

| Damage | Repair Way |
|---|---|
| Interior boot lock plastic trim damaged | Replace |

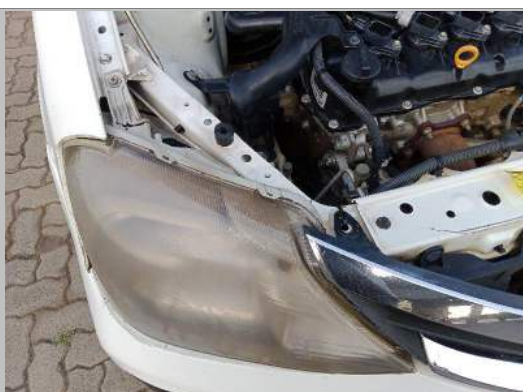
| Damage | Repair Way |
|---|---|
| Headlight Right Damaged | Replace |

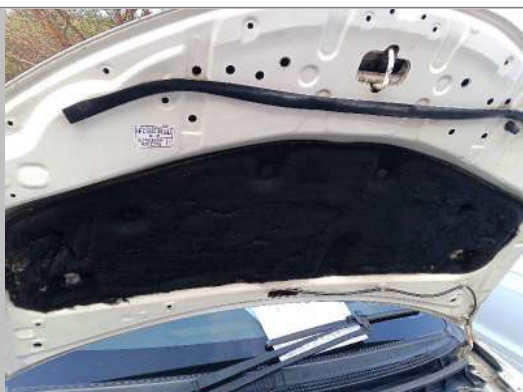
| Damage | Repair Way |
|---|---|
| Under bonnet insulation cover Damaged | Repair |

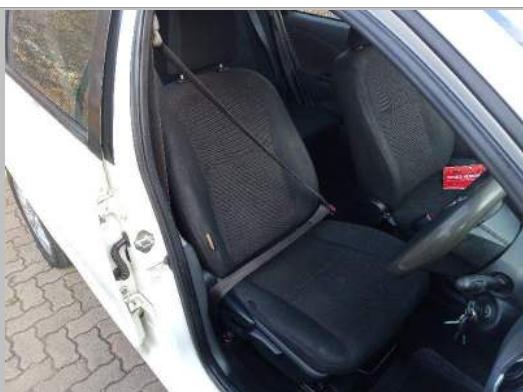
| Damage | Repair Way |
|---|---|
| Seat Front Right Damaged | Repair |

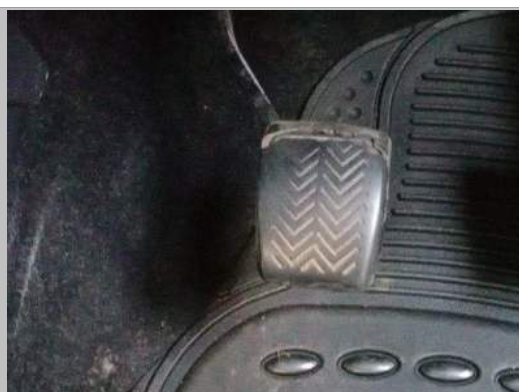
| Damage | Repair Way |
|---|---|
| Clutch Pedal Rubber Damaged | Replace |

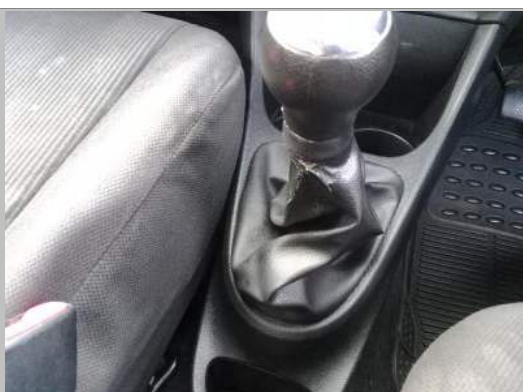
| Damage | Repair Way |
|---|---|
| Gear Lever Dust Boot Damaged | Repair |

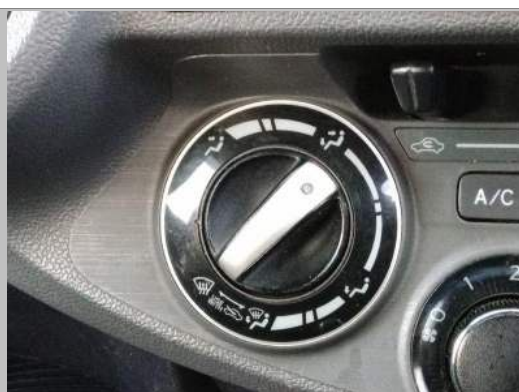
| Damage | Repair Way |
|---|---|
| Heater control Damaged | Replace |

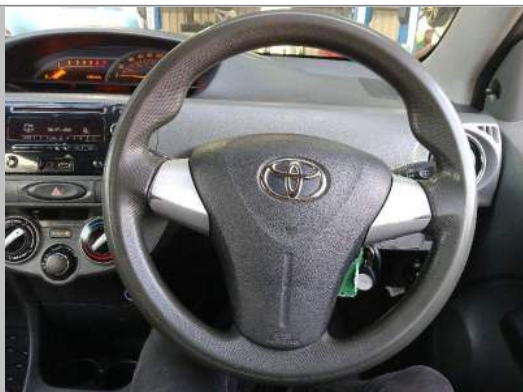
| Damage | Repair Way |
|---|---|
| Steering Wheel Trim Excessive Wear & Tear | Repair |

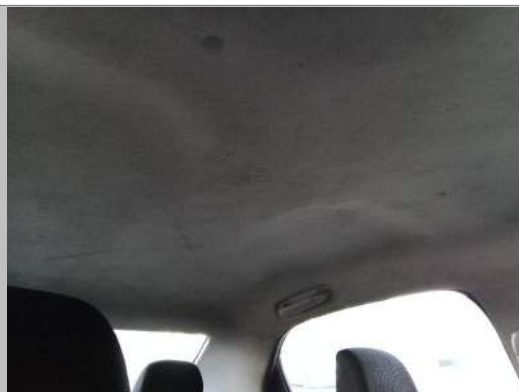
| Damage | Repair Way |
|---|---|
| Hood Lining Dirty | Repair |

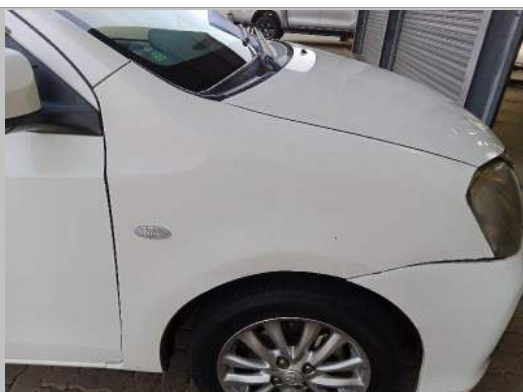
| Damage | Repair Way |
|---|---|
| Front Fender Right Damaged | Repair |

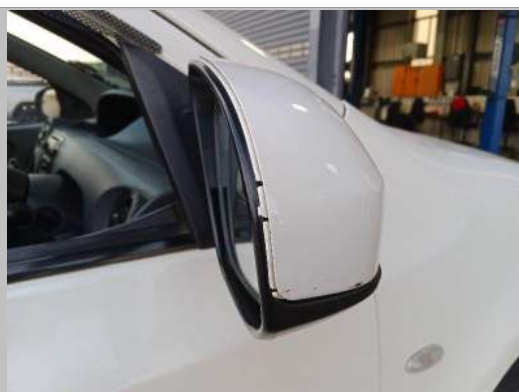
| Damage | Repair Way |
|---|---|
| Side Mirror Right Damaged | Repair |

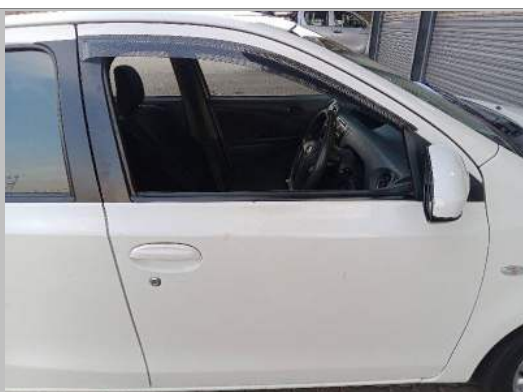
| Damage | Repair Way |
|---|---|
| Door Front Right Damaged | Repair |

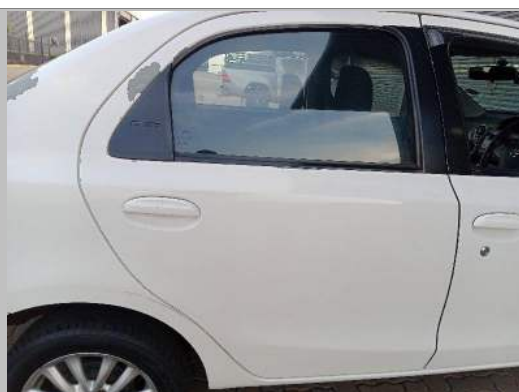
| Damage | Repair Way |
|---|---|
| Door Rear Right Paintwork • Flaking | Repair |

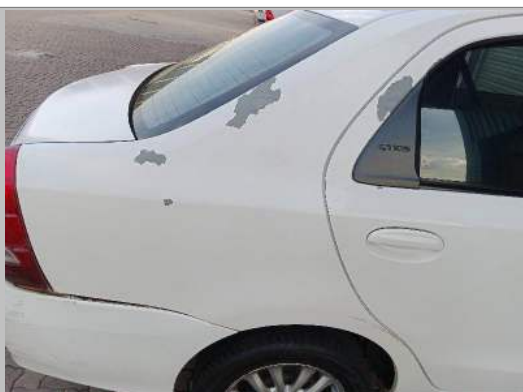
| Damage | Repair Way |
|---|---|
| Rear Fender Right Damaged | Repair |

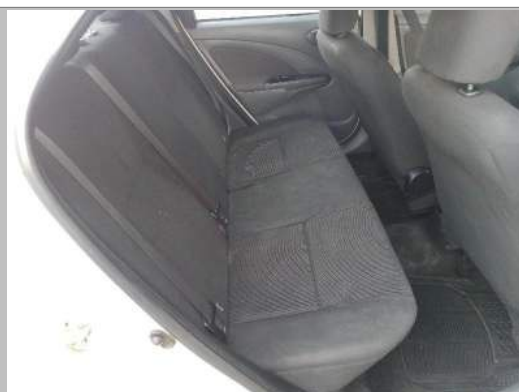
| Damage | Repair Way |
|---|---|
| Seat Rear Dirty | Repair |

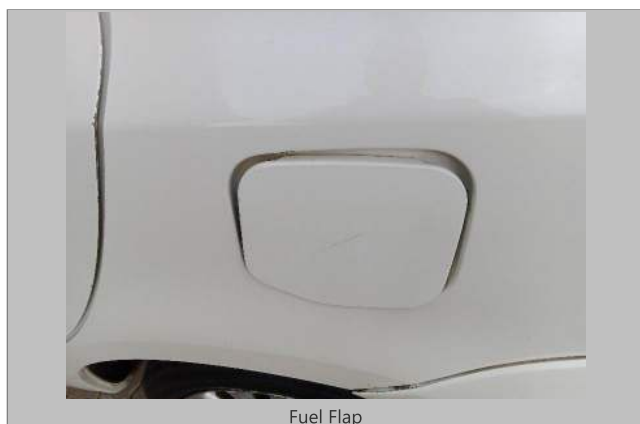
| Damage | Repair Way |
|---|---|
| Fuel Flap Damaged | Repair |

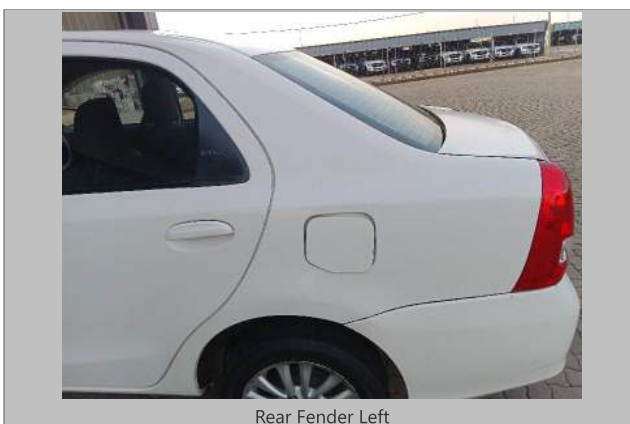
| Damage | Repair Way |
|---|---|
| Rear Fender Left Residual Traces of Repair | Repair |

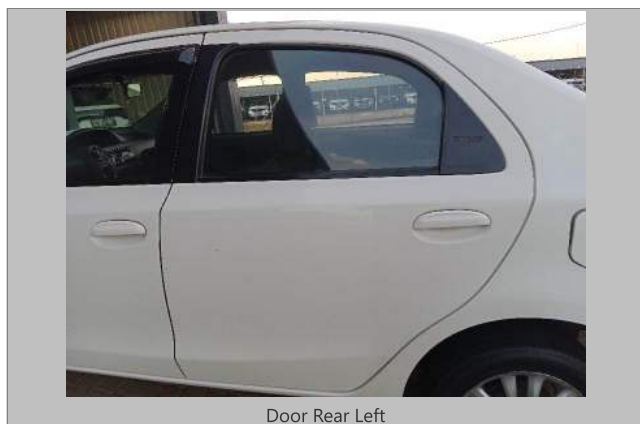
| Damage | Repair Way |
|---|---|
| Door Rear Left Residual Traces of Repair | Repair |

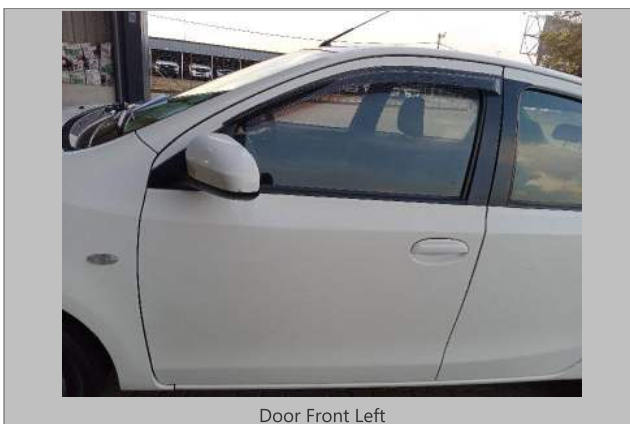
| Damage | Repair Way |
|---|---|
| Door Front Left Residual Traces of Repair | Repair |

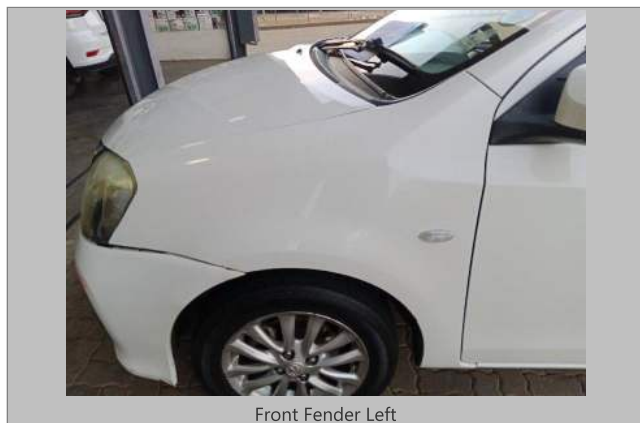
| Damage | Repair Way |
|---|---|
| Front Fender Left Damaged | Repair |

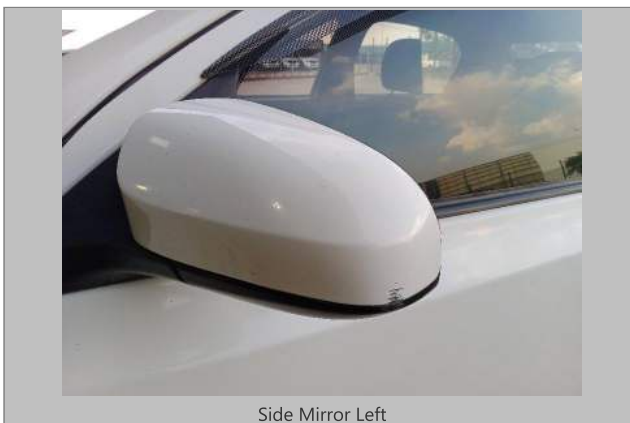
| Damage | Repair Way |
|---|---|
| Side Mirror Left Paintwork • Scratched | Repair |

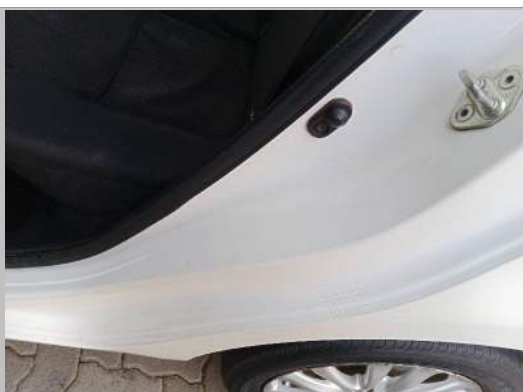
| Damage | Repair Way |
|---|---|
| C • Pillar Left Dented | Repair |

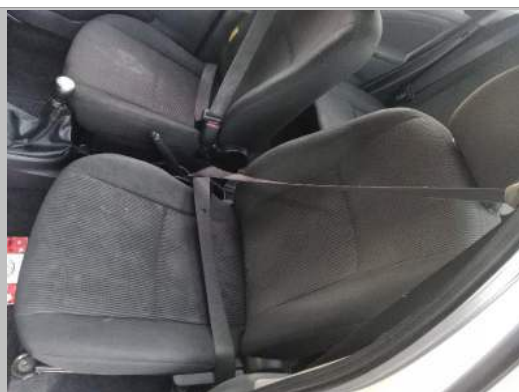
| Damage | Repair Way |
|---|---|
| Seat Front Left Dirty | Repair |

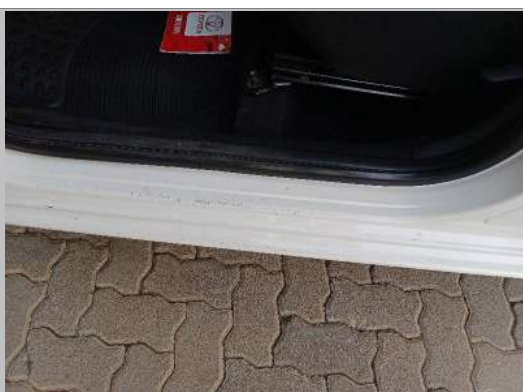
| Damage | Repair Way |
|---|---|
| Sill Panel Left Paintwork • Scratched | Repair |

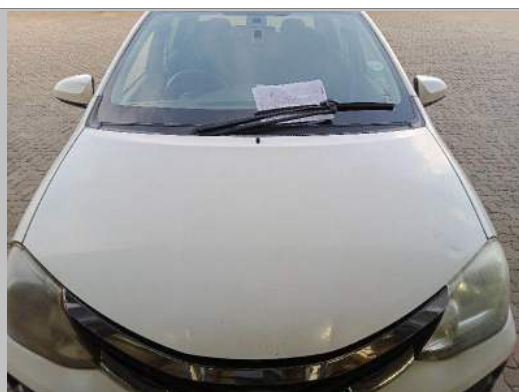
| Damage | Repair Way |
|---|---|
| Bonnet Damaged | Repair |

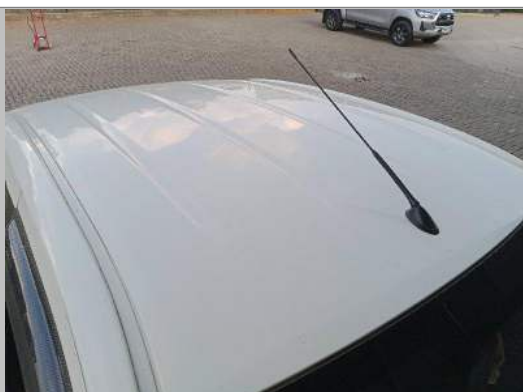
| Damage | Repair Way |
|---|---|
| Roof Dented | Repair |

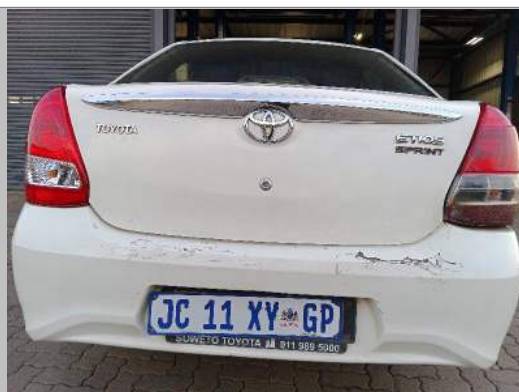
| Damage | Repair Way |
|---|---|
| Rear bumper Damaged | Repair |

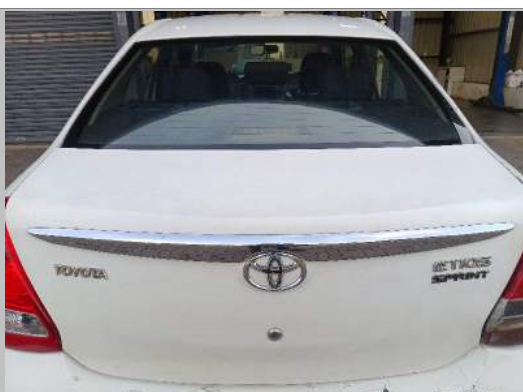
| Damage | Repair Way |
|---|---|
| Boot Lid / Hatch door Residual Traces of Repair | Repair |

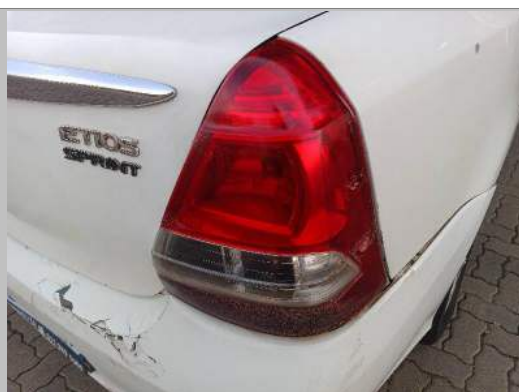
| Damage | Repair Way |
|---|---|
| Tail Light Right Damaged | Replace |

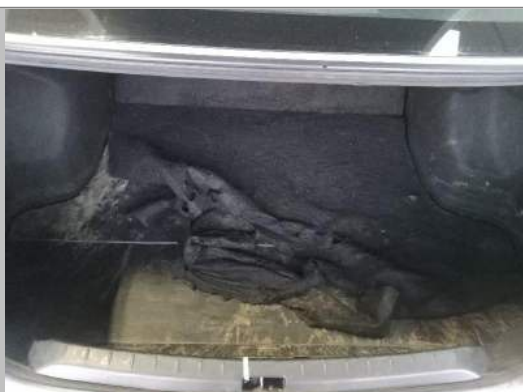
| Damage | Repair Way |
|---|---|
| Boot Carpet Damaged | Repair |

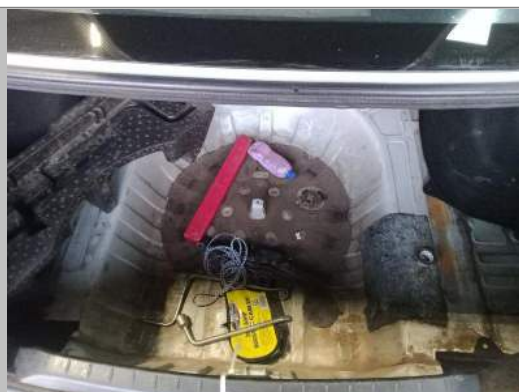
| Damage | Repair Way |
|---|---|
| Inner Boot Floor Pan and Spare Wheel Well Damaged | Repair |

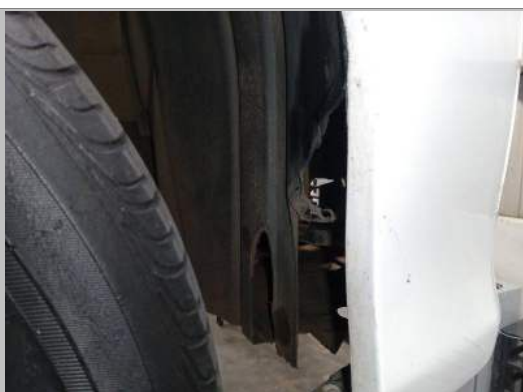
| Damage | Repair Way |
|---|---|
| Front Fender Right / Inner Tray Damaged | Replace |

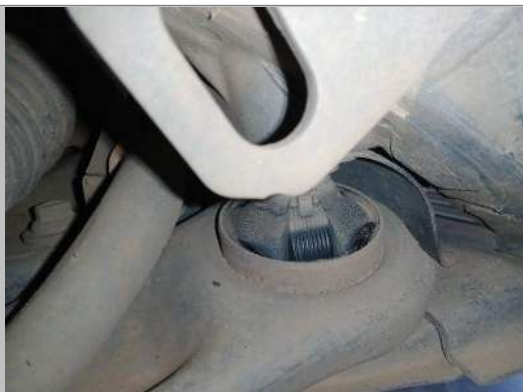
| Damage | Repair Way |
|---|---|
| Control Arm Bush(es) Front Axle Left Cracked | Replace |

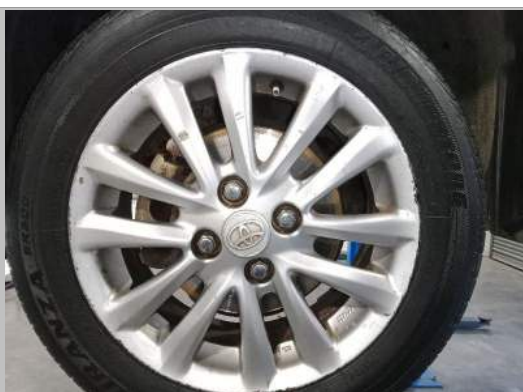
| Damage | Repair Way |
|---|---|
| Rim Front Left Scratched | Repair |

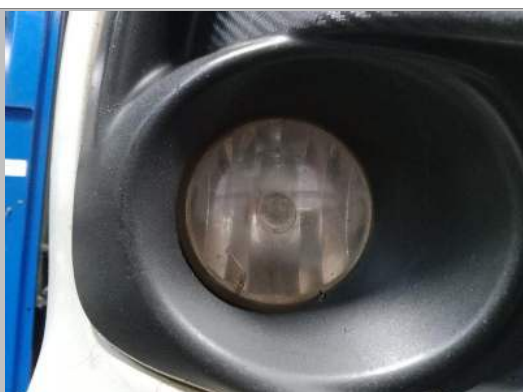
| Damage | Repair Way |
|---|---|
| Fog Light Front Right Cracked | Replace |

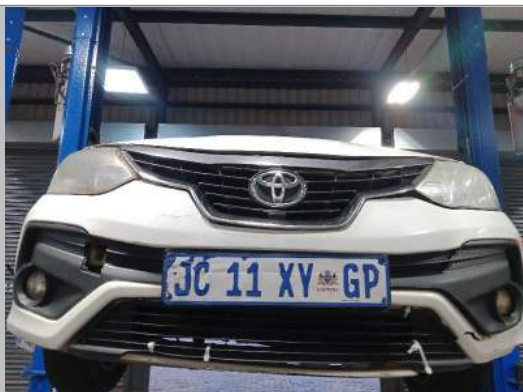
| Damage | Repair Way |
|---|---|
| Front Bumper Damaged | Replace |

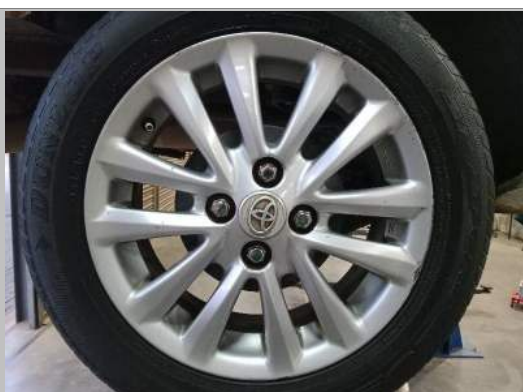
| Damage | Repair Way |
|---|---|
| Rim Rear Right Scratched | Repair |

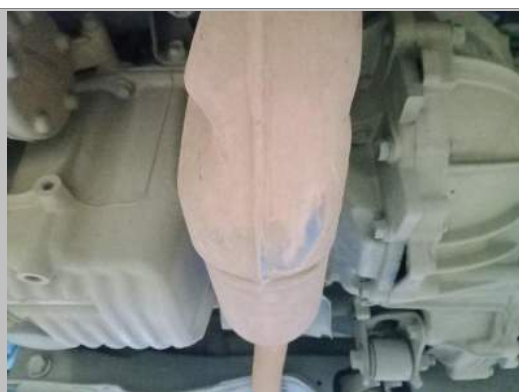
| Damage | Repair Way |
|---|---|
| Engine to silencer pipe Damaged | Replace |

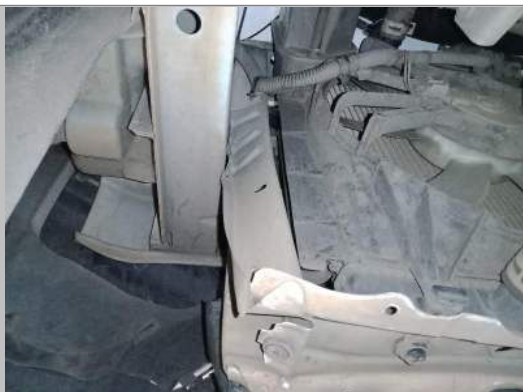
| Damage | Repair Way |
|---|---|
| Radiator Cradle Damaged | Replace |

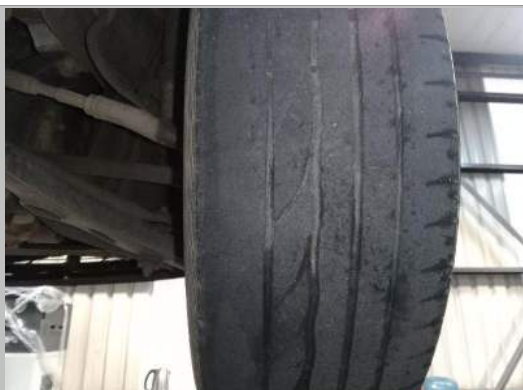
| Damage | Repair Way |
|---|---|
| Tyre Front Right Worn | Replace |

| | Size | Load/Speed Index | Manufacture | Model | Type* | Production Date | Tread Depth (mm) |
|---|---|---|---|---|---|---|---|
| Front Right | 185/60 R15 | 84H | Bridgestone | Turanza | V | 3218 | 0 mm |

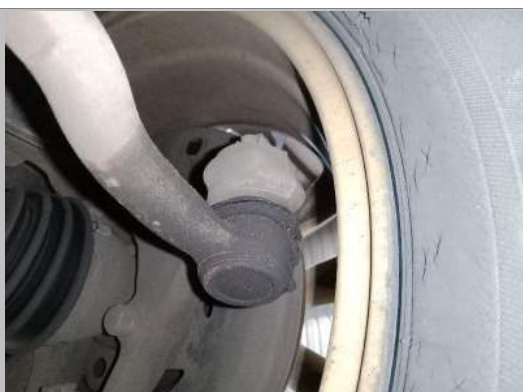
| Damage | Repair Way |
|---|---|
| Tie Rod End right Damaged | Replace |

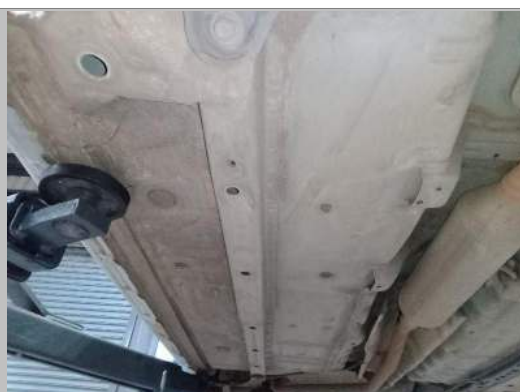
| Damage | Repair Way |
|---|---|
| Chassis Dented | Repair |

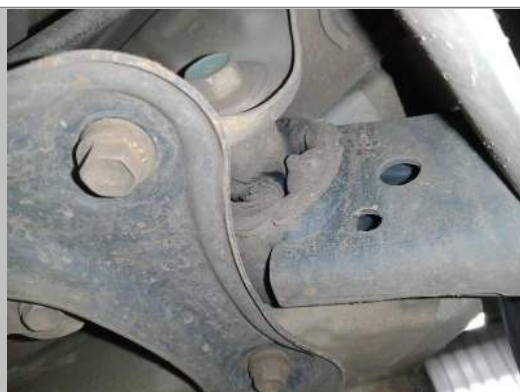
| Damage | Repair Way |
|---|---|
| Mounting Rubber(s) Rear Axle Right Cracked | Replace |

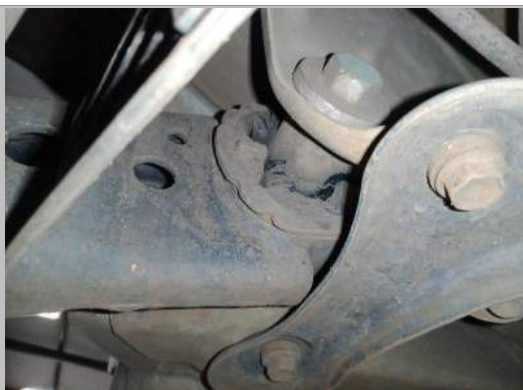
| Damage | Repair Way |
|---|---|
| Mounting Rubber(s) Rear Axle Left Cracked | Replace |

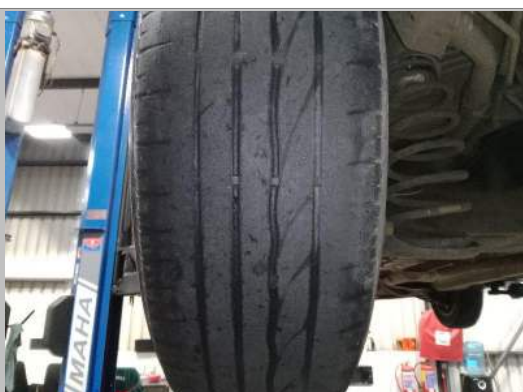
| Damage | Repair Way |
|---|---|
| Tyre Rear Left Worn | Replace |

| | Size | Load/Speed Index | Manufacture | Model | Type* | Production Date | Tread Depth (mm) |
|---|---|---|---|---|---|---|---|
| Rear Left | 185/60 R15 | 84H | Bridgestone | Turanza | V | 3218 | 0 mm |

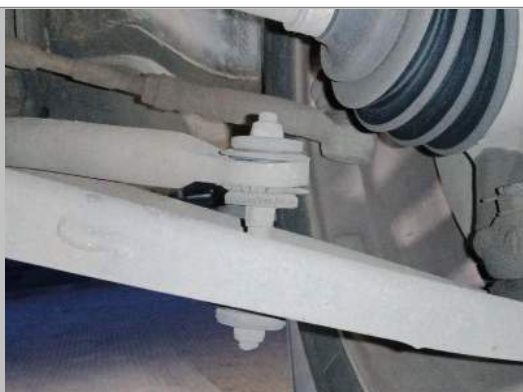
| Damage | Repair Way |
|---|---|
| Shock Absorber Mounting Front Left Damaged | Replace |

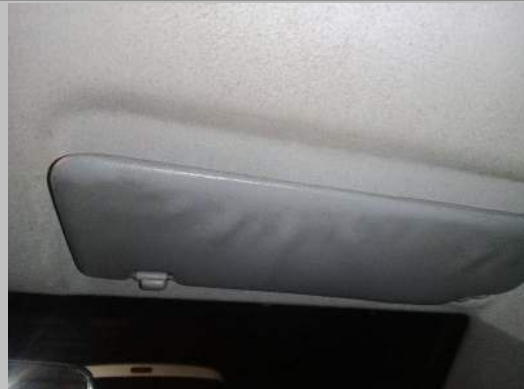
| Damage | Repair Way |
|---|---|
| Sun Visor Right Excessive Wear & Tear | Repair |
