## CONDITION REPORT

Report No:  
2017210529  
DATE  
07/04/2026

Vehicle Type	PASSENGER VEHICLE	Registered Owner	MFC
Manufacturer	TOYOTA	Registration Number	FLN994L
Model	ETIOS 1.5 SPRINT 5-DR [2019-2021]	Register Number	
VIN	MBJM29BT102063399	Date Of First Licensing	
Engine Number		Last COR	
Doors	5	License Expiry Date	31/05/2023
Color	WHITE	Power / Displacement	
Year Model	2019	Paint Finish	TWO COAT UNI
Km Reading	85,274 KM	Fuel	PETROL
Cab / Body Type	HATCHBACK	Transmission	MANUAL

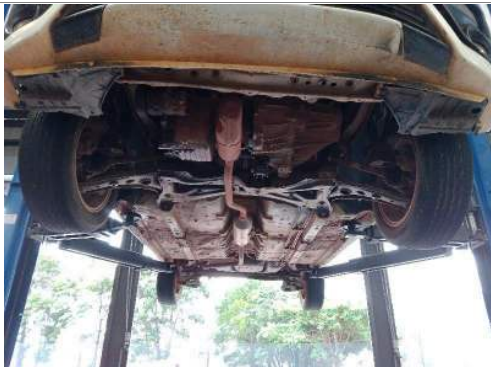
Front chassis

Damage	Repair Way
Road test	Vehicle has a hard start
Airbag warning light illuminated on dashboard	Repair
Engine	Aircon condenser dented
Road test	Vehicle is a cut and joint on chassis
Road test	Vehicle safety integrity compromised

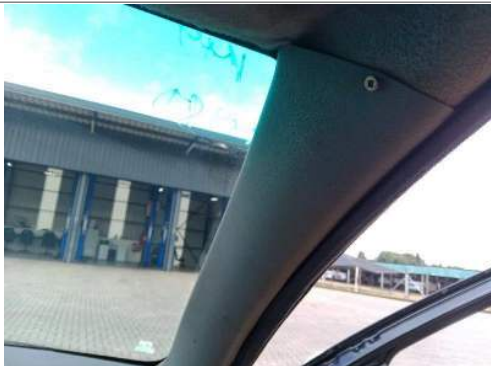
Front right inner A pillar pla

CV Joint(s) Boot(s) Front Right (inner/outer) Damaged	Replace
Radiator Cradle Damaged	Replace
Steering Malfunction	Repair
Brakes Insufficient	Repair
Interior	Front right inner A pillar plastic trim damaged
Body and Exterior	Front bumper stiffener dented

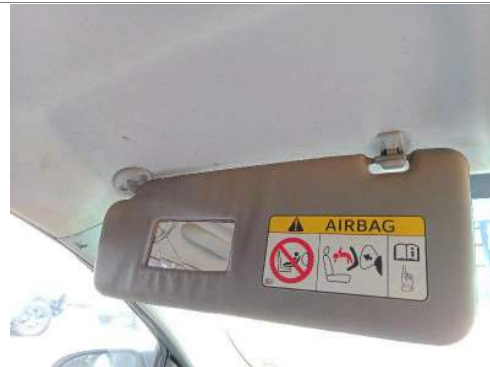
Damage	Repair Way
Engine Oil Sweat	Repair
Oil level Insufficient	Replace
Air cleaner Damaged	Replace
Hooter Defective	Repair
Windscreen Wiper Damaged	Replace
Air Conditioner Insufficient	Replace
Tail Light Right Defective	Replace
Headlight Right Damaged	Replace
Seat Rear Damaged	Repair
Sun Visor Left Cracked	Replace
Sun Visor Right Cracked	Replace
Hood Lining Damaged	Repair
Door Panel Front Left Damaged	Repair
Door Panel Front Right Damaged	Repair
Door Handle Rear Right Damaged	Replace
Dash Padding Damaged	Repair
Carpet Rear Torn / Cut	Repair
Front Bumper Damaged	Repair
Grill Damaged	Replace
Bonnet Residual Traces of Repair	Repair
Bonnet slam plate (Shock tower/ Inner tray) Damaged	Repair
A • Pillar Left Residual Traces of Repair	Repair
A • Pillar Right Residual Traces of Repair	Repair
B • Pillar Left Residual Traces of Repair	Repair
B • Pillar Right Residual Traces of Repair	Repair
C • Pillar Right Residual Traces of Repair	Repair

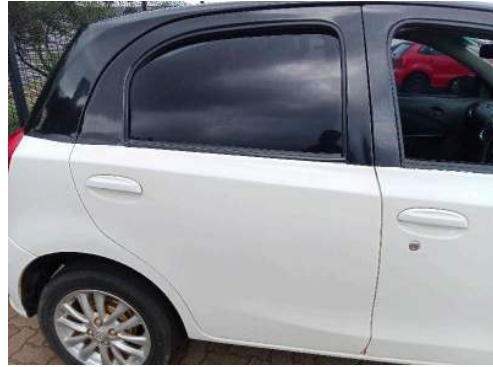
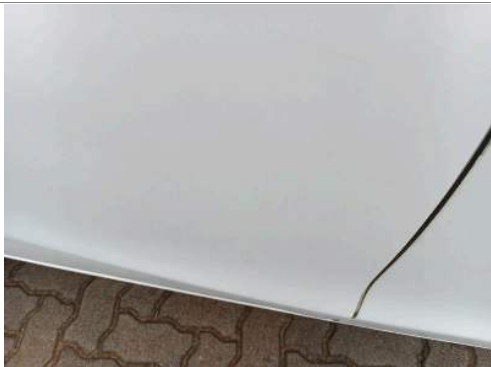
Front Fender Right Damaged	Repair
Rear Fender Left Dented	Repair
Front Fender Right / Inner Tray Damaged	Repair
Door Front Left Paintwork • Scratched	Repair
Door Front Right Damaged	Repair
Door Rear Left Residual Traces of Repair	Repair
Door Rear Right Paintwork • Scratched	Repair
Boot Lid / Hatch door Damaged	Repair
Rear bumper Residual Traces of Repair	Repair
Inner Boot Floor Pan and Spare Wheel Well Dented	Repair
Sill Panel Left Damaged	Repair
Sill Panel Right Dented	Repair
Roof Residual Traces of Repair	Repair
Service Brake Performance Rear Axle Left / Right	Repair
Difference out of legal range	
Shock Absorber Rear Right Leak	Replace
Alignment Poor Alignment	Repair
Control Arm Bush(es) Front Axle Left Cracked	Replace
Control Arm Bush(es) Front Axle Right Cracked	Replace
Tyre Rear Left Damaged	Replace
Tyre Rear Right Worn	Replace
Rim Front Left Scratched	Repair
Main Beam Right Dented	Repair
Chassis Welded	Repair

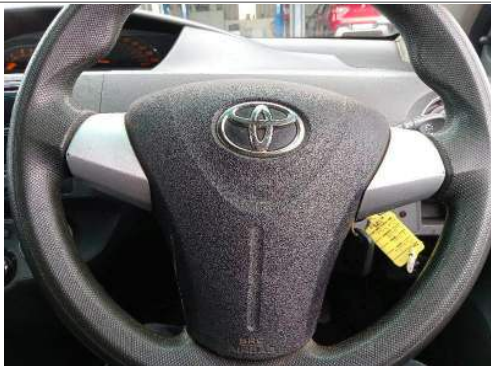
General Comments: ACCORDING TO THE AGE AND MILEAGE OF THE VEHICLE, NORMAL WEAR AND TEAR MARKS ARE VISIBLE ON THE INTERIOR, EXTERIOR, ELECTRICAL AND MECHANICAL PARTS. Electrical Components and Instruments: Hooter not working  
Body • Exterior: Dents and scratches on some body panels. Stone chips and spray work on some body panels. Some body panels misaligned. Poor residual traces of repair on some body panels.  
Road Test: Vehicle unsafe to drive.
