CONDITION REPORT

Report No: 2016269378

Vehicle Type	PASSENGER VEHICLE	Registered Owner	MFC AUCTION HOUSE
Manufacturer	NISSAN	Registration Number	FZ83CBGP
Model	ALMERA	Register Number	
VIN	MDHBBAN17Z0718574	Date Of First Licensing	
Engine Number		Last COR	
Doors	4	License Expiry Date	29/02/2024
Color	SILVER	Power / Displacement	
Year Model		Paint Finish	M - METALLIC
Km Reading	328,332 KM	Fuel	PETROL
Cab / Body Type	SEDAN	Transmission	MANUAL

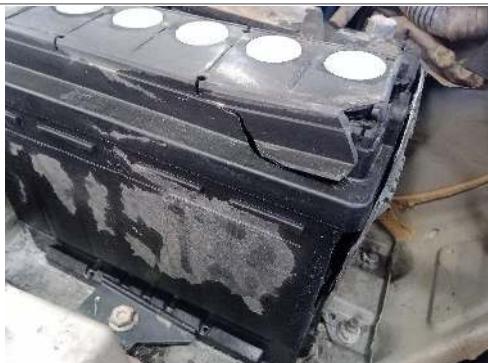
Battery damage

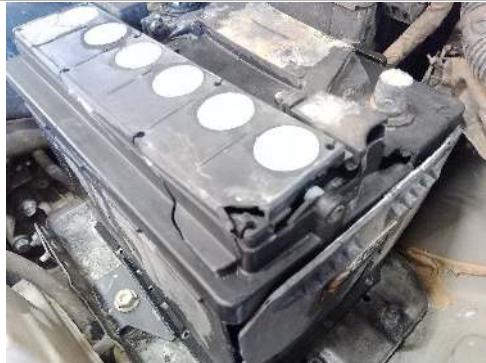
Battery damage

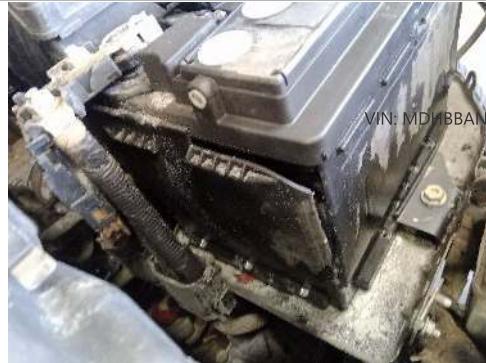
Battery damage

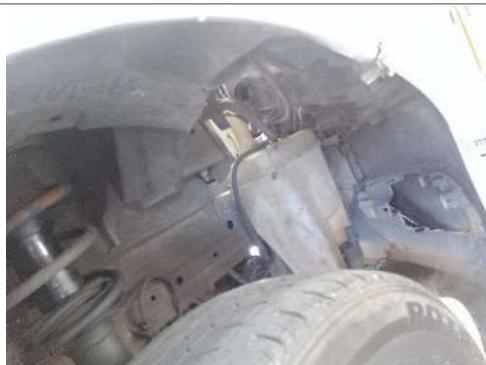
R/F fender liner missing.

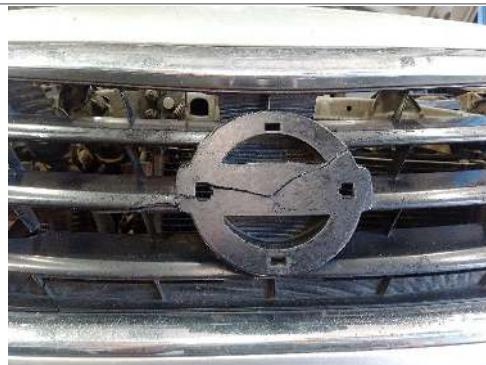
Missing badge

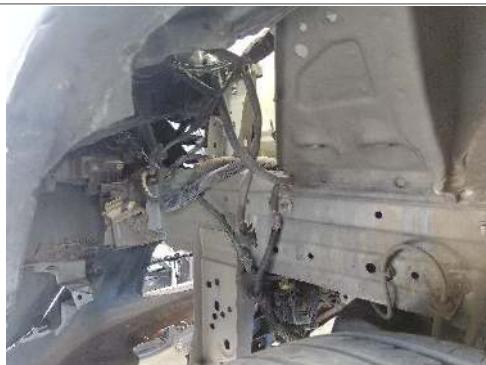
L/F fender liner missing.

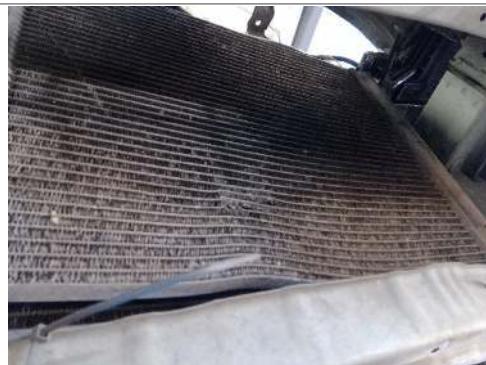
Aircon condenser dent.

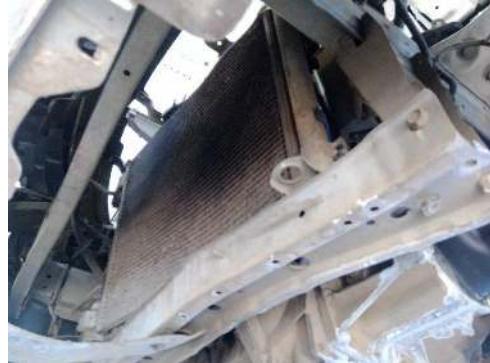
Aircon condenser and radiator.

Damage	Repair Way
Aircon condenser and radiator misaligned	on radiator cradle.

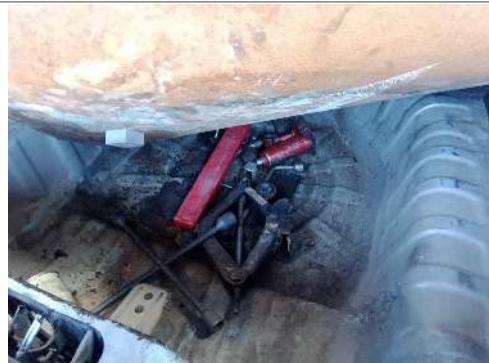
No sparewheel

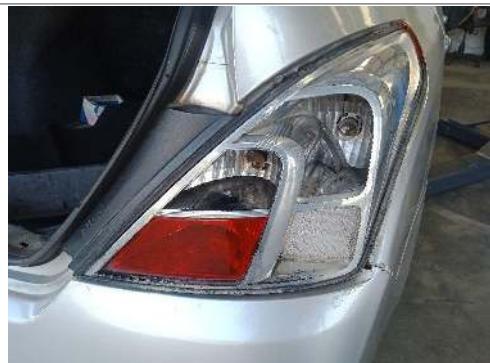
Damage	Repair Way
Air cleaner Damaged	Replace
Park Light Front Left Defective	Repair
Park Light Front Right Defective	Repair
Park Light Rear Left Defective	Repair
Tail Light Left Broken	Replace
Tail Light Right Broken	Replace
Seat Front Left Torn / Cut	Replace
Rear Lower Valance Welded	Replace
Front Bumper Damaged	Replace
Grill Damaged	Replace
Bonnet slam plate (Shock tower/ Inner tray) Dented	Repair
Front Fender Left Dented	Repair
Front Fender Right Damaged	Repair
Door Front Left Dented	Repair
Door Rear Left Paintwork • Scratched	Repair
Rear bumper Damaged	Repair
Shock Absorber Front Left Leak	Replace
Control Arm Bush(es) Front Axle Right Cracked	Replace
Ball Joint(s) Front Axle Left Loose / Excessive Play	Replace
Ball Joint(s) Front Axle Right Loose / Excessive Play	Replace
Tyre Front Left Excessive Wear & Tear	Replace
Tyre Front Right Torn / Cut	Replace
Tyre Rear Right Smooth	Replace
Rim Rear Right Dented	Repair

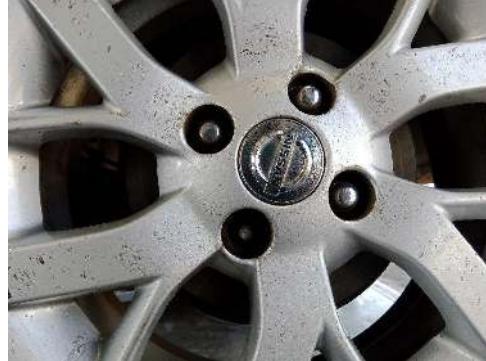
Bolt(s) / Nut(s) Rear Wheel Left Missing	Replace
Bolt(s) / Nut(s) Rear Wheel Right Missing	Replace
Belly plates Damaged	Replace
Gearbox Damaged	Repair
Rear tyre size differs.	Replace.
