MFC Auction House  
M57 Pretoria Rd, Glenmarais, KEMPTON PARK  
Gauteng

## Vehicle Data

Vehicle Type	PASSENGER VEHICLE	Registered Owner	
Manufacturer	NISSAN	Registration Number	JM15BWGP
Model	ALMERA 1.5 ACENTA [2016-2023]	Register Number	
VIN	MDHBBAN17Z0730286	Date Of First Licensing	
Engine Number		Last COR	
Doors	4	License Expiry Date	28/02/2026
Color	WHITE	Power / Displacement	
Year Model	2020	Paint Finish	C - COMMON
Km Reading	400,779 KM	Fuel	PETROL
Cab / Body Type	SEDAN	Transmission	MANUAL

## VEHICLE INSPECTION

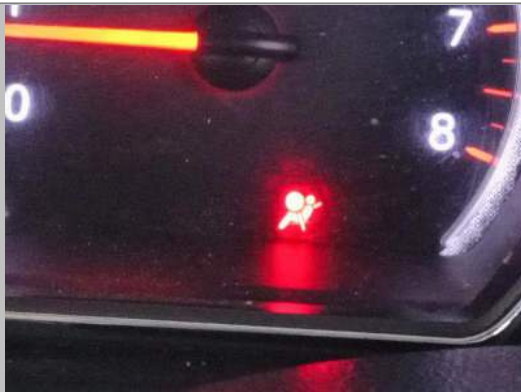
Airbag warning lights

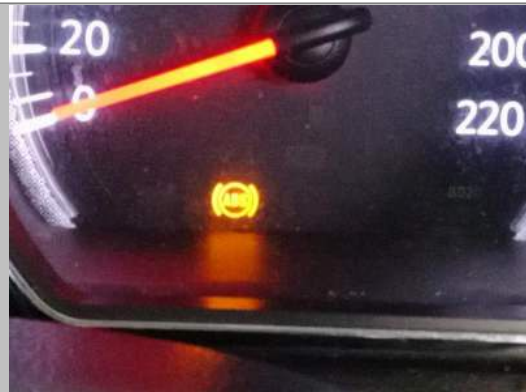
Damage	Repair Way
Gearbox Leak	Repair
Warning lights illuminated	Repair

No	System	Code	Description	Status
1	ABS	C1107	RIGHT FRONT SENSOR 2

ABS warning lights illuminated

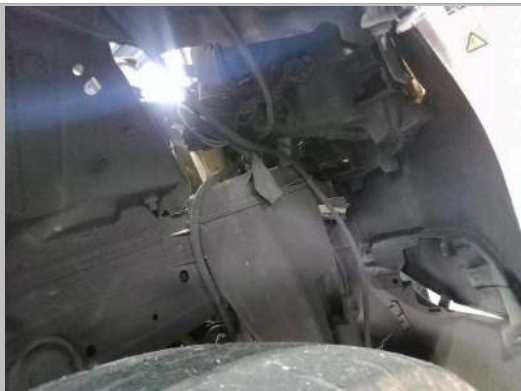
R/F fender liner missing

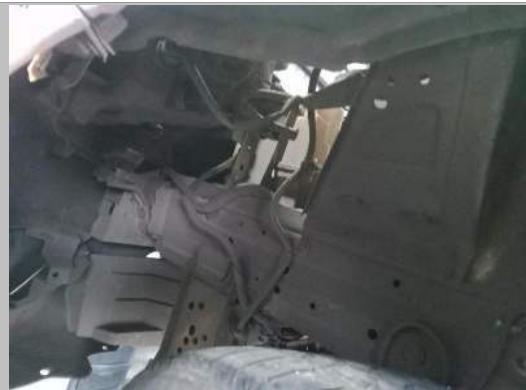
L/F fender liner missing

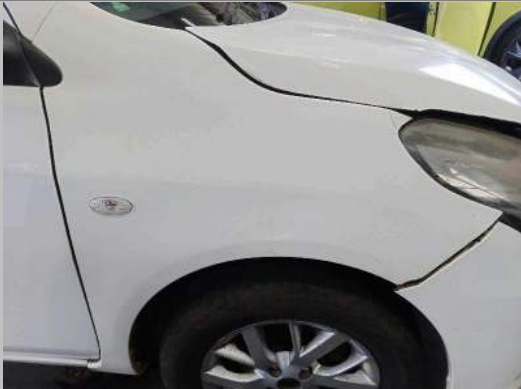
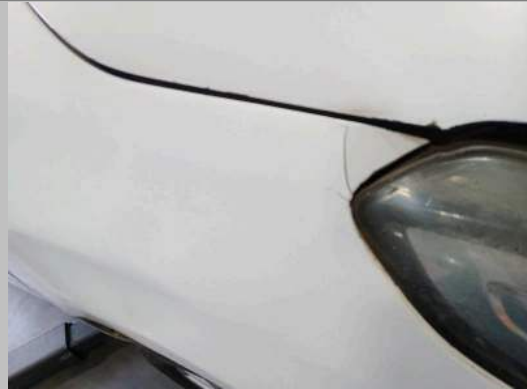
Damage	Repair Way
Engine Oil Sweat	Repair
Air cleaner Damaged	Repair
Seat Front Right Torn / Cut	Repair
Front Bumper Damaged	Replace
Bonnet Residual Traces of Repair	Repair
A • Pillar Left Damaged	Repair
Front Fender Left Residual Traces of Repair	Repair
Front Fender Right Damaged	Repair
Rear Fender Left Dented	Repair
Door Front Left Residual Traces of Repair	Repair
Door Rear Left Residual Traces of Repair	Repair
Boot Lid / Hatch door Paintwork • Scratched	Repair
Rear bumper Paintwork • Scratched	Repair
Sill Panel Left Damaged	Repair
Roof Dented	Repair
Control Arm Bush(es) Front Axle Right Damaged	Replace
Ball Joint(s) Front Axle Right Damaged	Replace
Tyre Front Left Excessive Wear & Tear	Replace
Tyre Rear Left Excessive Wear & Tear	Replace
Tyre Rear Right Excessive Wear & Tear	Replace

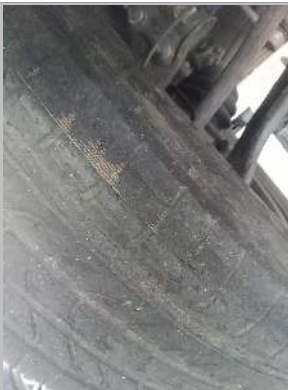
Tyre Front Left

Size	Load/Speed Index	Manufacture	Model	Type*	Production Date	Tread Depth (mm)
Front Left	195/65R15	91V	Nexen	Npriz	V	0000	0 mm
Front Right	195/65R15	91H	Continental	Contact	V	4522	1 mm
Rear Left	185/60R15	84H	Goodyear	Duragrip	V	0000	1 mm
Rear Right	195/60R15	88H	Firestone	Touring	V	4812	2 mm
Spare	185/65R15	91H	Goodyear	Excellence	V	0000	1 mm
