CONDITION REPORT

Report No: 2016866851

MFC Auction House
M57 Pretoria Rd, Glenmarais, KEMPTON PARK
Gauteng

Vehicle Type	PASSENGER VEHICLE	Registered Owner	
Manufacturer	NISSAN	Registration Number	KS84HTGP
Model	MAGNITE TURBO 1.0T ACENTA 5-DR CVT [2021-ON]	Register Number	
VIN	MDHFBADD0Z0006648	Date Of First Licensing	
Engine Number		Last COR	
Doors	5	License Expiry Date	31/07/2025
Color	SILVER	Power / Displacement	
Year Model	2022	Paint Finish	TWO COAT METALLIC
Km Reading	62,159 KM	Fuel	PETROL
Cab / Body Type	HATCHBACK	Transmission	AUTOMATIC

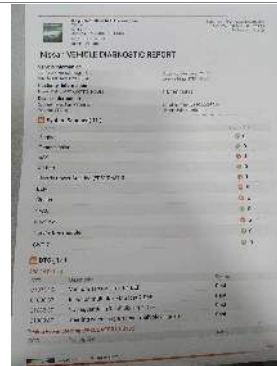
Diagnostics

No	System	Code	Description	Status
1	ABS	C1073:1C	VACUUM SENSOR CIRCUIT 4.DEF

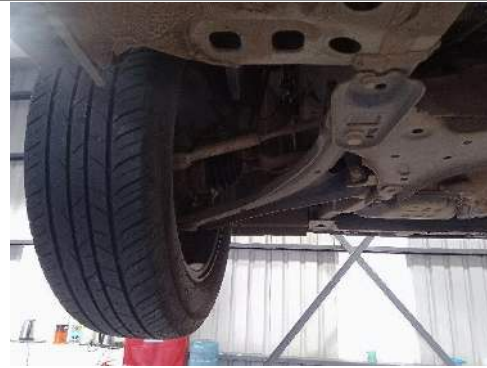
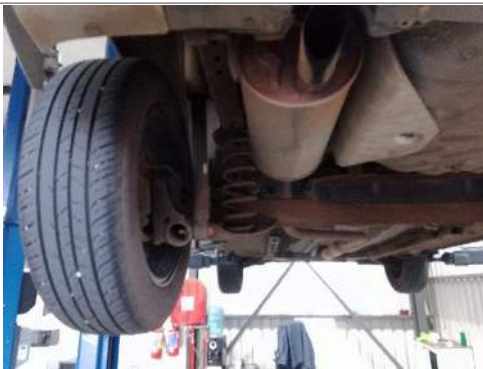
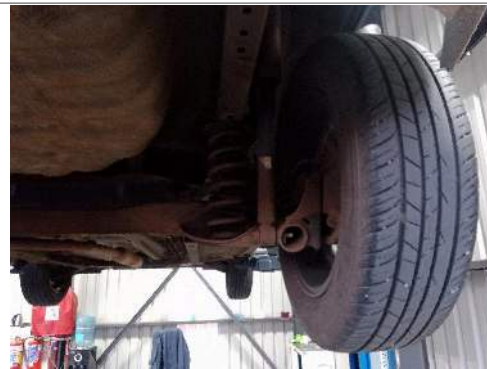
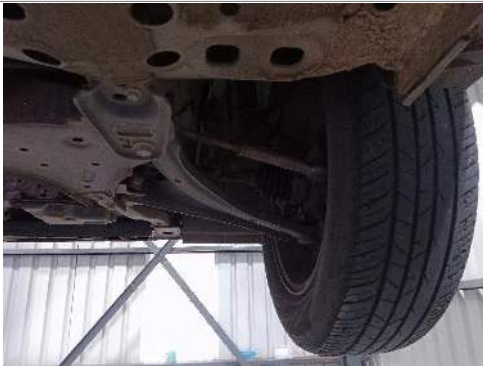
Size	Load/Speed Index	Manufacture	Model	Type*	Production Date	Tread Depth (mm)
Front Left	195/60R16	89V	Ceat	And	V	1022	2 mm
Front Right	195/60R16	89V	Ceat	Radial	V	1422	2 mm
Rear Left	195/60R16	89V	Ceat	Radial	V	1422	2 mm
Rear Right	195/60R16	89V	Ceat	Radial	V	1422	2 mm

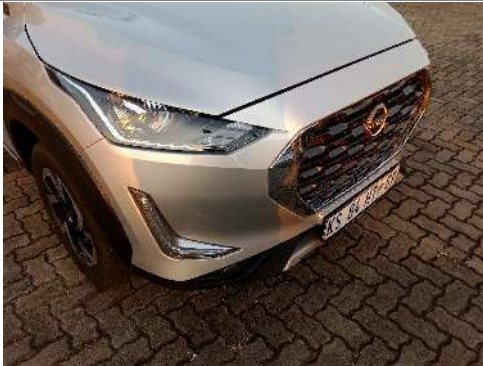
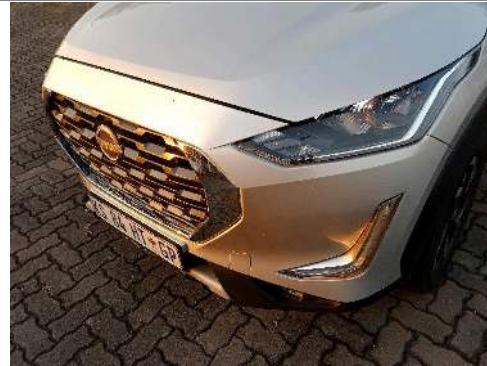
Damage	Repair Way
Front Bumper Damaged	Repair
Bonnet Damaged	Repair
Rear Fender Right Damaged	Repair
Door Front Right Damaged	Repair
Door Rear Left Damaged	Repair
Door Rear Right Damaged	Repair
Boot Lid / Hatch door Damaged	Repair
Rear bumper Damaged	Repair
Warning light illuminated	Repair
