MFC Auction House  
M57 Pretoria Rd, Glenmarais, KEMPTON PARK  
Gauteng

Vehicle Type	PASSENGER VEHICLE	Registered Owner	MFC
Manufacturer	NISSAN	Registration Number	KSF759MP
Model	MAGNITE	Register Number	
VIN	MDHFBADD0Z0007449	Date Of First Licensing	
Engine Number		Last COR	
Doors	5	License Expiry Date	31/10/2023
Color	RED	Power / Displacement	
Year Model		Paint Finish	TWO COAT METALLIC
Km Reading	18,070 KM	Fuel	PETROL
Cab / Body Type	HATCHBACK	Transmission	AUTOMATIC

## CONDITION REPORT

Report No: 2016212721

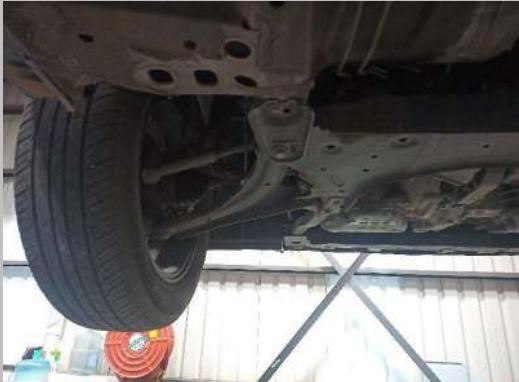
LF TYRE TREAD

Size	Load/Speed Index	Manufacture	Model	Type*	Production Date	Tread Depth (mm)
Front Left	195/60R16	89V	Ceat	Radial	V	2522	3 mm
Front Right	195/60R16	89V	Ceat	Radial	V	2422	3 mm
Rear Left	195/60R16	89V	Ceat	Radial	V	2522	2 mm
Rear Right	195/60R16	89V	Ceat	Radial	V	2422	3 mm

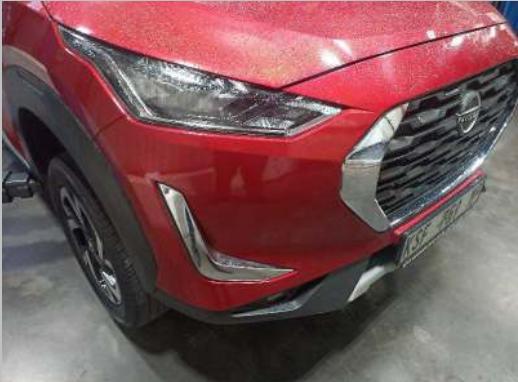
Damage	Repair Way
Front Bumper Damaged	Repair
Bonnet Damaged	Repair
Front Fender Left Damaged	Repair
Front Fender Right Damaged	Repair
Door Front Left Damaged	Repair
Door Front Right Damaged	Repair
Door Rear Left Damaged	Repair
Door Rear Right Damaged	Repair
Boot Lid / Hatch door Damaged	Repair
Rear bumper Damaged	Repair
