## CONDITION REPORT

Report No:  
2016996317  
DATE  
29/08/2025

Vehicle Type	PASSENGER VEHICLE	Registered Owner	MFC
Manufacturer	NISSAN	Registration Number	LJ55ZVGP
Model	MAGNITE TURBO 1.0T ACENTA PLUS 5-DR CVT [2022-2024]	Register Number	
VIN	MDHFBADD0Z0016332	Date Of First Licensing	
Engine Number		Last COR	
Doors	5	License Expiry Date	31/10/2025
Color	RED	Power / Displacement	
Year Model	2023	Paint Finish	TWO COAT UNI
Km Reading	44,352 KM	Fuel	PETROL
Cab / Body Type	HATCHBACK	Transmission	AUTOMATIC

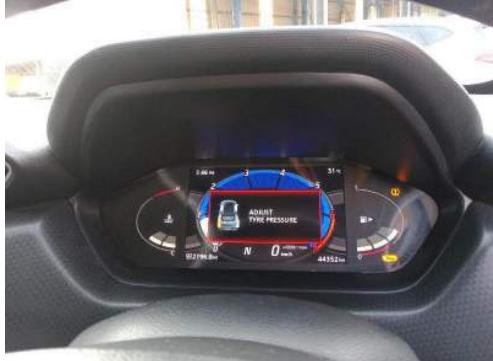
DASHBOARD (W/ ENGINE RUNNING)

Hoses Oil Leak	Repair
Seat Front Left Dirty	Repair
Seat Rear Dirty	Repair
Front Bumper Damaged	Repair
C • Pillar Left Paintwork • Scratched	Repair
Front Fender Left Dented	Repair
Front Fender Right Paintwork • Scratched	Repair
Rear Fender Left Paintwork • Scratched	Repair
Door Front Right Dented	Repair
Door Rear Right Paintwork • Scratched	Repair
Inner Boot Floor Pan and Spare Wheel Well Damaged	Repair
Windscreen Cracked	Replace
Spare Tyre Damaged	Replace
Warning lights illuminated on dashboard	Repair

No	System	Code	Description	Status
1	ABS	C1082:87	NO SEQUENTIAL GEARBOX MLTIPLEX SIG 2.DEF

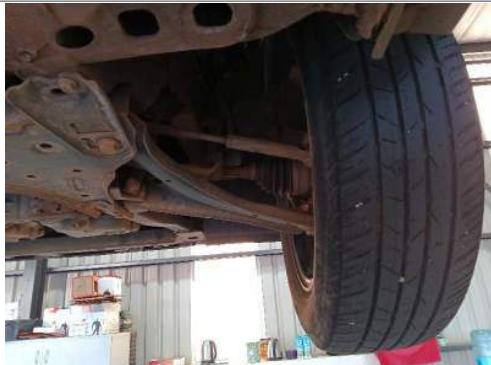
RF TYRE TREAD

Size	Load/Speed Index	Manufacture	Model	Type*	Production Date	Tread Depth (mm)
Front Left	195/60 R16	89V	Ceat	Secure drive	V	0423	6 mm
Front Right	195/60 R16	89V	Ceat	Secure drive	V	0423	3 mm
Rear Left	195/60 R16	89V	Ceat	Secure drive	V	0523	5 mm
Rear Right	195/60 R16	89V	Ceat	Secure drive	V	0423	5 mm
Spare	205/60 R16	96H	Davanti	DX390	V	2422	0 mm

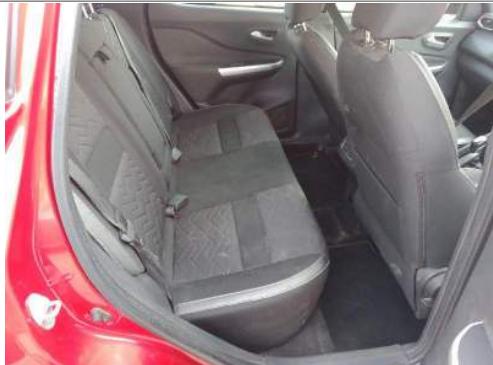
Seat Rear

General Comments: ACCORDING TO THE AGE AND MILEAGE OF THE VEHICLE, NORMAL WEAR AND TEAR MARKS ARE VISIBLE ON THE INTERIOR, EXTERIOR, ELECTRICAL AND MECHANICAL PARTS. Engine Compartment: Engine bay dirty.  
Interior: Vehicle interior dirty and some panels scratched  
Body • Exterior: Minor dents and scratches on some body panels  
Tyres and Rims: Spare wheel regrooved.
