CONDITION REPORT

Report No:  
2017299055  
DATE  
15/09/2026

MFC Auction House  
M57 Pretoria Rd, Glenmarais, KEMPTON PARK  
Gauteng

| Model | MAGNITE 1.0 VISIA 5-DR [2023-2025] | Register Number | |

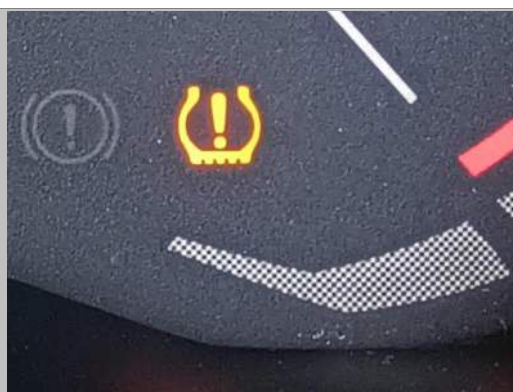
| Warning lights illuminated | Repair |

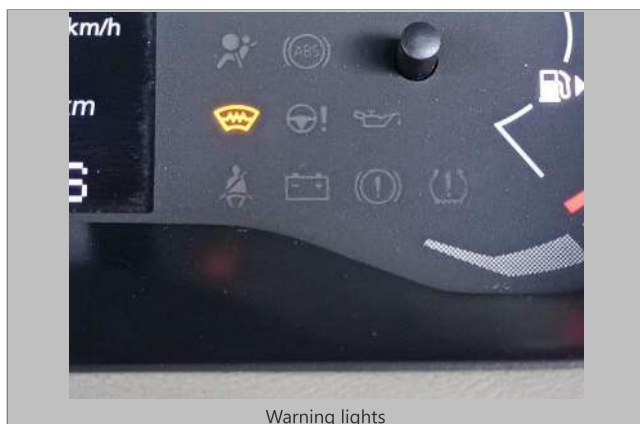
Warning lights

| No | System | Code | Description | Status |
|---|---|---|---|---|
| 1 | ENGINE | P0657:11 | MAIN RELAY CONTROL CIRCUIT CC.O | |

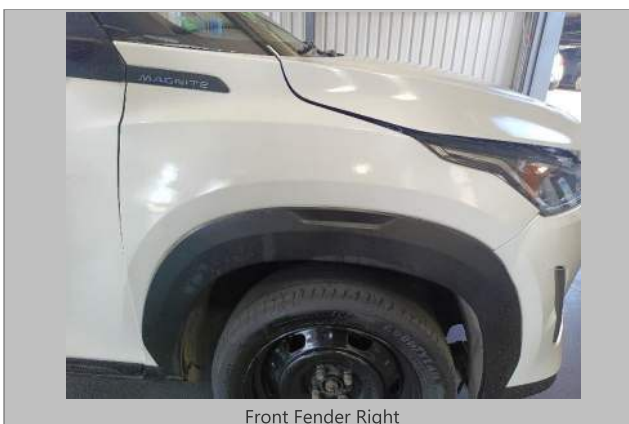
| Front Fender Right Residual Traces of Repair | Repair |

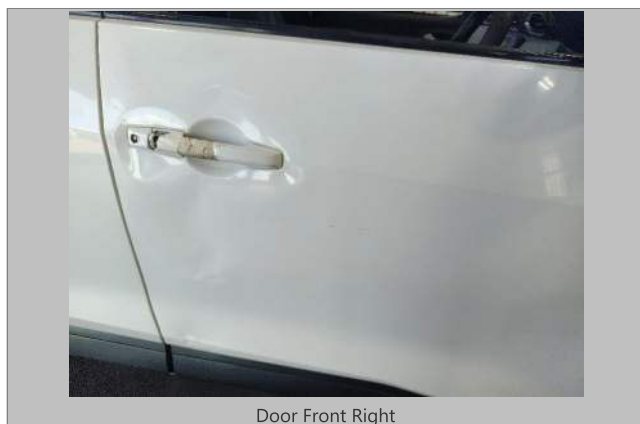
| Door Front Right Dented | Repair |

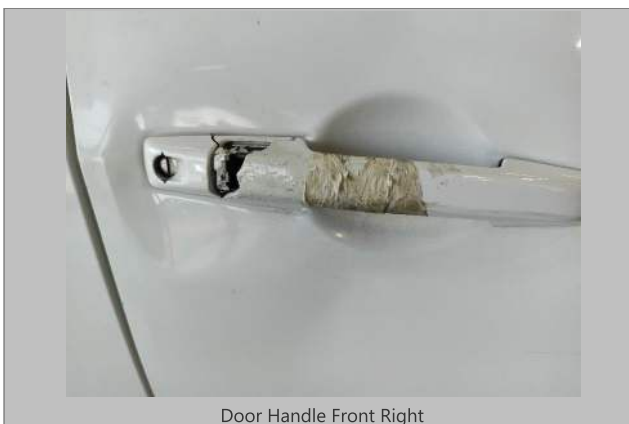
| Door Handle Front Right Damaged | Replace |

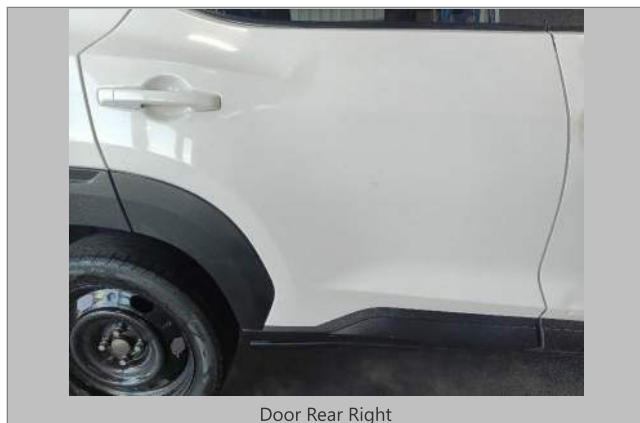
| Door Rear Right Dented | Repair |

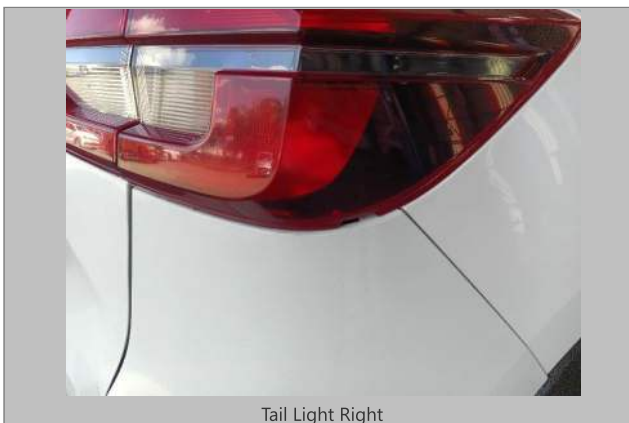
| Tail Light Right Chipped | Replace |

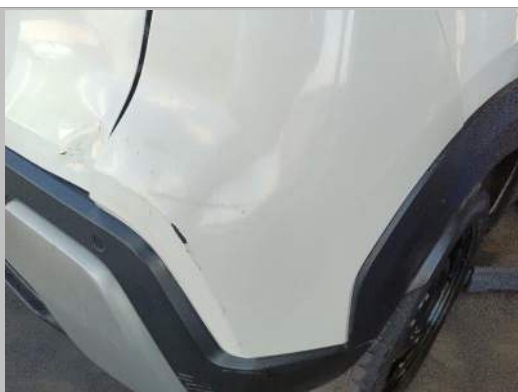
| Rear Fender Right Paintwork • Scratched | Repair |

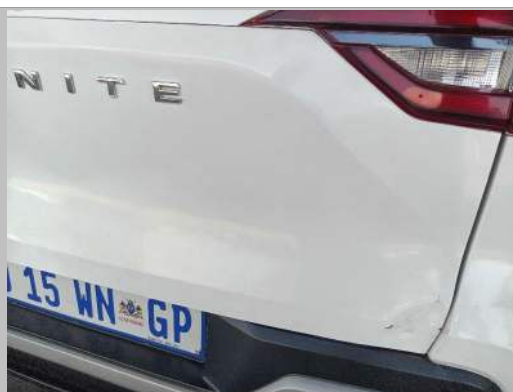
| Boot Lid / Hatch door Dented | Repair |

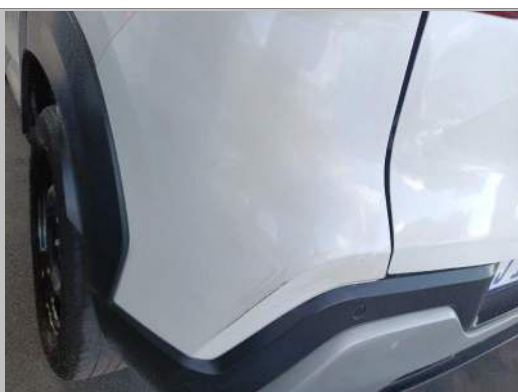
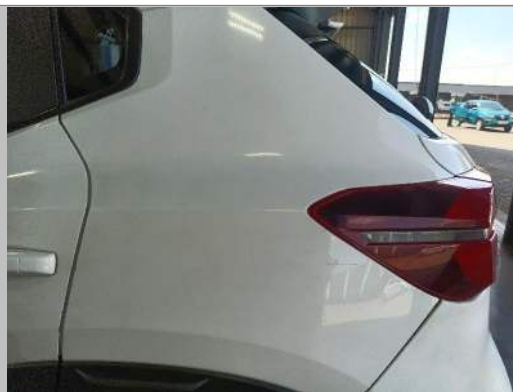
| Rear Fender Left Paintwork • Scratched | Repair |

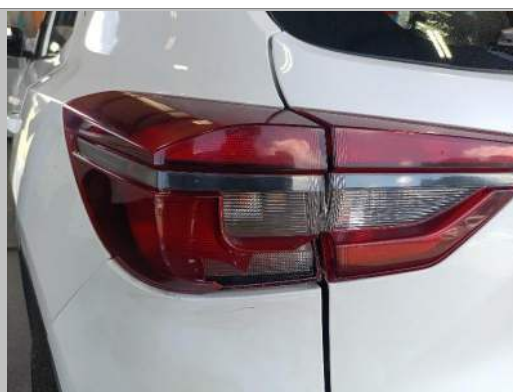
| Tail Light Left Damaged | Replace |

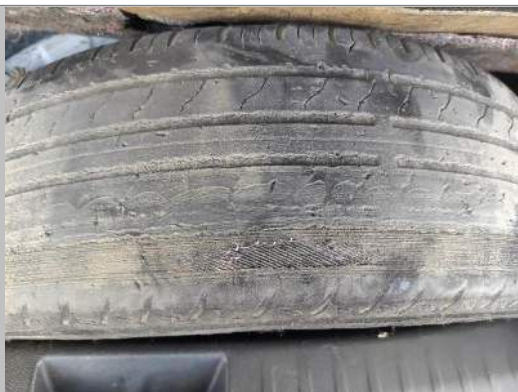
| Spare Tyre Excessive Wear & Tear | Replace |

| | Size | Load/Speed Index | Manufacture | Model | Type* | Production Date | Tread Depth (mm) |
|---|---|---|---|---|---|---|---|
| Spare | 195/60R16 | 89H | MRF | Wanderer | V | //// | 0 mm |

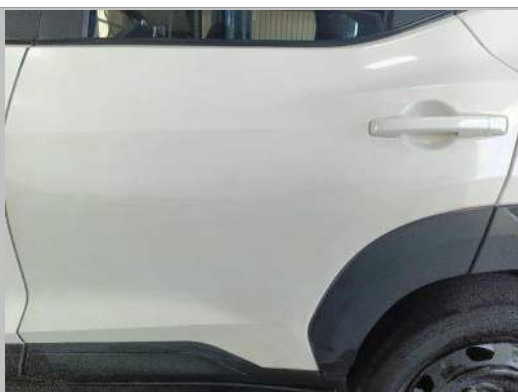
| Door Rear Left Residual Traces of Repair | Repair |

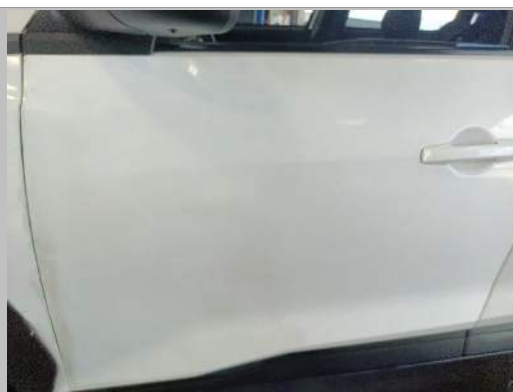
| Door Front Left Residual Traces of Repair | Repair |

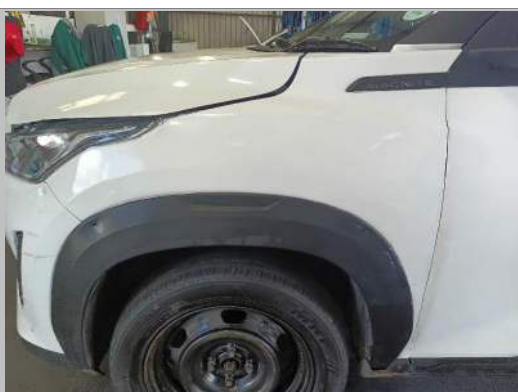
| Front Fender Left Residual Traces of Repair | Repair |

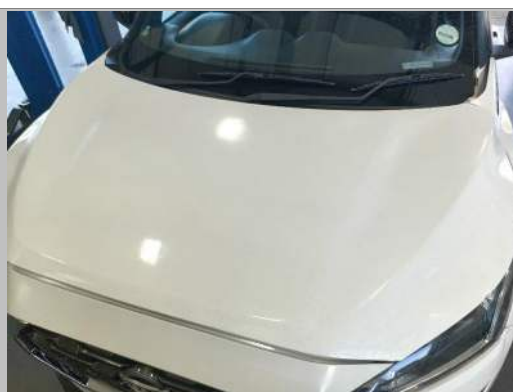
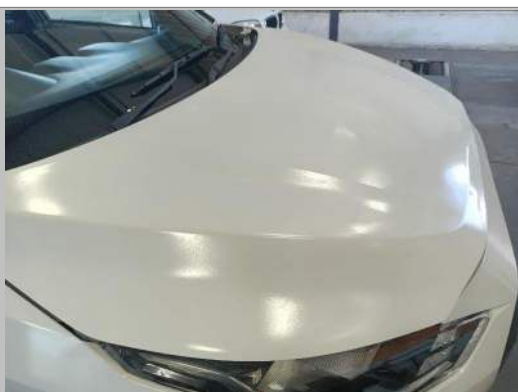
| Bonnet Residual Traces of Repair | Repair |

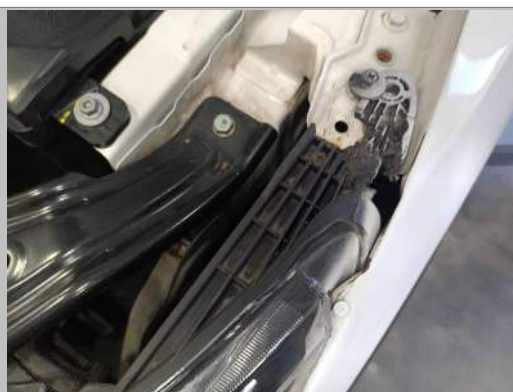
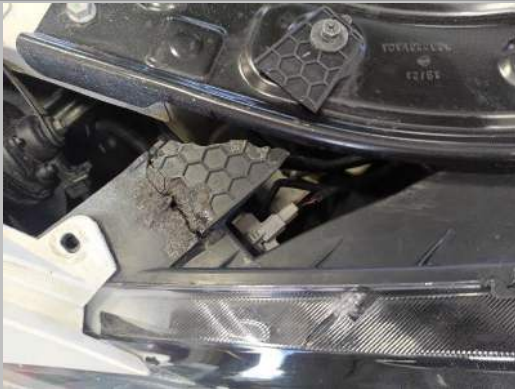
| Headlight Left Damaged | Replace |

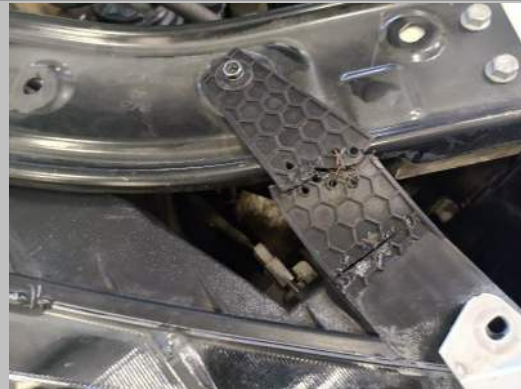
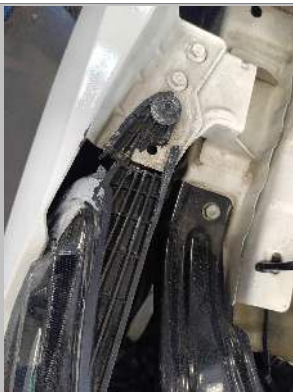
| Headlight Right Damaged | Replace |

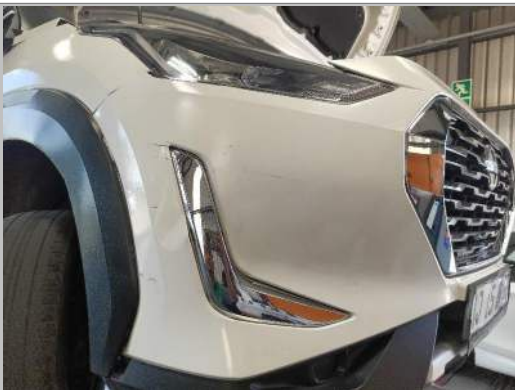
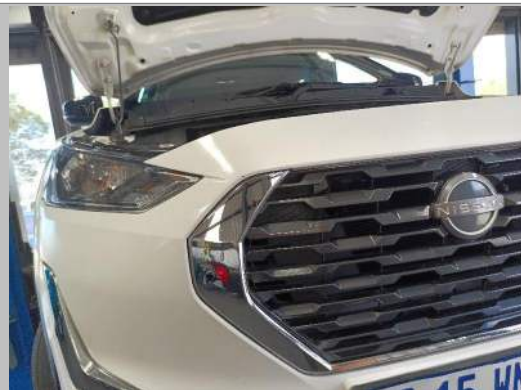
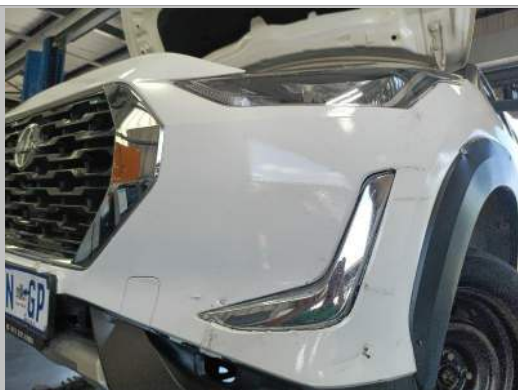
| Front Bumper Residual Traces of Repair | Repair |

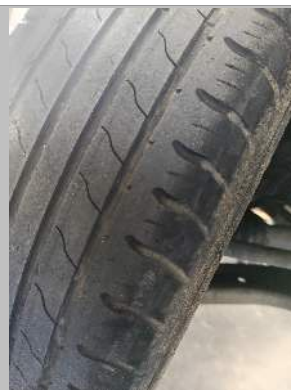
| Tyre Front Left Excessive Wear & Tear | Replace |

| | Size | Load/Speed Index | Manufacture | Model | Type* | Production Date | Tread Depth (mm) |
|---|---|---|---|---|---|---|---|
| Front Left | 195/60R16 | 89H | MRF | Wanderer | V | 2621 | 0 mm |

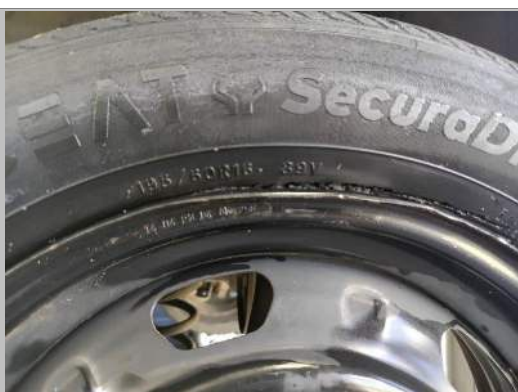
| Rim Rear Left Deformed | Repair |

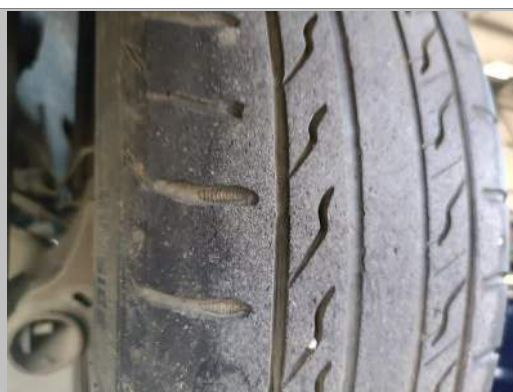
| Tyre Rear Right Excessive Wear & Tear | Replace |

| | Size | Load/Speed Index | Manufacture | Model | Type* | Production Date | Tread Depth (mm) |
|---|---|---|---|---|---|---|---|
| Rear Right | 195/55R16 | 91V | Autogrip | Grip100 | V | | 0 mm |

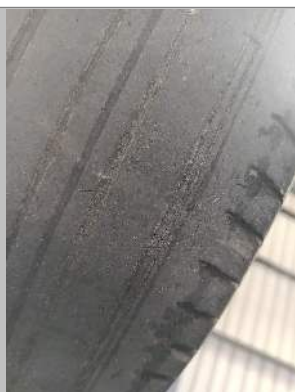
| Tyre Front Right Smooth | Replace |

| | Size | Load/Speed Index | Manufacture | Model | Type* | Production Date | Tread Depth (mm) |
|---|---|---|---|---|---|---|---|
| Front Right | 195/55R6 | 87H | Goodyear | Eagle | V | 1722 | 0 mm |

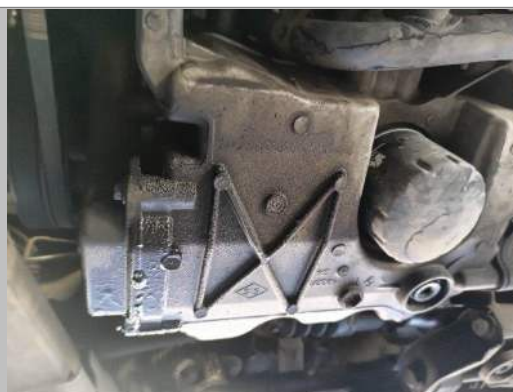
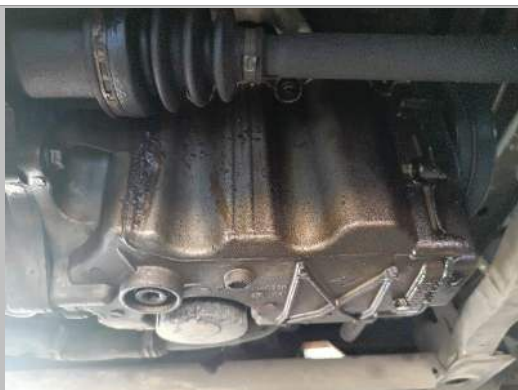
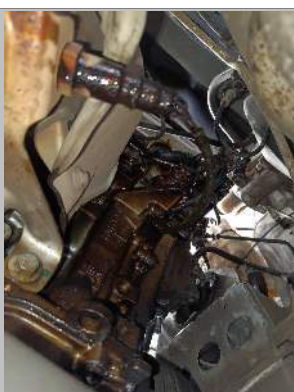
| Engine Oil Leak | Repair |

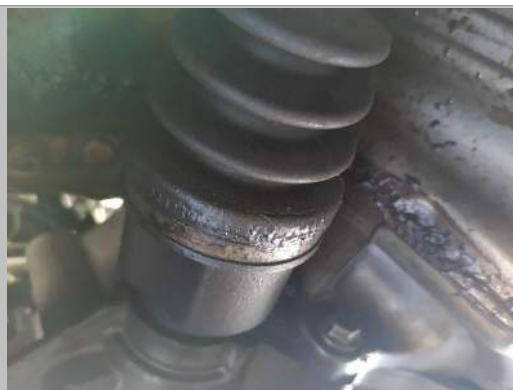
| CV Joint(s) Boot(s) Front Right (inner/outer) Damaged | Replace |

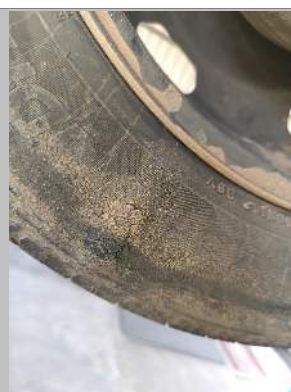
| Tyre Rear Left Torn / Cut | Replace |

| | Size | Load/Speed Index | Manufacture | Model | Type* | Production Date | Tread Depth (mm) |
|---|---|---|---|---|---|---|---|
| Rear Left | 195/60R16 | 89V | Ceat | Securadrive | V | 2621 | 1 mm |

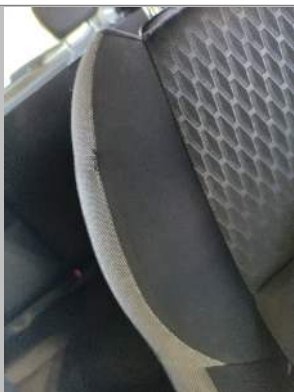
| Seat Front Left Torn / Cut | Repair |

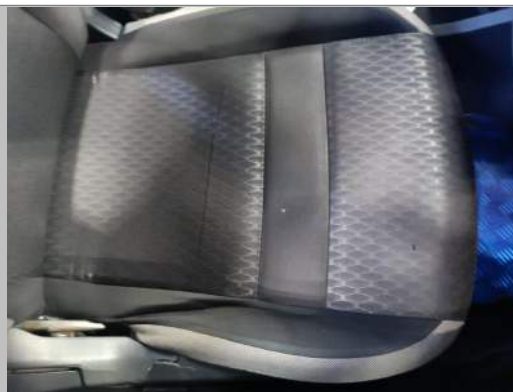
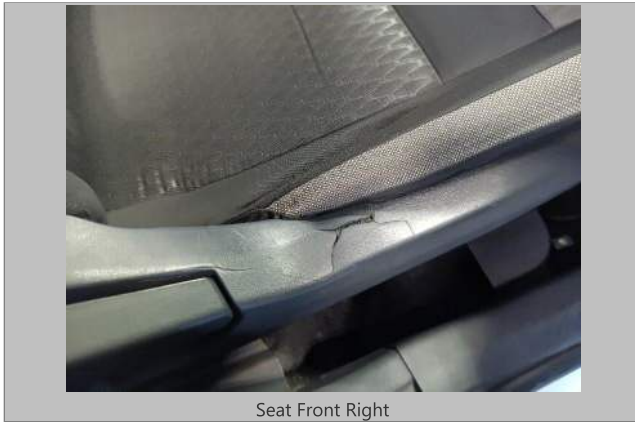
| Seat Front Right Torn / Cut | Repair |
