CONDITION REPORT

Report No: 2016569638

DATE  
14/10/2024

| Manufacturer | NISSAN | Registration Number | KZS501NW |

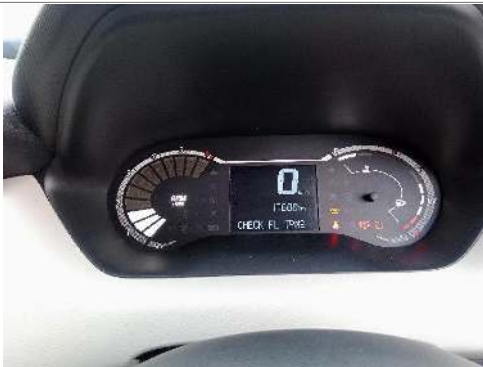
| Damage | Repair Way |
|---|---|
| Tyre pressure warning light | Repair |

DASHBOARD (W/ ENGINE RUNNING)

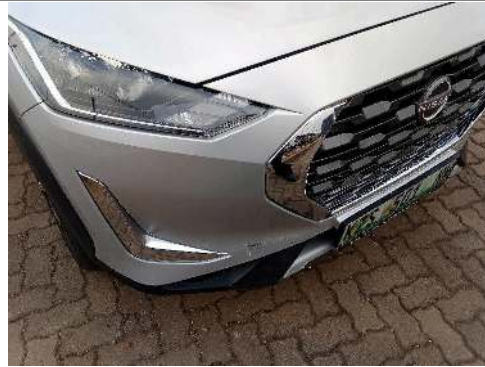
| Damage | Repair Way |
|---|---|
| Front Bumper Damaged | Repair |

Front Bumper

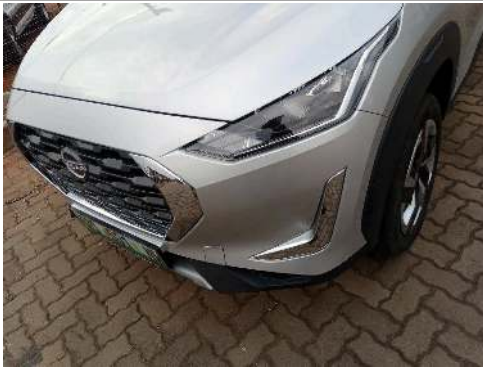
Front Bumper

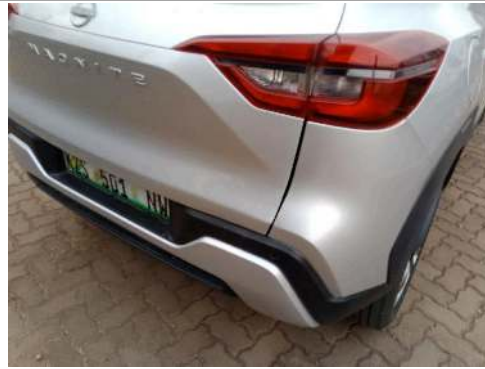
| Damage | Repair Way |
|---|---|
| Rear bumper Damaged | Repair |

Rear bumper

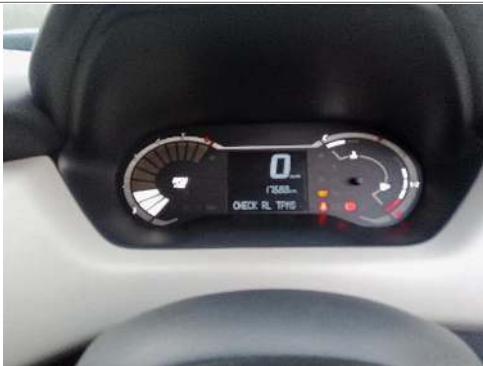
| Damage | Repair Way |
|---|---|
| Engine Management Lights Set | Repair |

Engine Management Lights
