CONDITION REPORT

Report No:  
2017301041  
DATE  
18/09/2026

MFC Auction House  
M57 Pretoria Rd, Glenmarais, KEMPTON PARK  
Gauteng

| Manufacturer | NISSAN | Registration Number | LGK065MP |

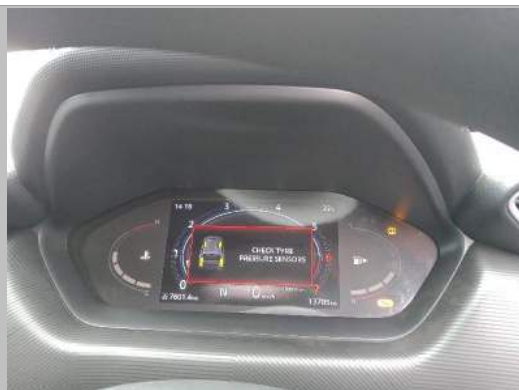
DASHBOARD (W/ ENGINE RUNNING)

| Warning light illuminated on dashboard | Repair |

| No | System | Code | Description | Status |
|---|---|---|---|---|
| 1 | ENGINE | P060A:49 | ECU 1.DEF | |

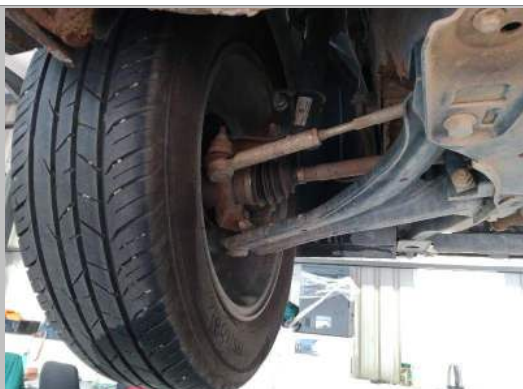
LF TYRE TREAD

| | Size | Load/Speed Index | Manufacture | Model | Type* | Production Date | Tread Depth (mm) |
|---|---|---|---|---|---|---|---|
| Front Left | 195/60 R16 | 89V | Ceat | Secure drive | V | 4124 | 4 mm |

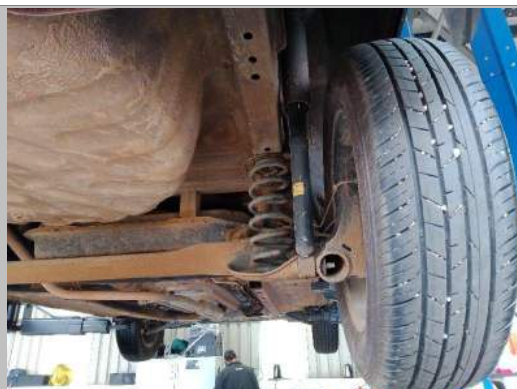
RR TYRE TREAD

| | Size | Load/Speed Index | Manufacture | Model | Type* | Production Date | Tread Depth (mm) |
|---|---|---|---|---|---|---|---|
| Rear Right | 195/60 R16 | 89V | Ceat | Secure drive | V | 4124 | 5 mm |

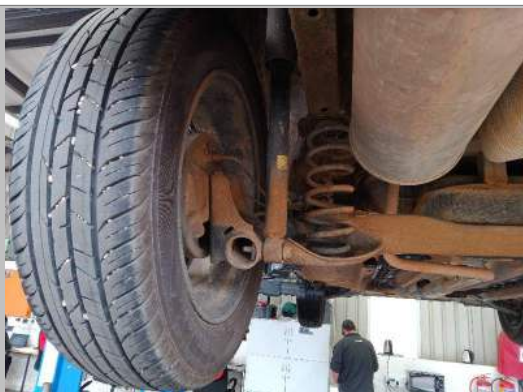
LR TYRE TREAD

| | Size | Load/Speed Index | Manufacture | Model | Type* | Production Date | Tread Depth (mm) |
|---|---|---|---|---|---|---|---|
| Rear Left | 195/60 R16 | 89V | Ceat | Secure drive | V | 4124 | 5 mm |

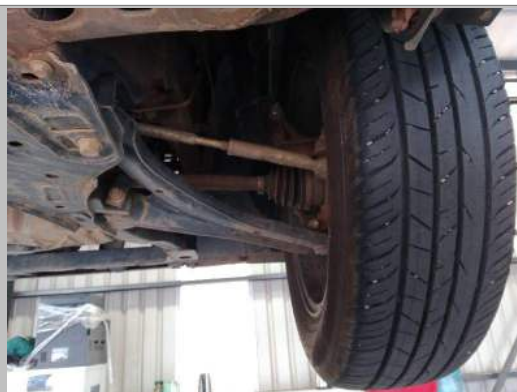
RF TYRE TREAD

| | Size | Load/Speed Index | Manufacture | Model | Type* | Production Date | Tread Depth (mm) |
|---|---|---|---|---|---|---|---|
| Front Right | 195/60 R16 | 89V | Ceat | Secure drive | V | 4124 | 4 mm |

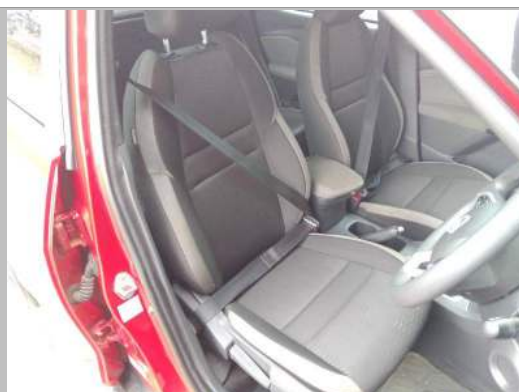
| Seat Front Right Dirty | Repair |

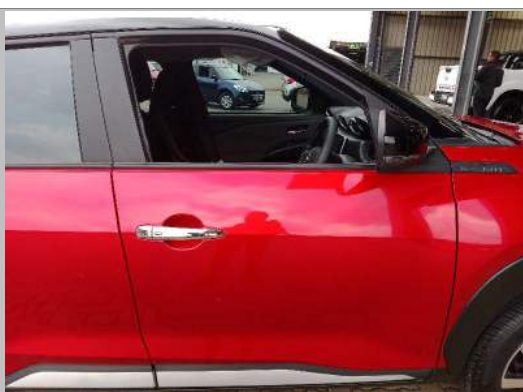
| Door Front Right Dented | Repair |

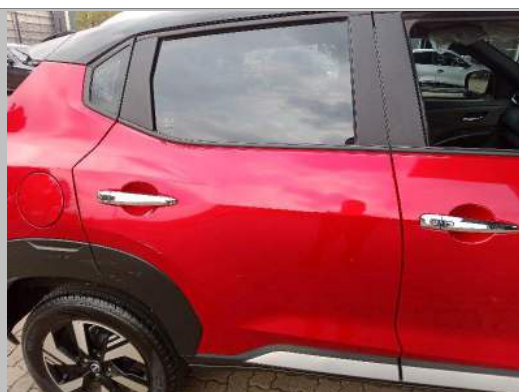
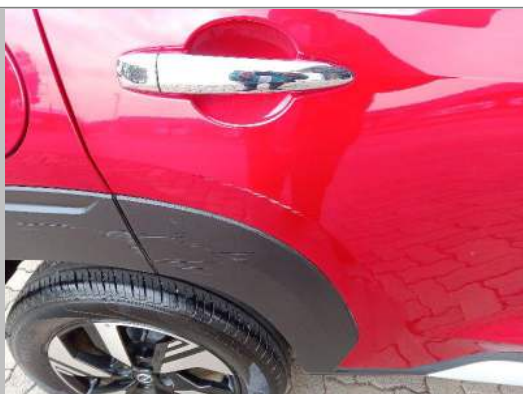
| Door Rear Right Paintwork • Scratched | Repair |

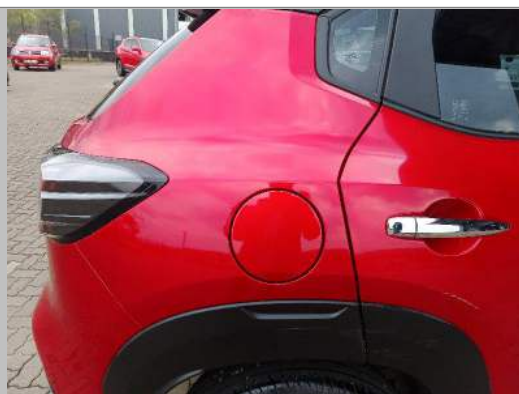
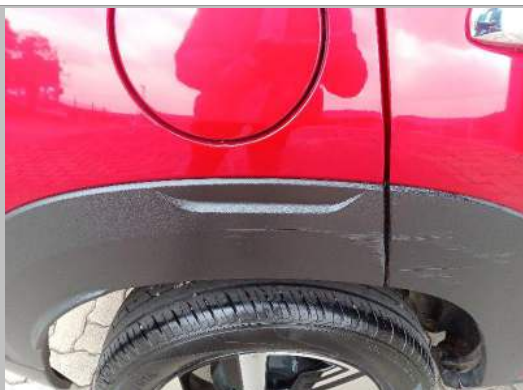
| Rear Fender Right Paintwork • Scratched | Repair |

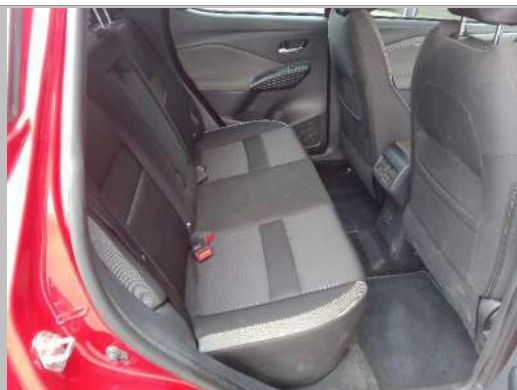
| Seat Rear Dirty | Repair |

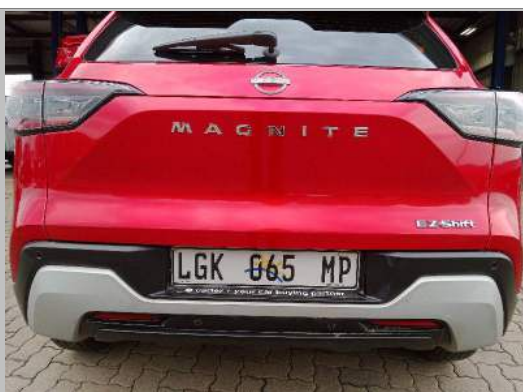
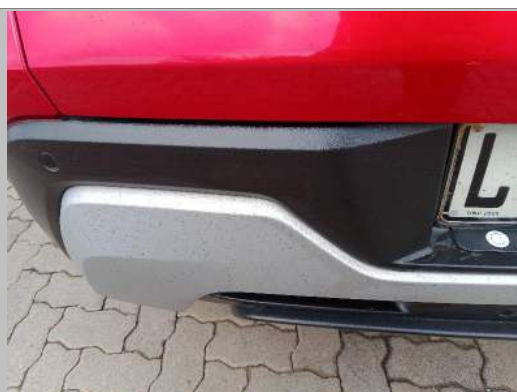
| Rear bumper Paintwork • Chipmarks | Repair |

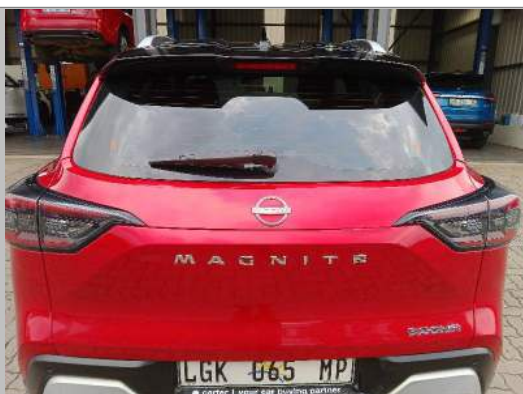
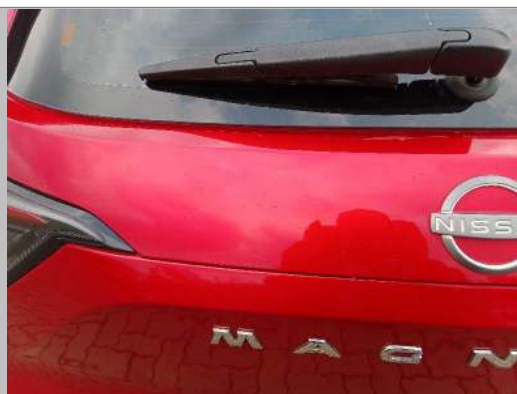
| Boot Lid / Hatch door Paintwork • Chipmarks | Repair |

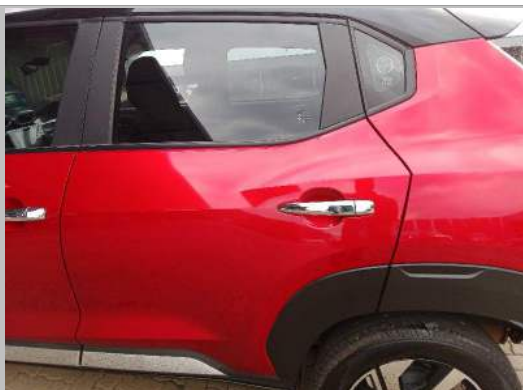
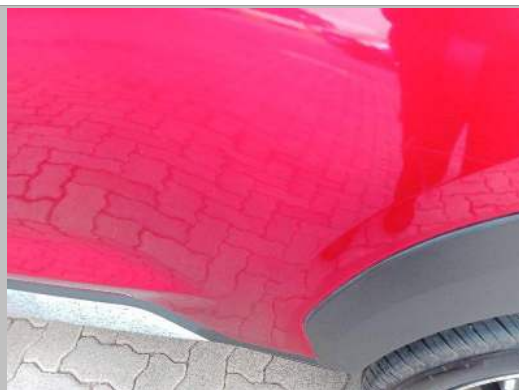
| Door Rear Left Defective | Repair |

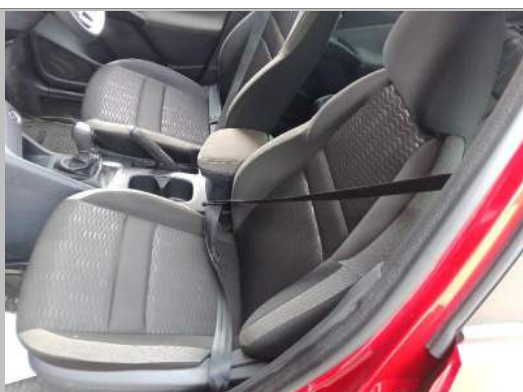
| Seat Front Left Dirty | Repair |

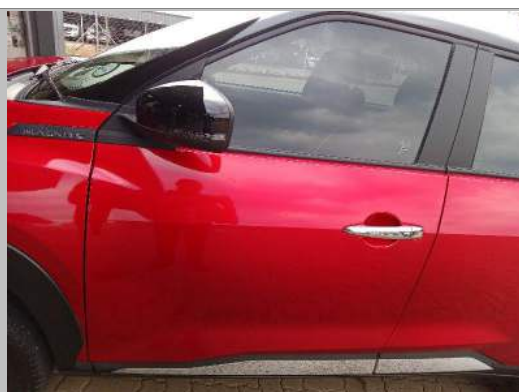
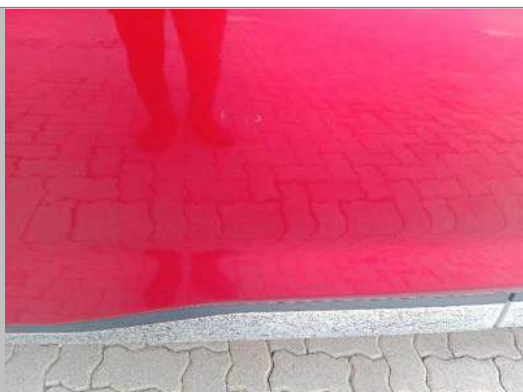
| Door Front Left Defective | Repair |

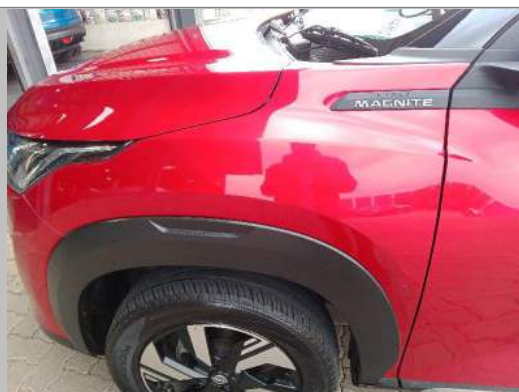
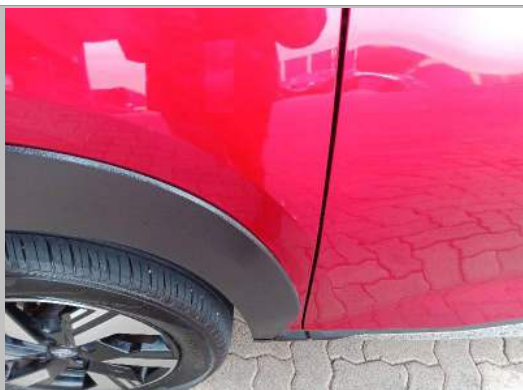
| Front Fender Left Defective | Repair |

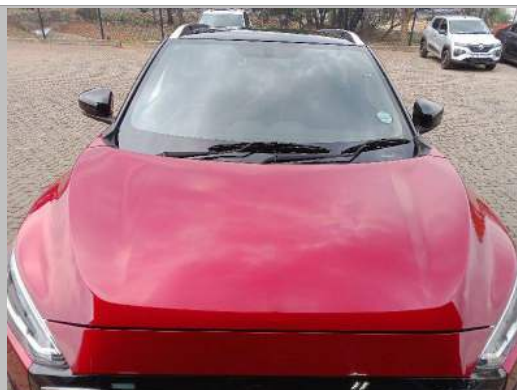
| Bonnet Dented | Repair |

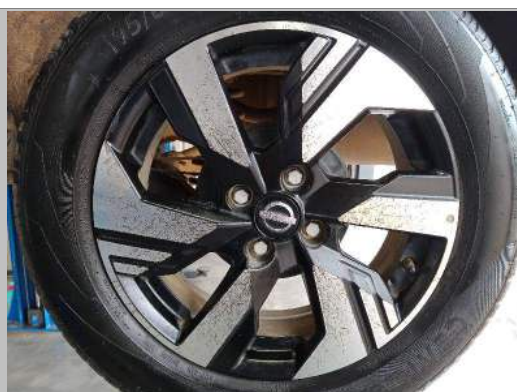
| Rim Rear Left Defective | Repair |

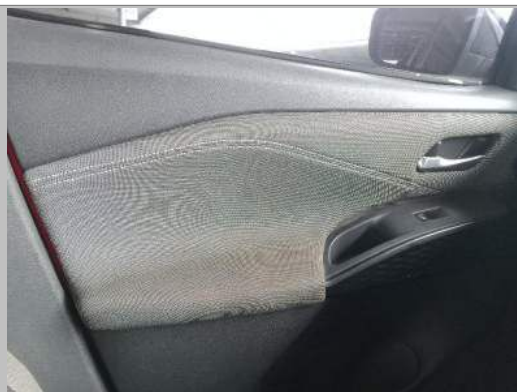
| Door Panel Front Left Dirty | Repair |

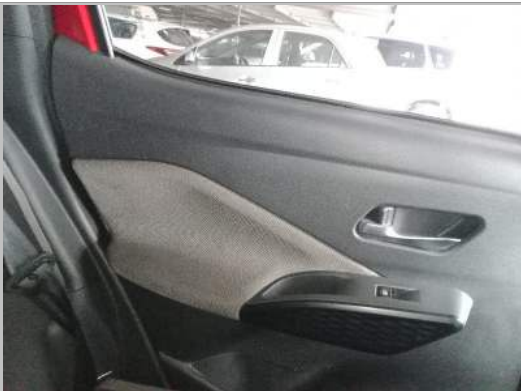
| Door Panel Rear Left Dirty | Repair |

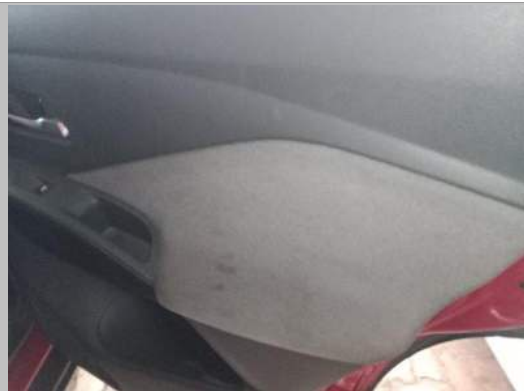
| Door Panel Rear Right Dirty | Repair |
