MFC Auction House
M57 Pretoria Rd, Glenmarais, KEMPTON PARK
Gauteng

Vehicle Type	PASSENGER VEHICLE	Registered Owner	MFC AUCTION HOUSE
Manufacturer	NISSAN	Registration Number	DKP643L
Model	MICRA	Register Number	
VIN	MDHFBUK13Z0516881	Date Of First Licensing	
Engine Number		Last COR	
Doors	5	License Expiry Date	07/02/2024
Color	BLUE	Power / Displacement	
Year Model		Paint Finish	TWO COAT UNI
Km Reading	238,956 KM	Fuel	PETROL
Cab / Body Type	HATCHBACK	Transmission	MANUAL

VEHICLE INSPECTION

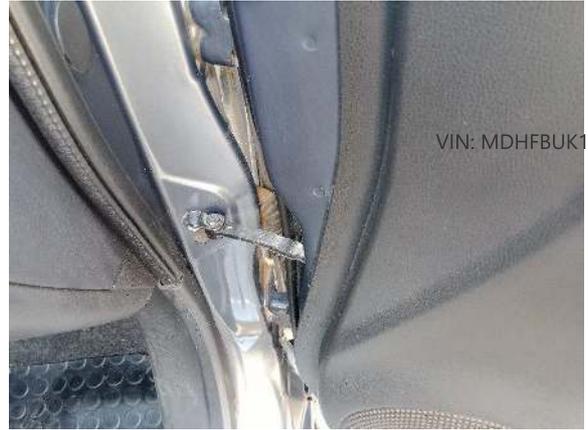
Damage	Repair Way
Door Front Right Damaged	Repair
Door Rear Left Dented	Repair
Door Rear Right Damaged	Repair
Doorstopper Front Left Defective	Replace
Doorstopper Front Right Defective	Replace
Doorstopper Rear Left Defective	Replace
Doorstopper Rear Right Defective	Replace
Boot Lid / Hatch door Dented	Repair
Rear bumper Paintwork • Scratched	Repair
Inner Boot Floor Pan and Spare Wheel Well Dented	Repair
Sill Panel Left Paintwork • Scratched	Repair
Sill Panel Right Paintwork • Scratched	Repair
Rocker Panel Right Dented	Repair
Windscreen Cracked	Replace
Brake disc 1. Axle right Defective	Replace
Wheel bearing Front Left Loose / Excessive Play	Replace
Control Arm Bush(es) Front Axle Left Cracked	Replace
Control Arm Bush(es) Front Axle Right Cracked	Replace
Mounting Rubber(s) Rear Axle Left Cracked	Replace
Mounting Rubber(s) Rear Axle Right Cracked	Replace
Tyre Front Left Damaged	Replace
Tyre Front Right Worn	Replace

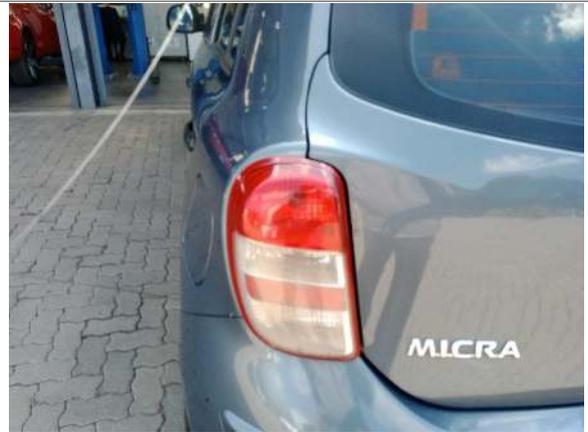
Damage	Repair Way
Engine Wiring Defective	Repair
Caps Missing	Replace
Fan Belt Defective	Replace
Battery clamps Defective	Repair
Air cleaner Defective	Repair
Heater control Defective	Replace
Windscreen Wiper Missing	Replace
Tail Light Left Defective	Replace
Headlight Left Defective	Replace
Headlight Right Defective	Replace
Seat Front Right Damaged	Repair
Seat Rear Defective	Repair
Hood Lining Defective	Repair
Door Sealing Rubber Front Right Damaged	Replace
Carpet Front Damaged	Repair
Boot Carpet Damaged	Replace
Steering Wheel Trim Defective	Repair
Number Plate Front Cracked	Replace
Number Plate Rear Damaged	Replace
Front Bumper Damaged	Repair
Bonnet Damaged	Repair
B • Pillar Left Paintwork • Scratched	Repair
B • Pillar Right Paintwork • Scratched	Repair
C • Pillar Right Dented	Repair
Front Fender Left Paintwork • Discoloured	Repair
Front Fender Right Damaged	Repair
Rear Fender Left Dented	Repair
Rear Fender Right Dented	Repair

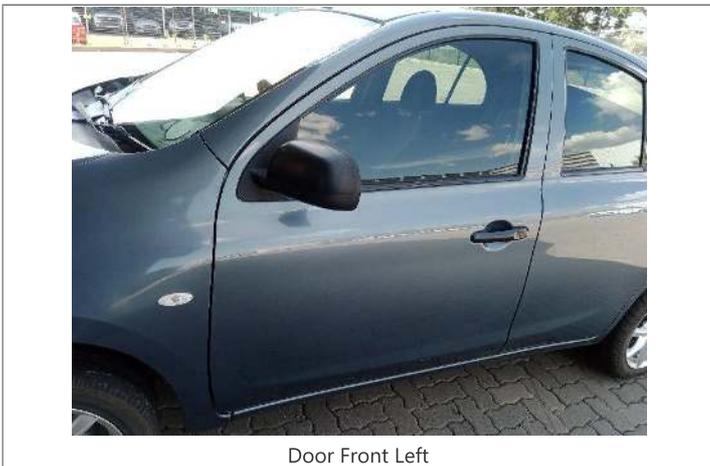
Door Front Left Dented	Repair

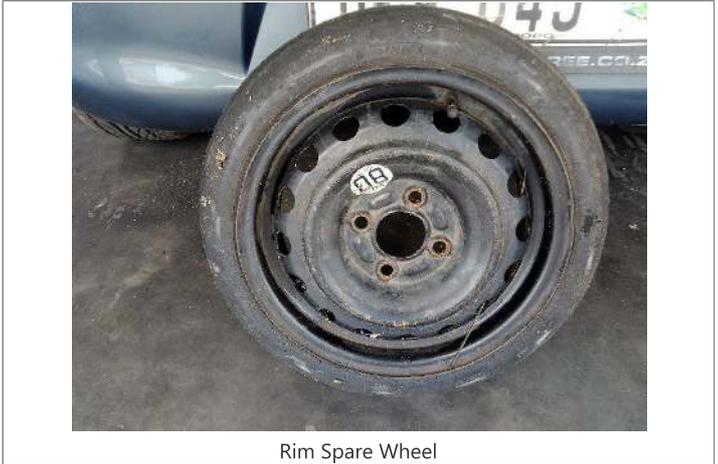
Tyre Rear Left Defective	Replace
Spare Tyre Worn	Replace
Rim Front Right Dented	Repair
Rim Rear Left Dented	Repair
Rim Rear Right Dented	Repair
Rim Spare Wheel Dented	Repair
Main Beam Left Dented	Repair
Chassis Dented	Repair
Sub Frame Dented	Repair
Gearbox Mountings Welded	Replace
Gearbox Damaged	Repair
Radiator Cradle Damaged	Replace
Engine management light illuminated on dashboard	Repair

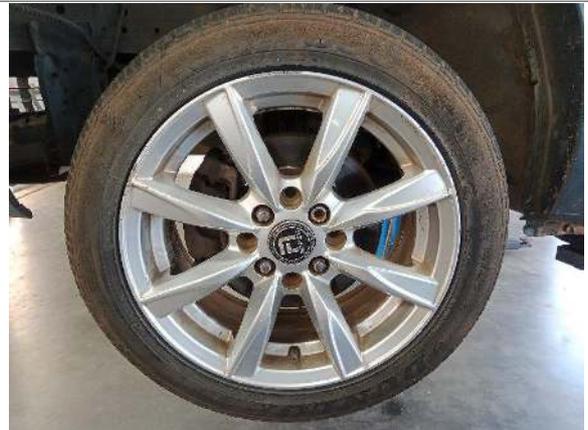
Tyre Front Left

Size	Load/Speed Index	Manufacture	Model	Type*	Production Date	Tread Depth (mm)
Front Left	195/50 R15	82V	Dunlop	Sp-Sport	V	1316	0 mm
Front Right	195/50 R15	82V	Dunlop	Sp-Sport	V	1319	0 mm
Rear Left	195/50 R15	82V	Symmetry	SY201	V	4821	5 mm
Rear Right	195/50 R15	82V	Symmetry	SY201	V	1822	5 mm
Spare	T115/70 D14	88M	Falken	Temporary	V	3913	0 mm

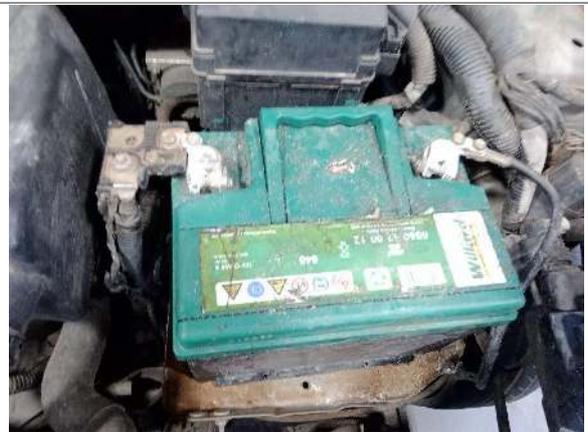
Battery clamps

General Comments: VEHICLE HAS NO LICENSE DISC
Engine Compartment: Engine bay dirty.Brake fluid level ok.Battery loose.Corrosion on battery box and clamps.Oil sump dented.Aircon condenser loose.Radiator and Aircon condenser misaligned.
Interior: Vehicle interior d
