## CONDITION REPORT

Report No:  
2016915581  
DATE  
19/06/2025

| Manufacturer | DATSUN | Registration Number | KXF708MP |
| Model | GO+ 1.2 LUX 7-S MPV CVT [2019-2022] | Register Number | |

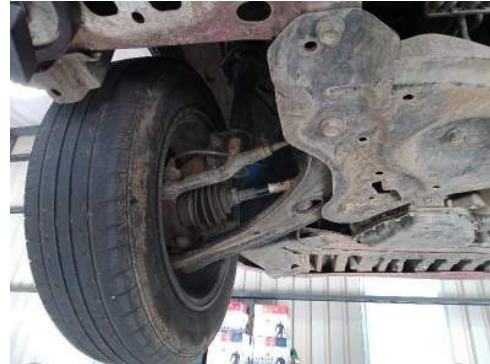
LF TYRE TREAD

| Damage | Repair Way |
|---|---|
| Front tyres size differs | Replace |

| | Size | Load/Speed Index | Manufacture | Model | Type* | Production Date | Tread Depth (mm) |
|---|---|---|---|---|---|---|---|
| Front Left | 165/70 R14 | 81T | Annaite | AN600 | V | 0124 | 2 mm |

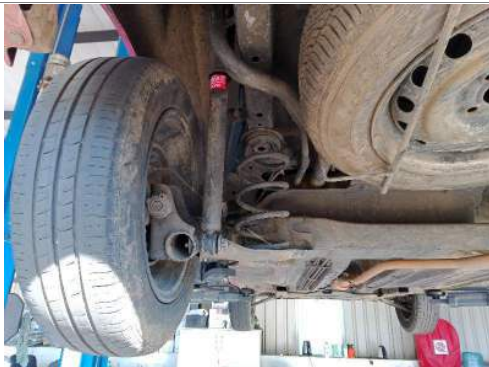
LR TYRE TREAD

| | Size | Load/Speed Index | Manufacture | Model | Type* | Production Date | Tread Depth (mm) |
|---|---|---|---|---|---|---|---|
| Rear Left | 175/65 R14 | 82H | Windforce | Catchfors | V | 0824 | 1 mm |

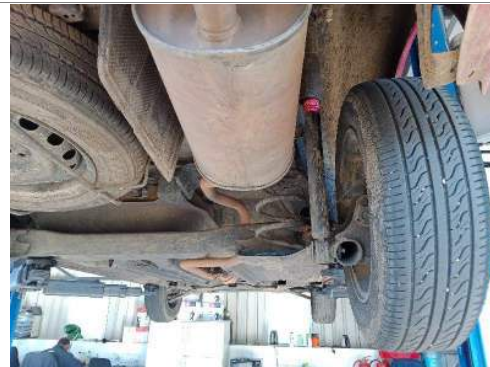
RR TYRE TREAD

| | Size | Load/Speed Index | Manufacture | Model | Type* | Production Date | Tread Depth (mm) |
|---|---|---|---|---|---|---|---|
| Rear Right | 175/65 R14 | 82H | Timax | Eco Comfort | V | 0824 | 2 mm |

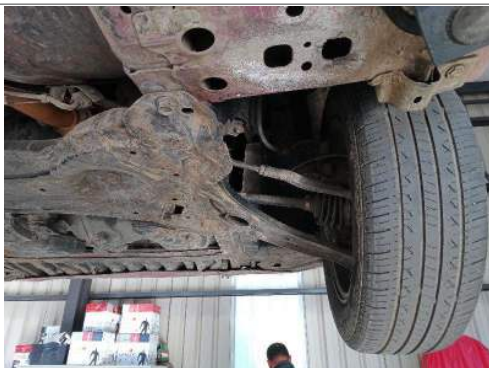
RF TYRE TREAD

| | Size | Load/Speed Index | Manufacture | Model | Type* | Production Date | Tread Depth (mm) |
|---|---|---|---|---|---|---|---|
| Front Right | 185/60 R14 | 82H | Annaite | AN600 | V | 1723 | 2 mm |

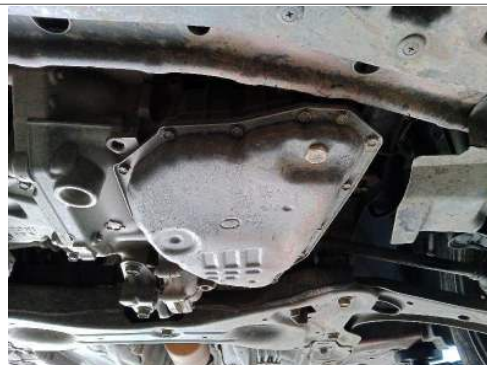
| Damage | Repair Way |
|---|---|
| Engine | Gearbox oil sump damaged |

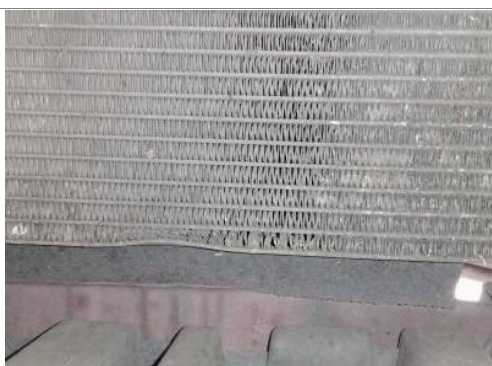
| Damage | Repair Way |
|---|---|
| Engine | Aircon condenser dented |

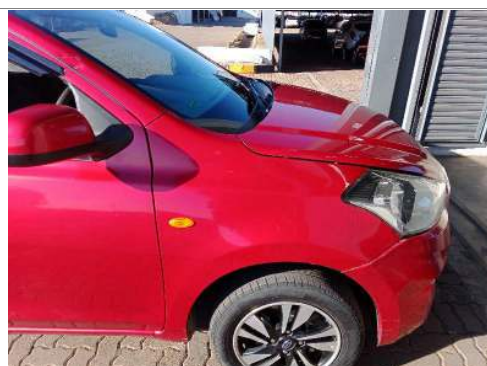
| Damage | Repair Way |
|---|---|
| Front Fender Right Damaged | Repair |

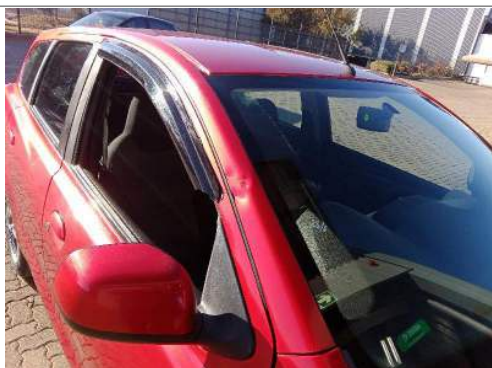
| Damage | Repair Way |
|---|---|
| A • Pillar Right Damaged | Repair |

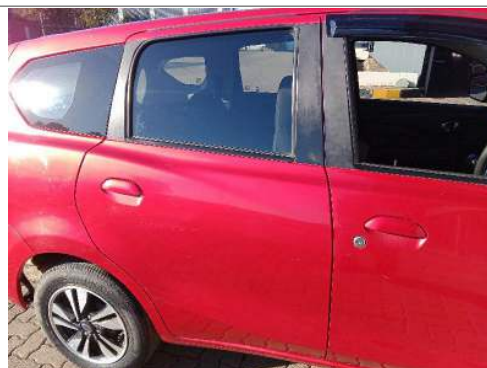
| Damage | Repair Way |
|---|---|
| Door Rear Right Damaged | Repair |

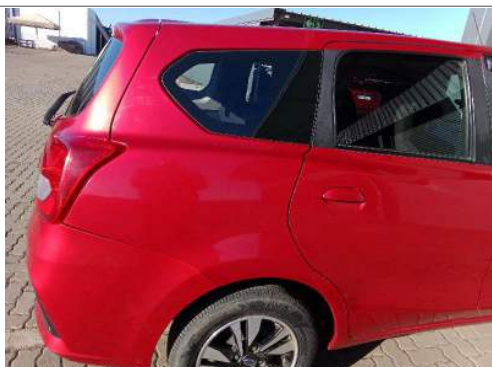
| Damage | Repair Way |
|---|---|
| Rear Fender Right Damaged | Repair |

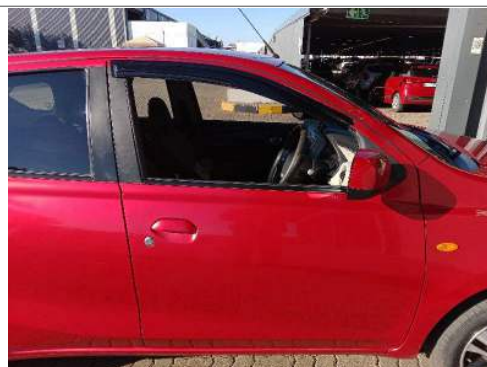
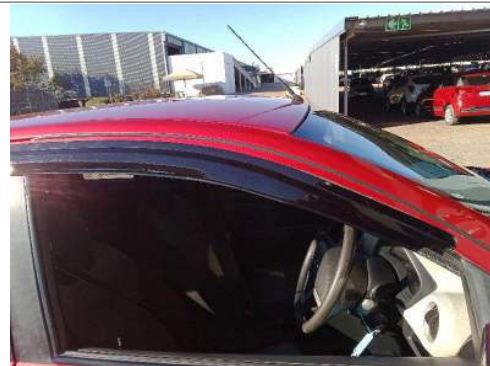
| Damage | Repair Way |
|---|---|
| Door Front Right Paintwork • Scratched | Repair |

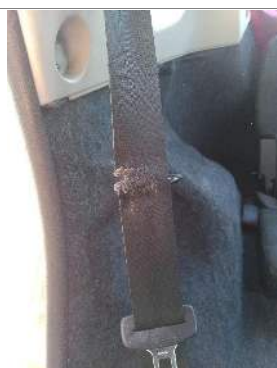
| Damage | Repair Way |
|---|---|
| Seat Belt Rear Right Damaged | Replace |

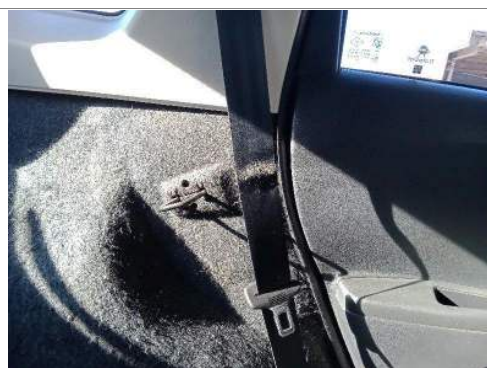
| Damage | Repair Way |
|---|---|
| Seat Belt Rear Left Damaged | Repair |

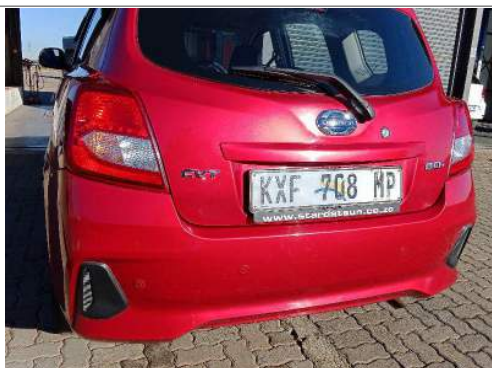
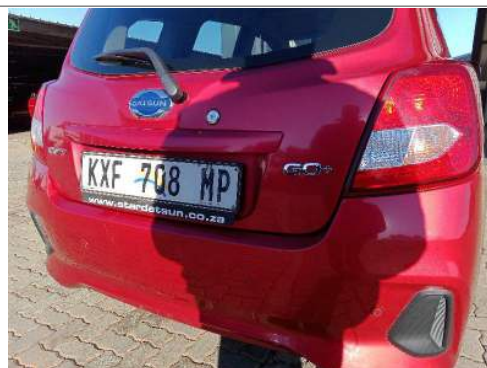
| Damage | Repair Way |
|---|---|
| Rear bumper Paintwork • Scratched | Repair |

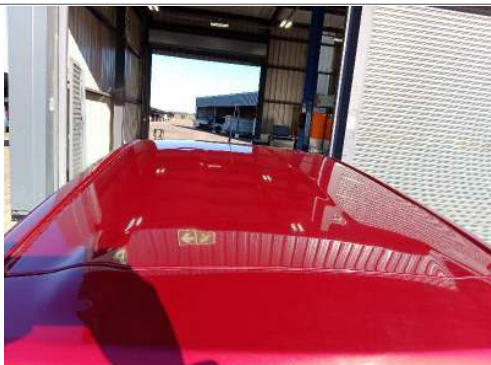
| Damage | Repair Way |
|---|---|
| Roof Dented | Repair |

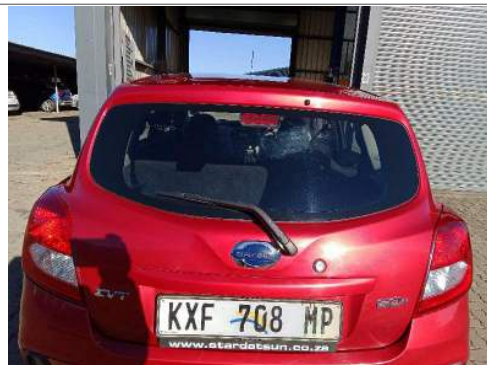
| Damage | Repair Way |
|---|---|
| Boot Lid / Hatch door Paintwork • Scratched | Repair |

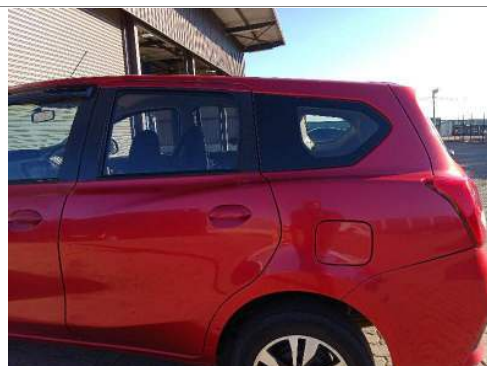
| Damage | Repair Way |
|---|---|
| Rear Fender Left Dented | Repair |

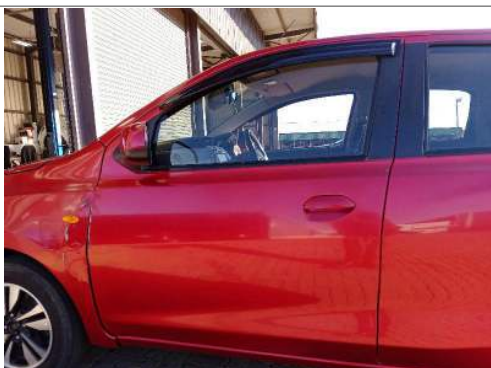
| Damage | Repair Way |
|---|---|
| Door Front Left Damaged | Repair |

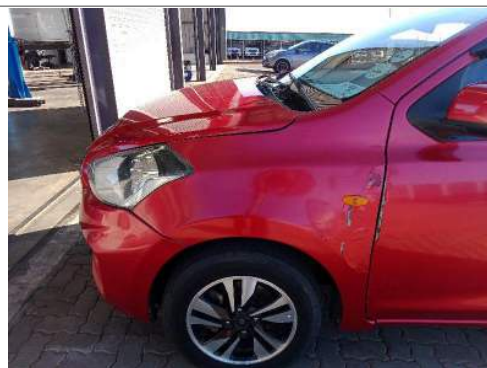
| Damage | Repair Way |
|---|---|
| Front Fender Left Damaged | Replace |

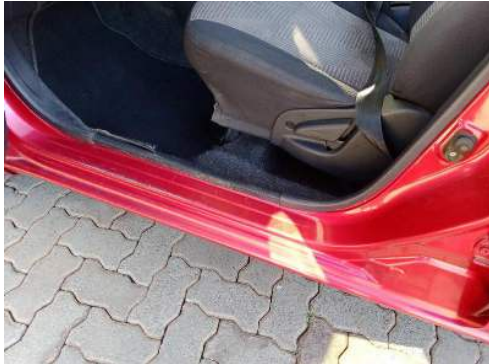
| Damage | Repair Way |
|---|---|
| Sill Panel Left Paintwork • Scratched | Repair |

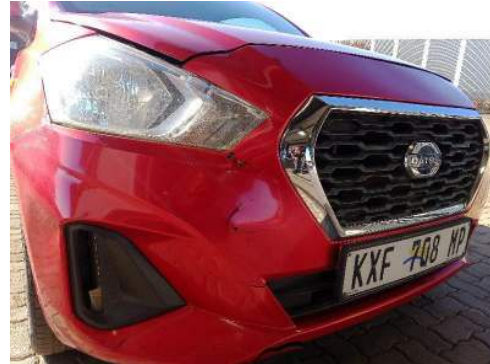
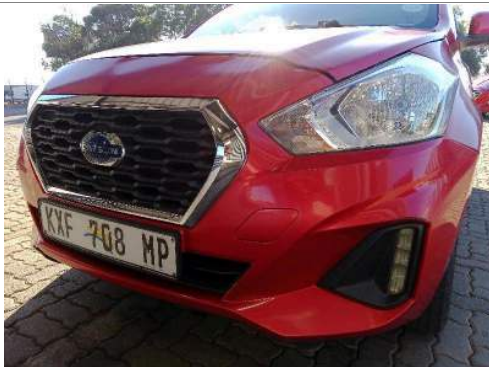
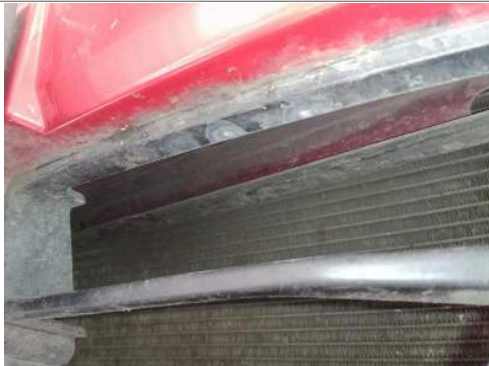
| Damage | Repair Way |
|---|---|
| Front Bumper Damaged | Repair |

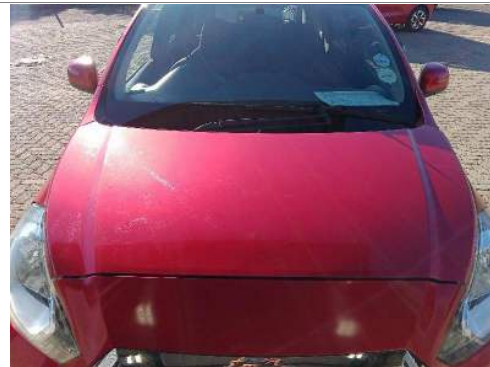
| Damage | Repair Way |
|---|---|
| Bonnet Dented | Repair |

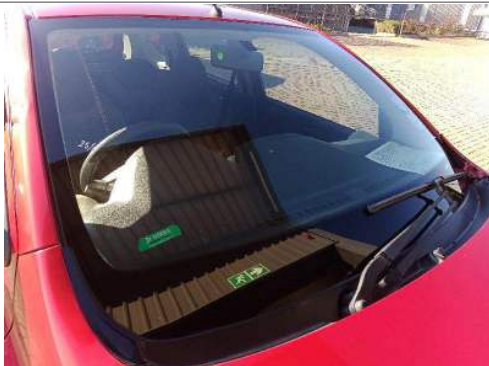
| Damage | Repair Way |
|---|---|
| Windscreen Chipped | Repair |

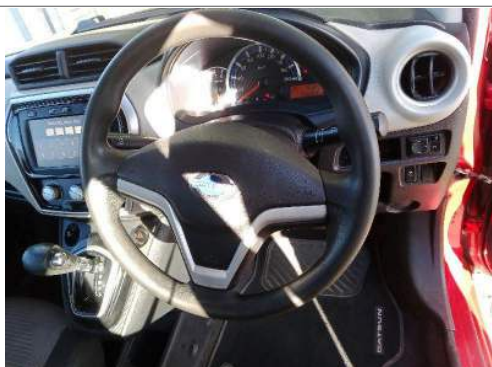
| Damage | Repair Way |
|---|---|
| Steering Wheel Trim Defective | Repair |

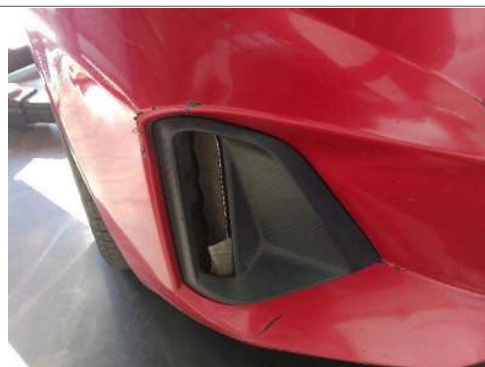
| Damage | Repair Way |
|---|---|
| Fog Light Front Right Damaged | Replace |

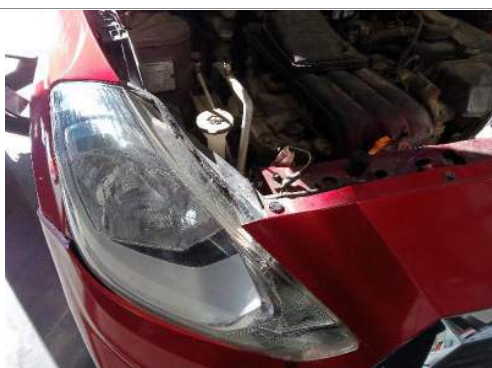
| Damage | Repair Way |
|---|---|
| Headlight Left Damaged | Replace |

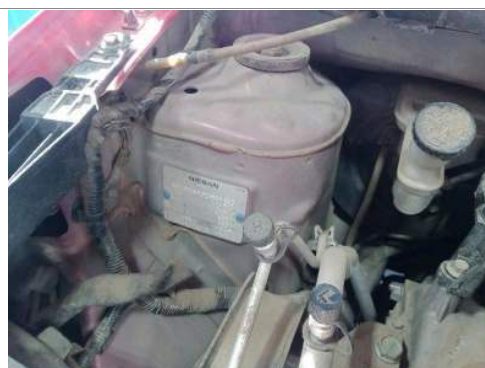
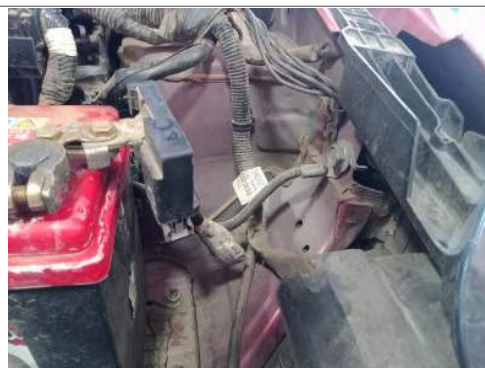
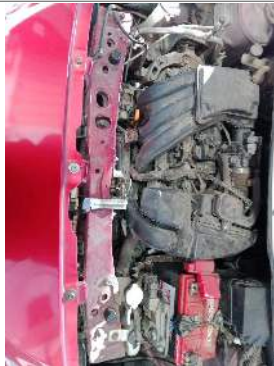
| Damage | Repair Way |
|---|---|
| Bonnet slam plate (Shock tower/ Inner tray) Damaged | Repair |

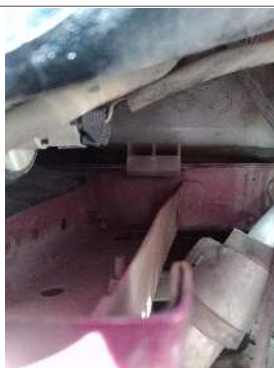
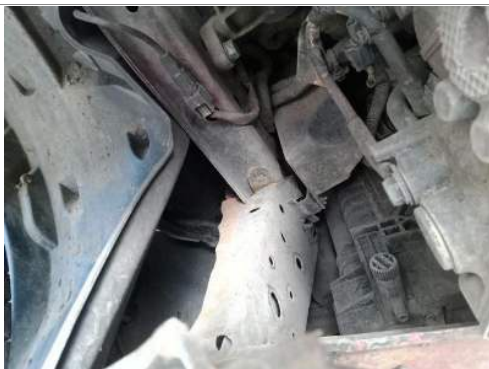
| Damage | Repair Way |
|---|---|
| Radiator Cradle Damaged | Replace |

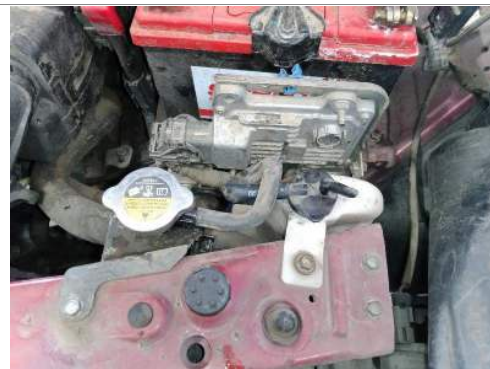
| Damage | Repair Way |
|---|---|
| Hoses Defective | Repair |

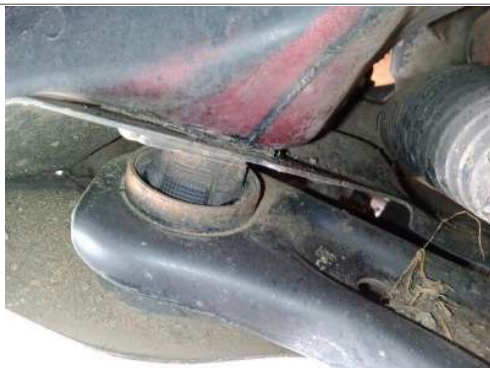
| Damage | Repair Way |
|---|---|
| Control Arm Bush(es) Front Axle Right Cracked | Replace |

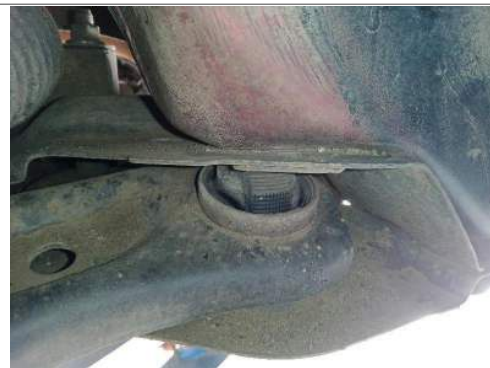
| Damage | Repair Way |
|---|---|
| Control Arm Bush(es) Front Axle Left Cracked | Replace |

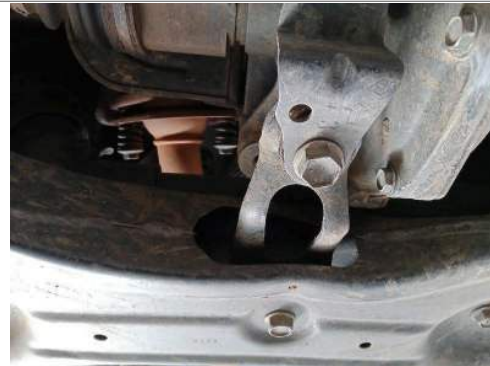
| Damage | Repair Way |
|---|---|
| Gearbox Mountings Damaged | Replace |

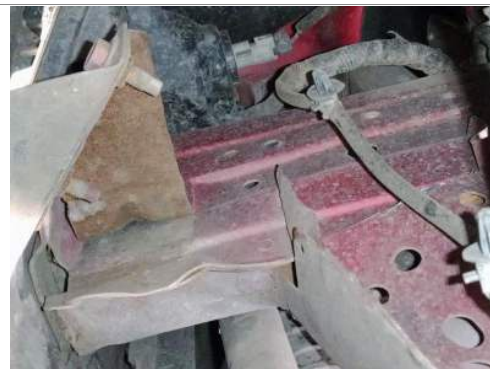
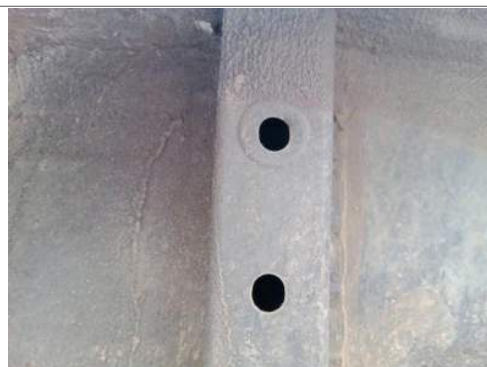
| Damage | Repair Way |
|---|---|
| Main Beam Left Damaged | Repair |

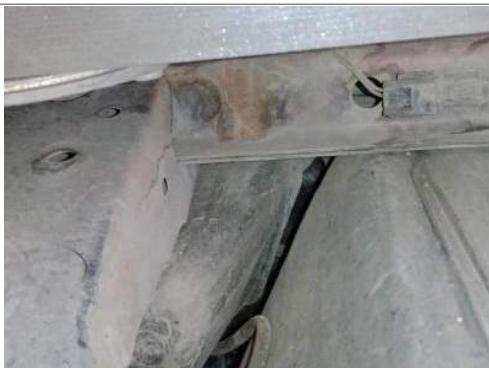
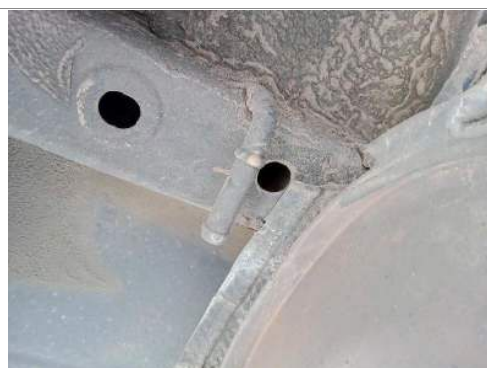
| Damage | Repair Way |
|---|---|
| Main Beam Right Damaged | Repair |

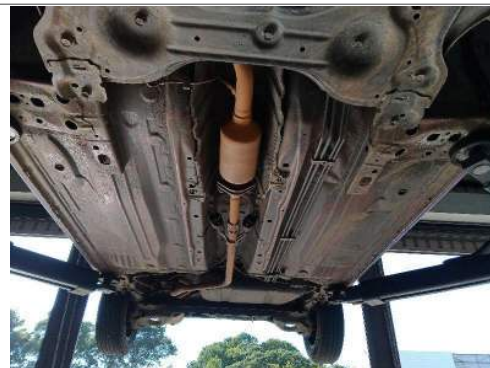
| Damage | Repair Way |
|---|---|
| Chassis Damaged | Repair |

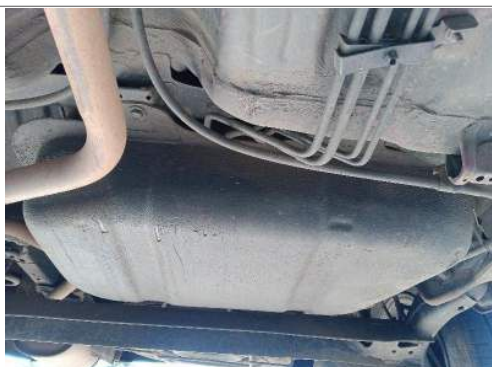
| Damage | Repair Way |
|---|---|
| Fuel Tank Dented | Repair |

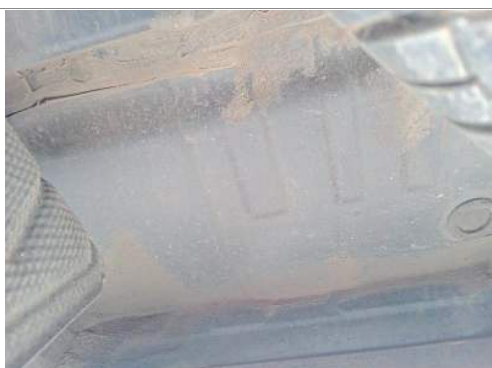
| Damage | Repair Way |
|---|---|
| Inner Boot Floor Pan and Spare Wheel Well Damaged | Repair |

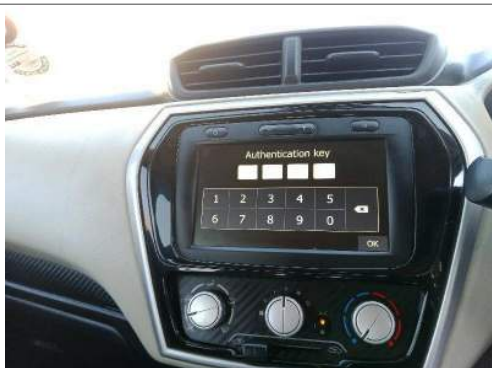
| Damage | Repair Way |
|---|---|
| Radio/CD/USB Defective | Repair |

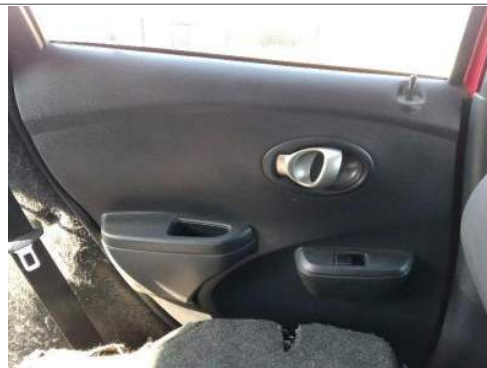
| Damage | Repair Way |
|---|---|
| Door Panel Rear Left Damaged | Repair |
