## CONDITION REPORT

Report No:  
2017298335  
DATE  
14/09/2026

| Manufacturer | DATSUN | Registration Number | KV80DYGP |
| Model | GO 1.2 LUX ULC 5-DR [2019-2021] | Register Number | |

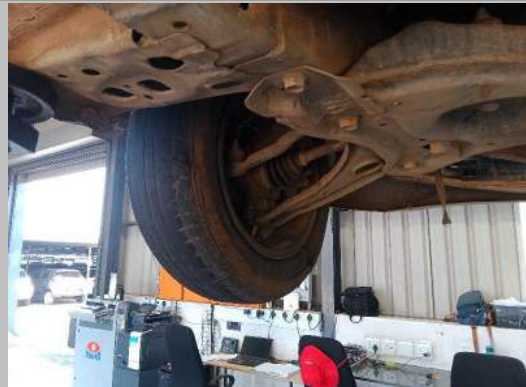
LF TYRE TREAD

| | Size | Load/Speed Index | Manufacture | Model | Type* | Production Date | Tread Depth (mm) |
|---|---|---|---|---|---|---|---|
| Front Left | 175/65R14 | 82T | Continental | Contact | V | 1719 | 1 mm |

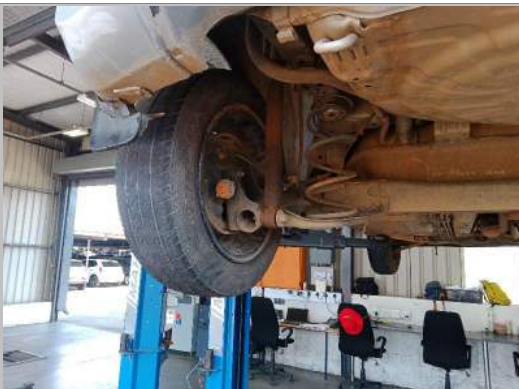
LR TYRE TREAD

| | Size | Load/Speed Index | Manufacture | Model | Type* | Production Date | Tread Depth (mm) |
|---|---|---|---|---|---|---|---|
| Rear Left | 165/65R14 | 79T | Hifly | Hf201 | V | 0920 | 2 mm |

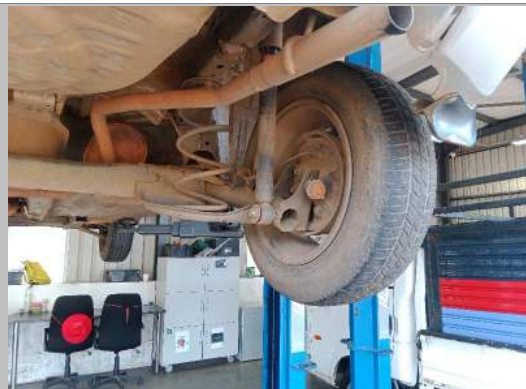
RR TYRE TREAD

| | Size | Load/Speed Index | Manufacture | Model | Type* | Production Date | Tread Depth (mm) |
|---|---|---|---|---|---|---|---|
| Rear Right | 165/70R14 | 81S | Bridgestone | B250 | V | 4317 | 3 mm |

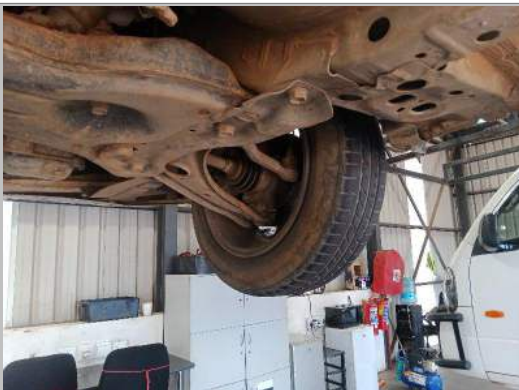
RF TYRE TREAD

| | Size | Load/Speed Index | Manufacture | Model | Type* | Production Date | Tread Depth (mm) |
|---|---|---|---|---|---|---|---|
| Front Right | 175/65R14 | 82H | Firestone | Touring | V | 4118 | 2 mm |

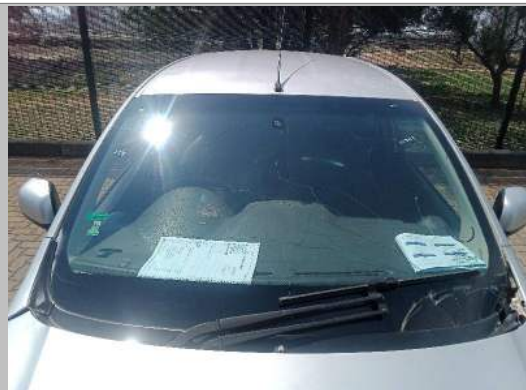
| No license disc | Replace |

No license disc

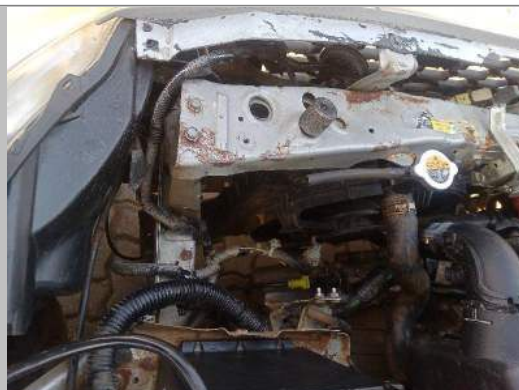
| Coolant bottle missing | Replace |
| Water leak from coolant bottle pipe | Repair |

Coolant bottle missing

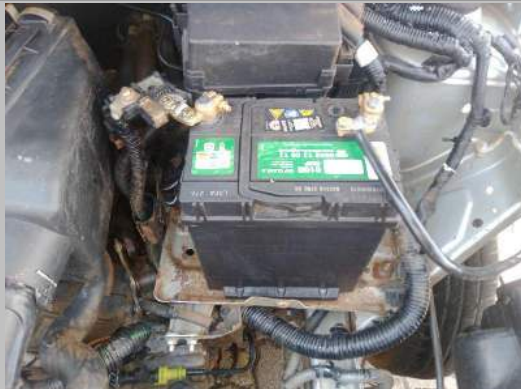
Battery loose

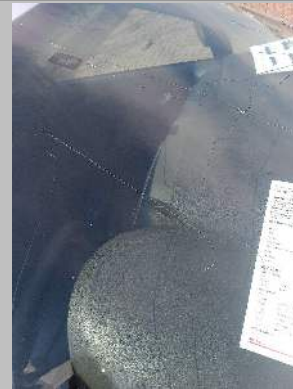
| Windscreen Cracked | Repair |
| Windscreen sealing rubber missing | Repair |

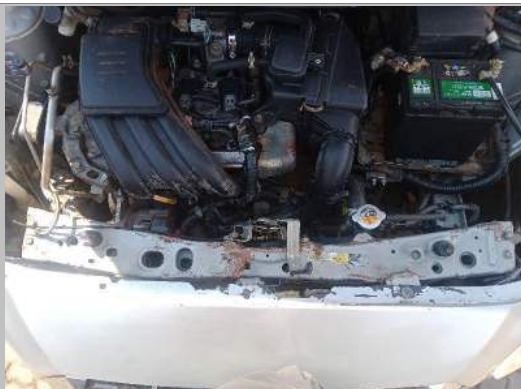
| Bonnet slam plate (Shock tower/ Inner tray) Dented | Repair |

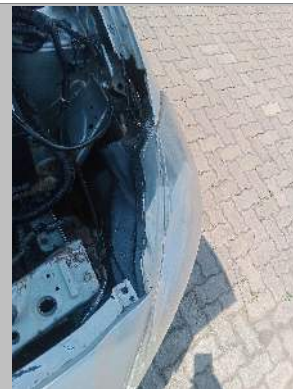
| Headlight Left Damaged | Repair |

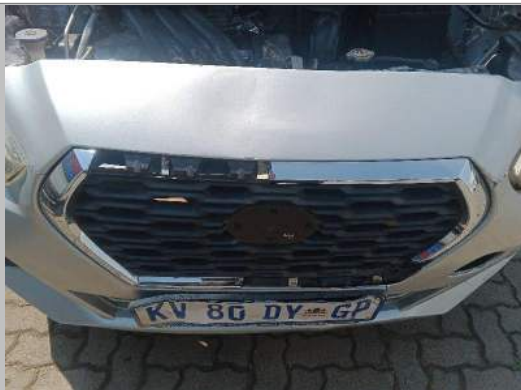
| Grill Damaged | Replace |

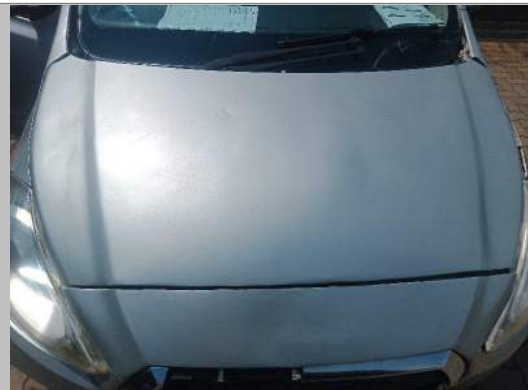
| Bonnet Residual Traces of Repair | Repair |

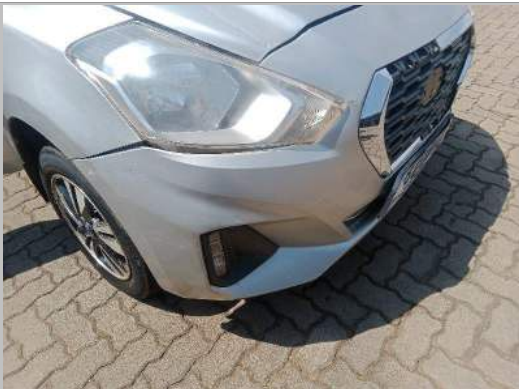
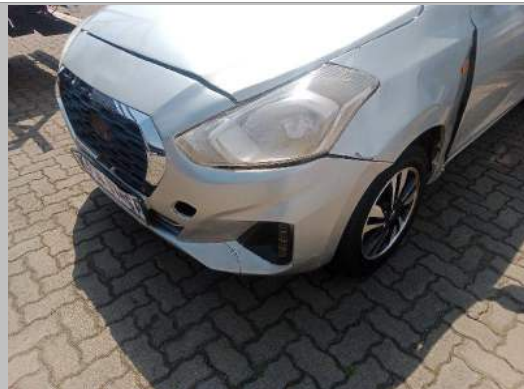
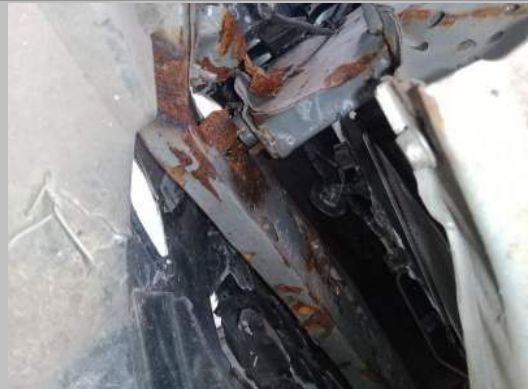
| Front Bumper Damaged | Repair |

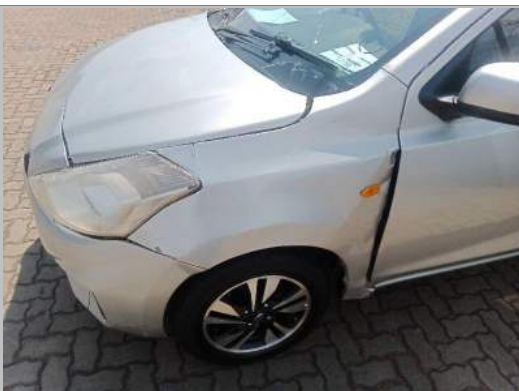
| Front Fender Left Dented | Repair |

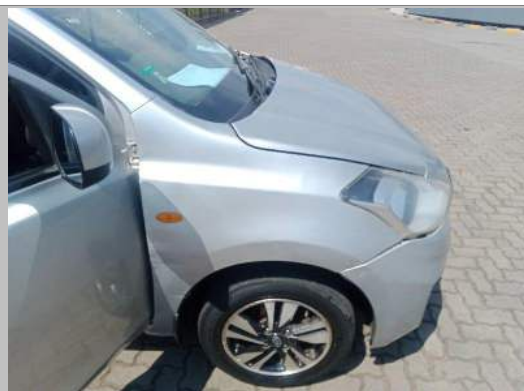
| Front Fender Right Residual Traces of Repair | Repair |

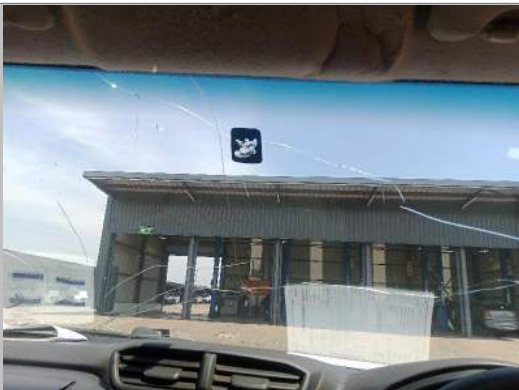
| Interior Mirror Missing | Replace |

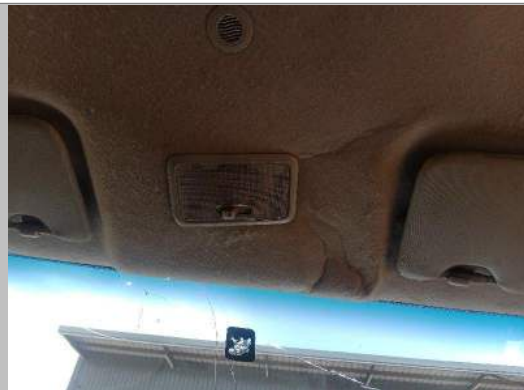
| Hood Lining Defective | Repair |

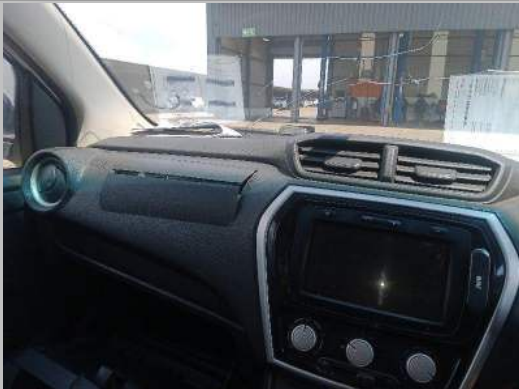
| Dash Padding Damaged | Repair |

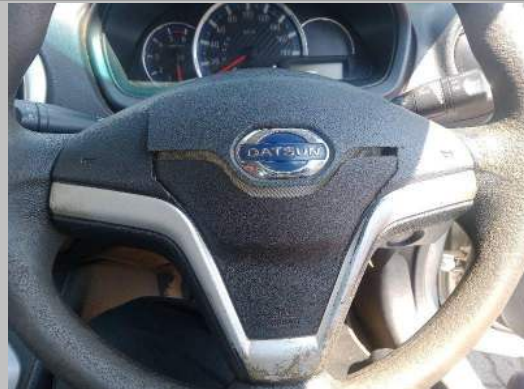
| Steering Wheel Trim Damaged | Repair |

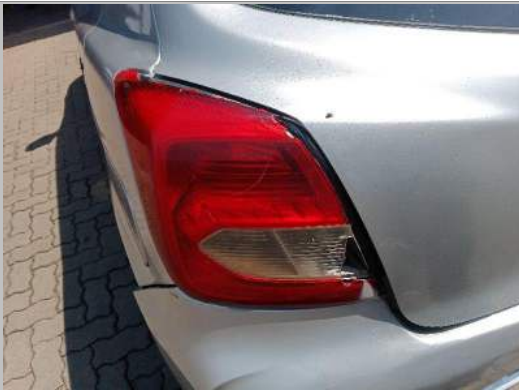
| Tail Light Left Damaged | Replace |

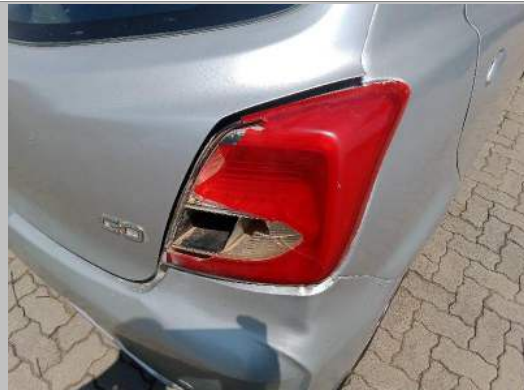
| Tail Light Right Damaged | Replace |

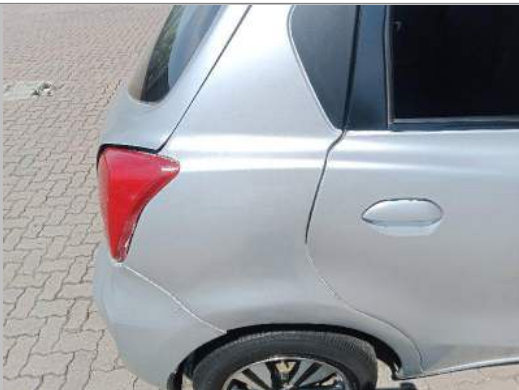
| Rear Fender Right Residual Traces of Repair | Repair |

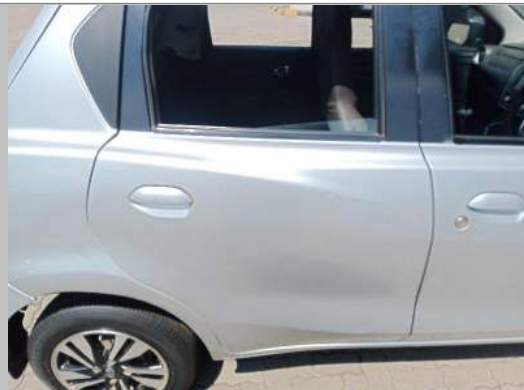
| Door Rear Right Residual Traces of Repair | Repair |

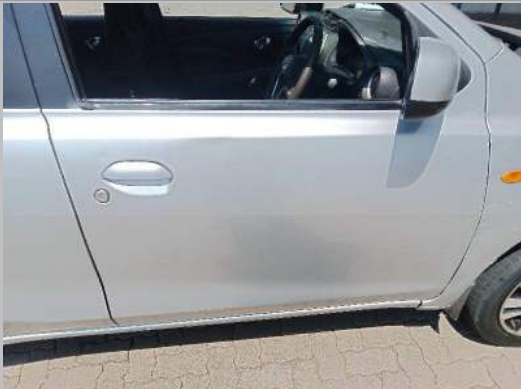
| Door Front Right Residual Traces of Repair | |

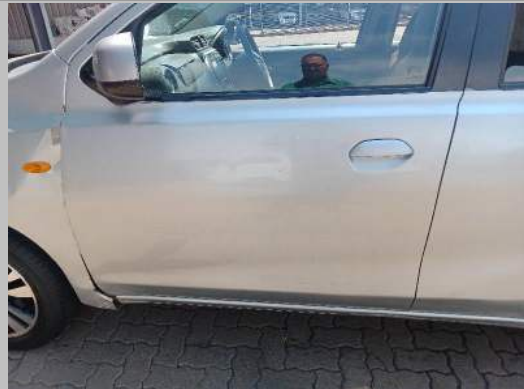
| Door Front Left Paintwork • Scratched | Repair |

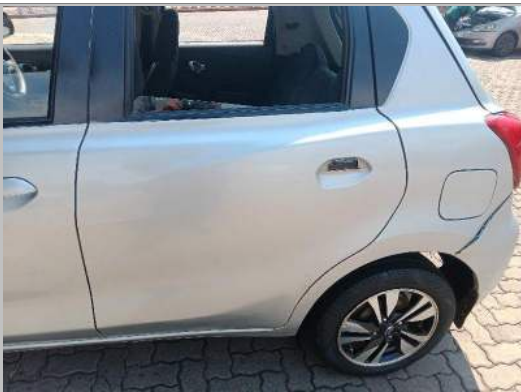
| Door Rear Left Residual Traces of Repair | Repair |

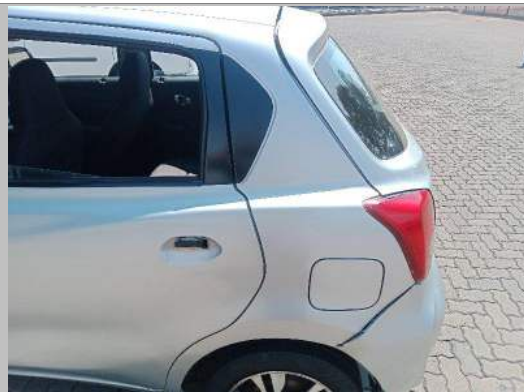
| Rear Fender Left Residual Traces of Repair | Repair |

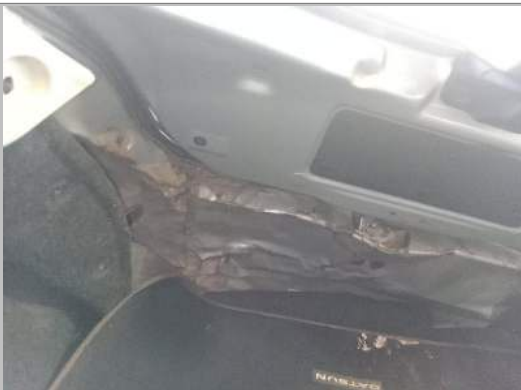
| Rear Upper Valance Damaged | Repair |

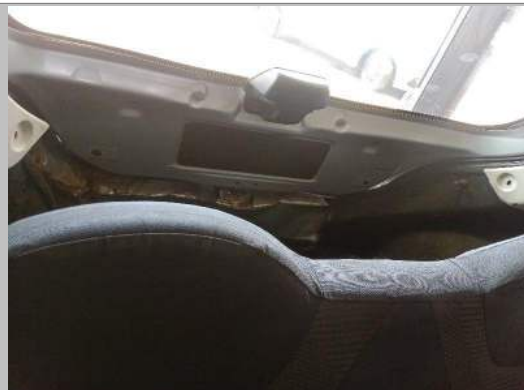
| Parcel Tray Missing | Replace |

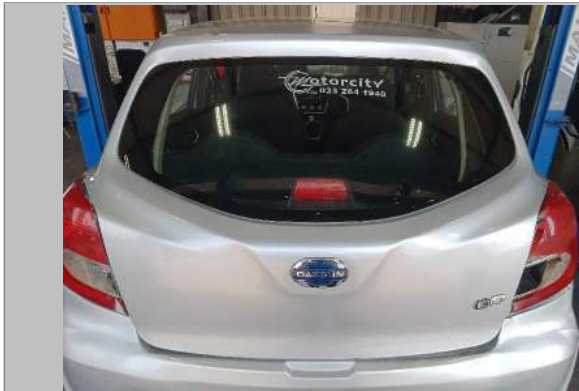
| Boot Lid / Hatch door Residual Traces of Repair | Repair |

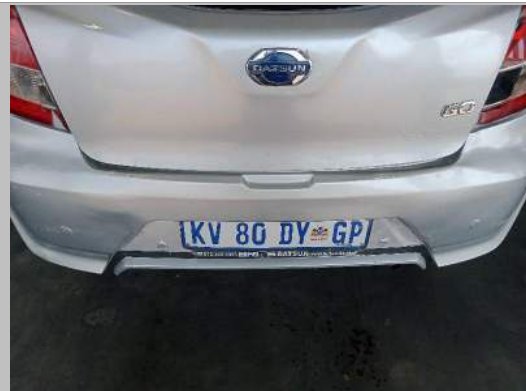
| Rear bumper Residual Traces of Repair | Repair |

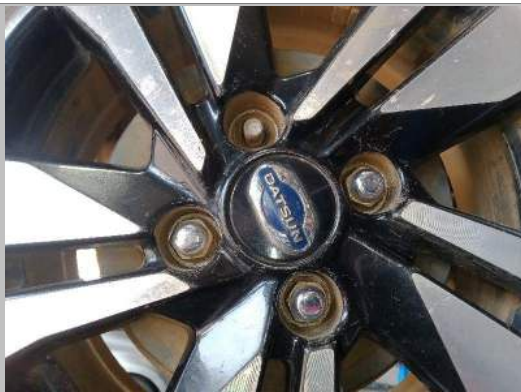
| Bolt(s) / Nut(s) Rear Wheel Right Missing | Replace |

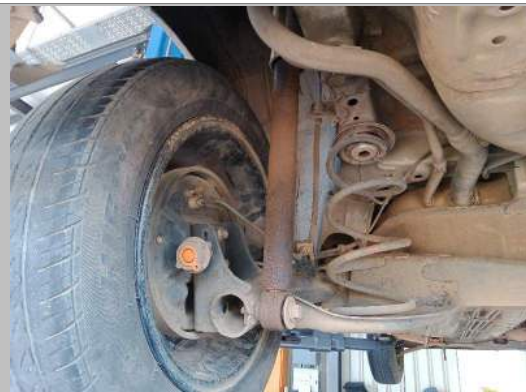
| Shock Absorber Rear Left Leak | Replace |

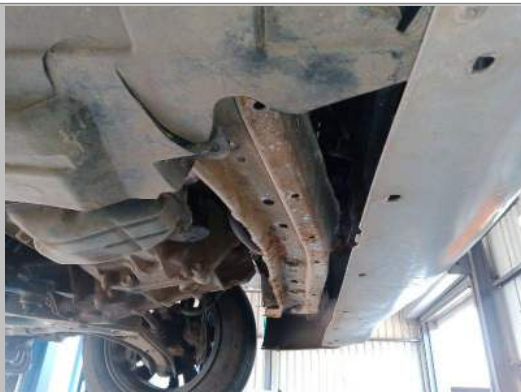
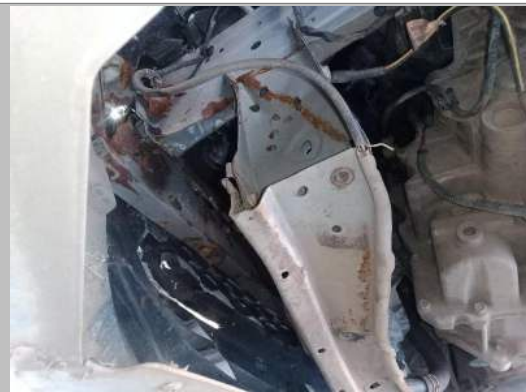
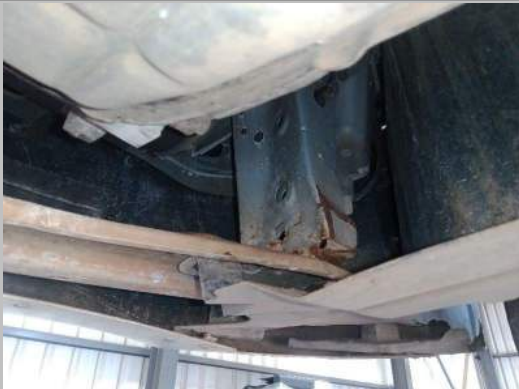
| Radiator Cradle Dented | Repair |

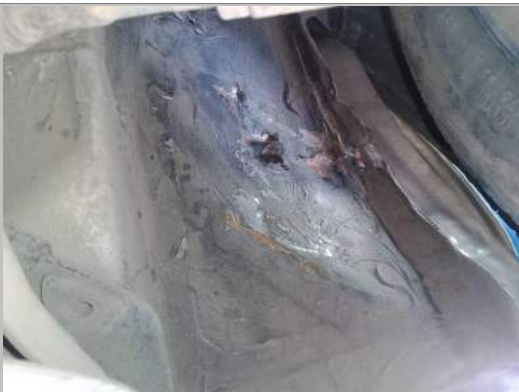
| Front Fender Left / Inner Tray Dented | Repair |

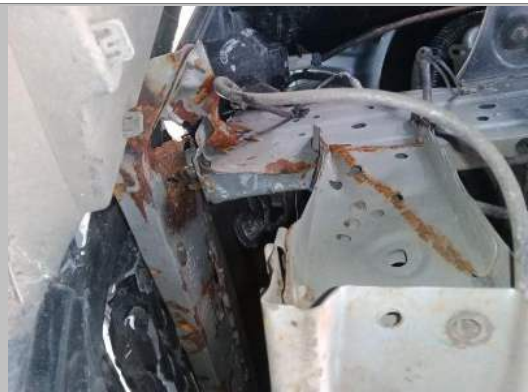
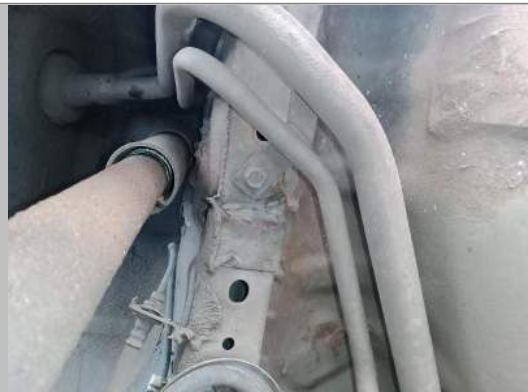
| Main Beam Left Dented | Repair |

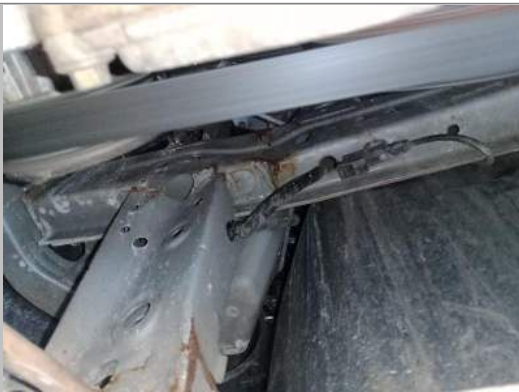
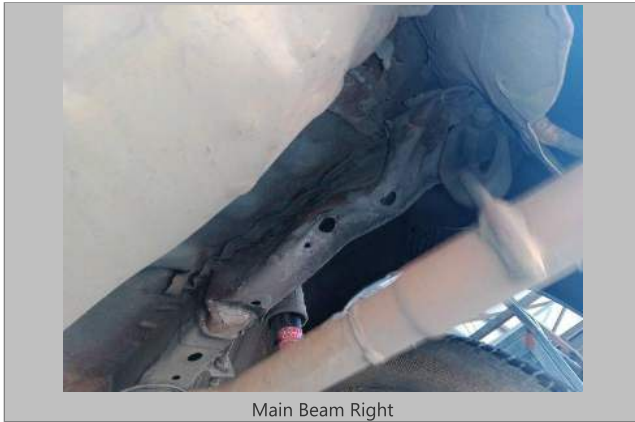
| Main Beam Right Dented | Repair |
