## CONDITION REPORT

Report No:  
2017305818  
DATE  
01/10/2026

| Manufacturer | RENAULT | Registration Number | HV72GGGP |
| Model | KWID | Register Number | |

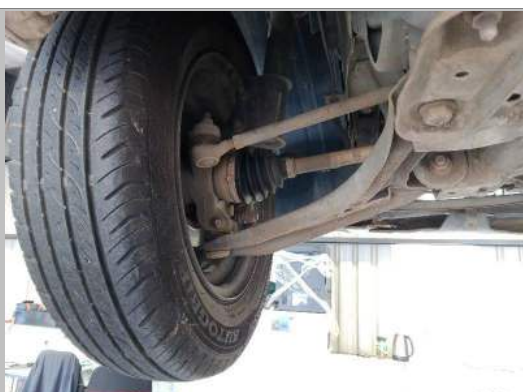
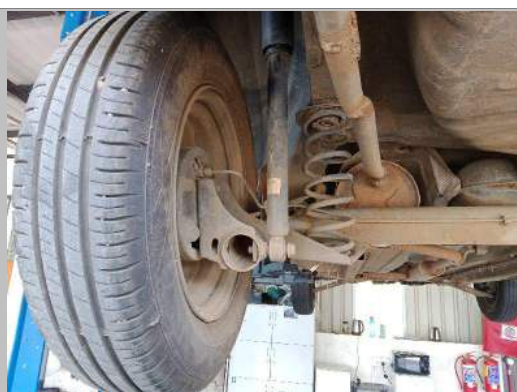
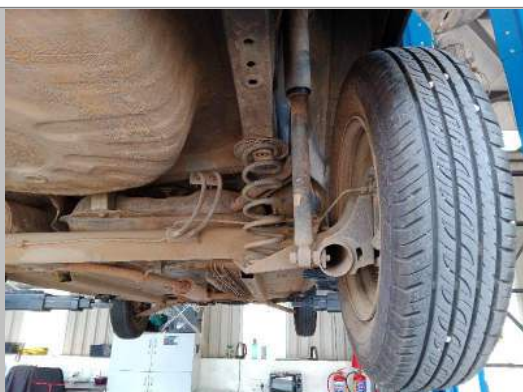
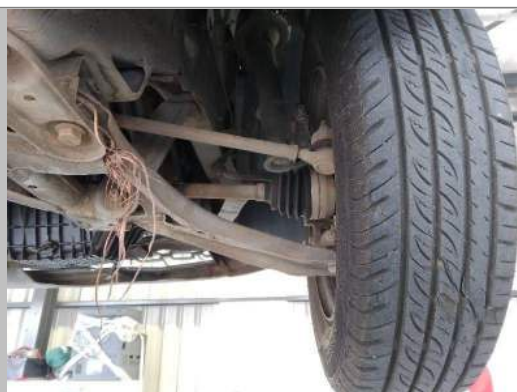
| | Size | Load/Speed Index | Manufacture | Model | Type* | Production Date | Tread Depth (mm) |
|---|---|---|---|---|---|---|---|
| Front Left | 155/80 R13 | 79T | Autogrip | P308 | V | 0125 | 3 mm |
| Front Right | 155/80 R13 | 79T | Autogrip | P308 | V | 0125 | 3 mm |
| Rear Left | 155/80 R13 | 79T | Dunlop | Sp-Touring | V | 2524 | 4 mm |
| Rear Right | 155/80 R13 | 79T | Autogrip | P308 | V | 0125 | 5 mm |

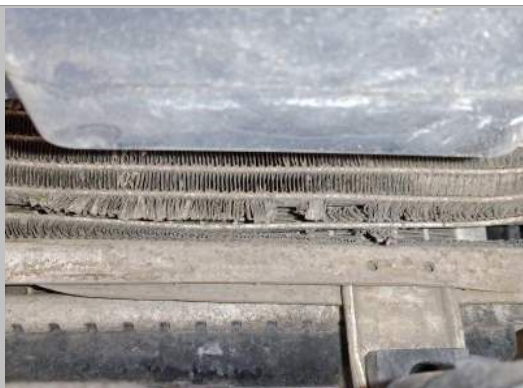
| Aircon condenser damaged | Replace |

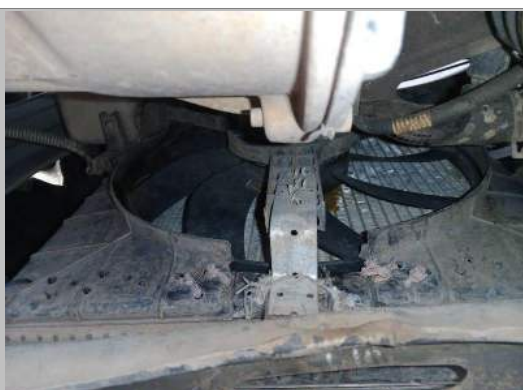
| Fan Cowley damaged | Replace |

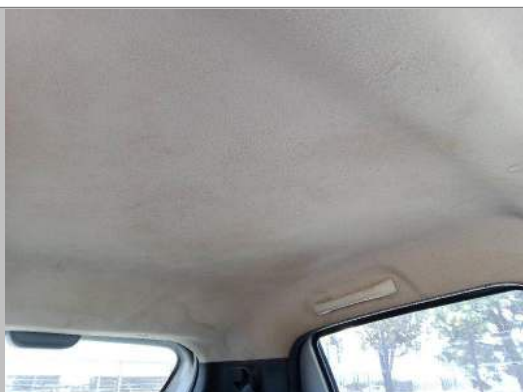
| Damage | Repair Way |
|---|---|
| Hood Lining Dirty | Repair |

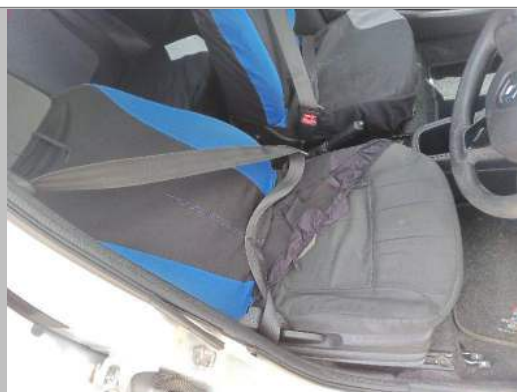
| Damage | Repair Way |
|---|---|
| Seat Front Right Damaged | Repair |

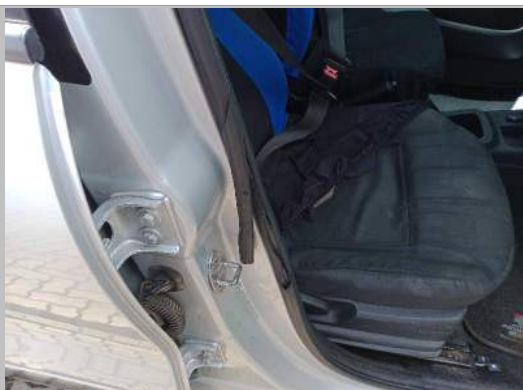
| Damage | Repair Way |
|---|---|
| Door Sealing Rubber Front Right Damaged | Replace |

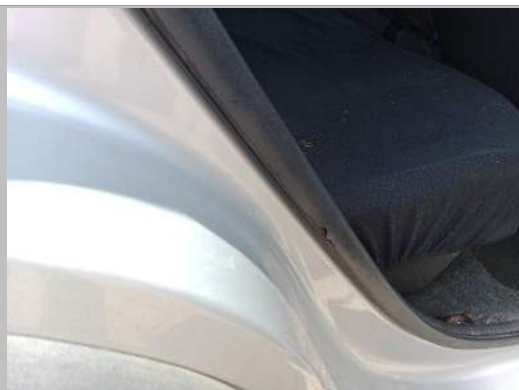
| Damage | Repair Way |
|---|---|
| Door Sealing Rubber Rear Right Damaged | Replace |

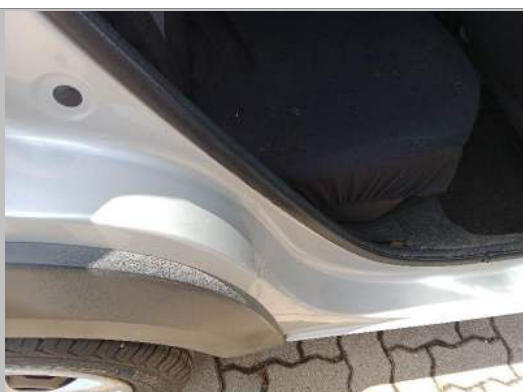
| Damage | Repair Way |
|---|---|
| C • Pillar Right Dented | Repair |

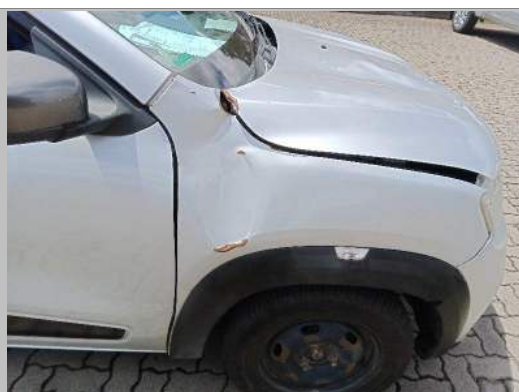
| Damage | Repair Way |
|---|---|
| Front Fender Right Damaged | Repair |

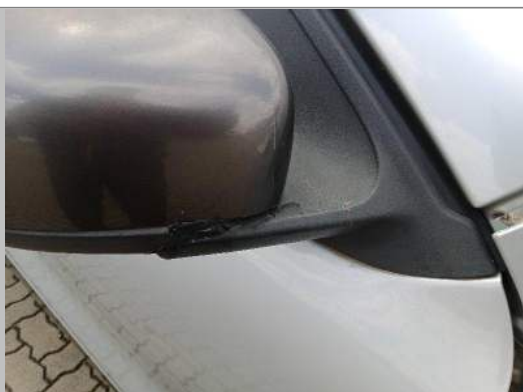
| Damage | Repair Way |
|---|---|
| Side Mirror Right Residual Traces of Repair | Replace |

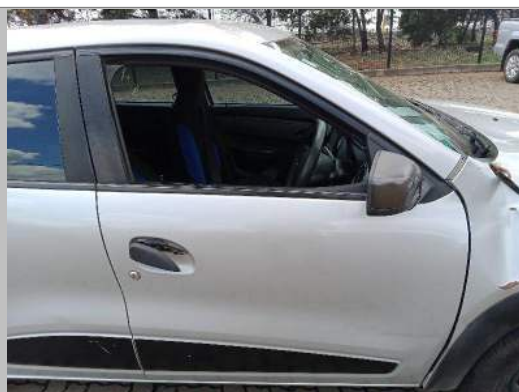
| Damage | Repair Way |
|---|---|
| Door Front Right Damaged | Repair |

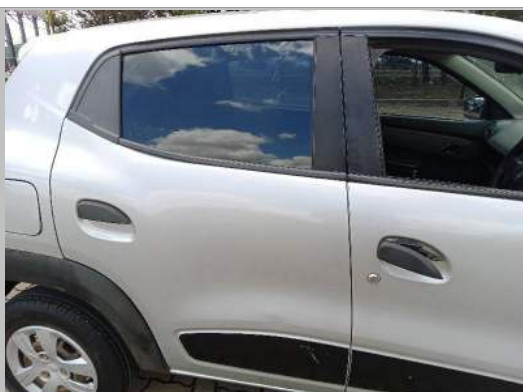
| Damage | Repair Way |
|---|---|
| Door Rear Right Damaged | Repair |

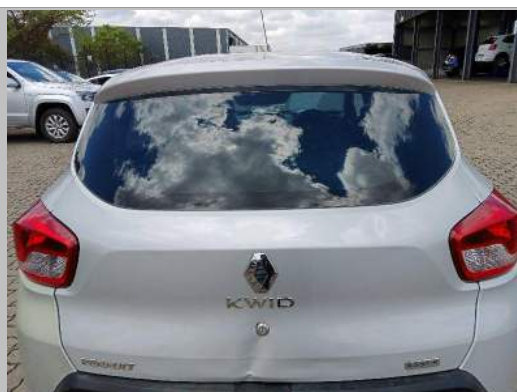
| Damage | Repair Way |
|---|---|
| Boot Lid / Hatch door Damaged | Repair |

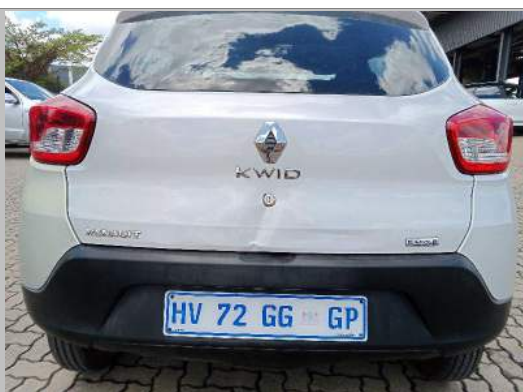
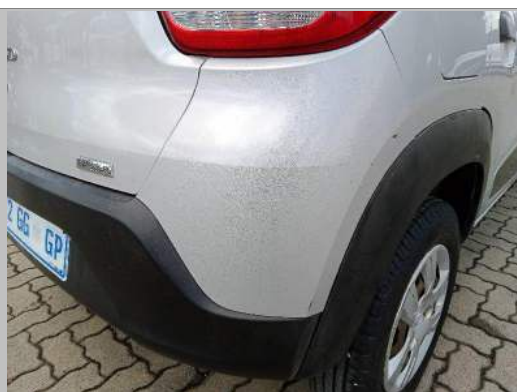
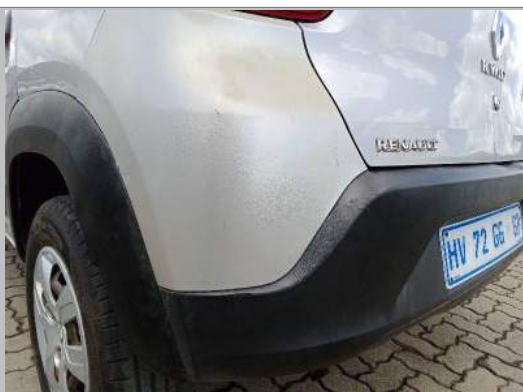
| Damage | Repair Way |
|---|---|
| Rear bumper Damaged | Repair |

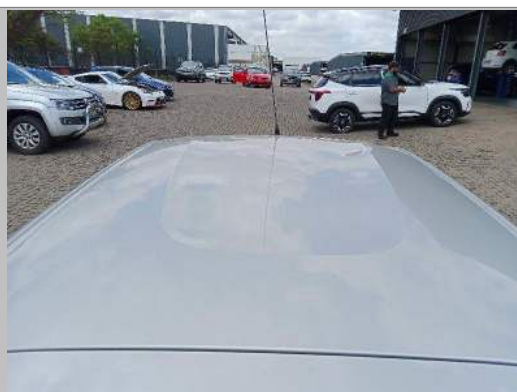
| Damage | Repair Way |
|---|---|
| Roof Dented | Repair |

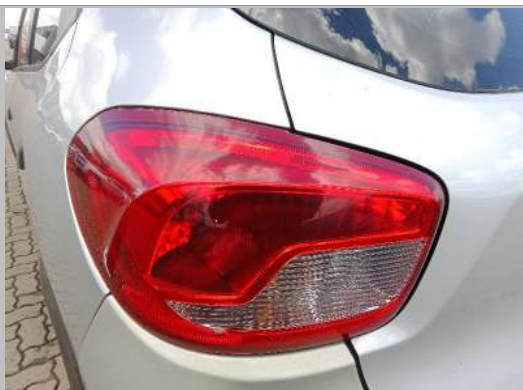
| Damage | Repair Way |
|---|---|
| Tail Light Left Cracked | Replace |

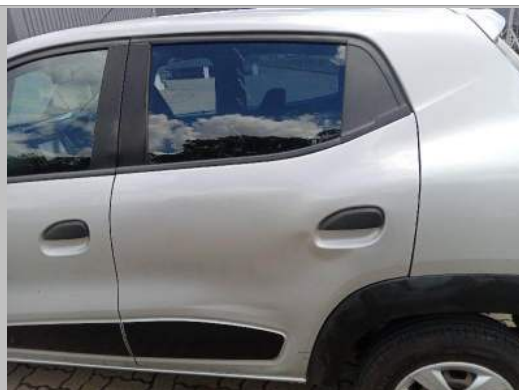
| Damage | Repair Way |
|---|---|
| Door Rear Left Damaged | Repair |

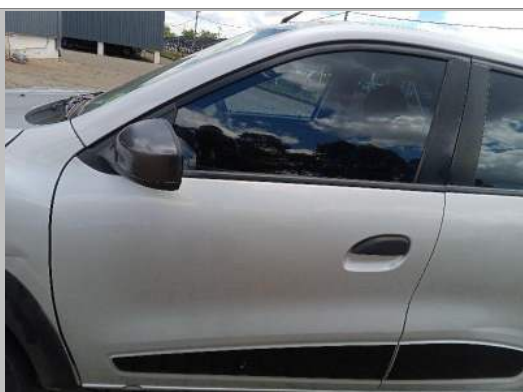
| Damage | Repair Way |
|---|---|
| Door Front Left Dented | Repair |

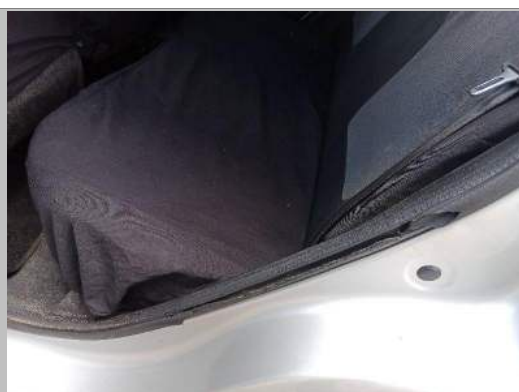
| Damage | Repair Way |
|---|---|
| Door Sealing Rubber Rear Left Damaged | Replace |

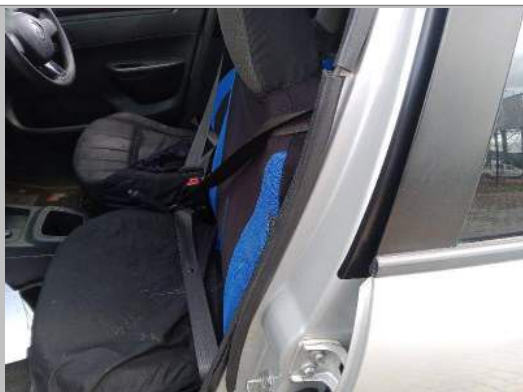
| Damage | Repair Way |
|---|---|
| Door Sealing Rubber Front Left Damaged | Replace |

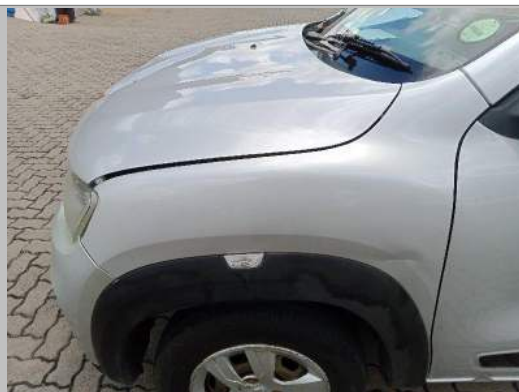
| Damage | Repair Way |
|---|---|
| Front Fender Left Damaged | Repair |

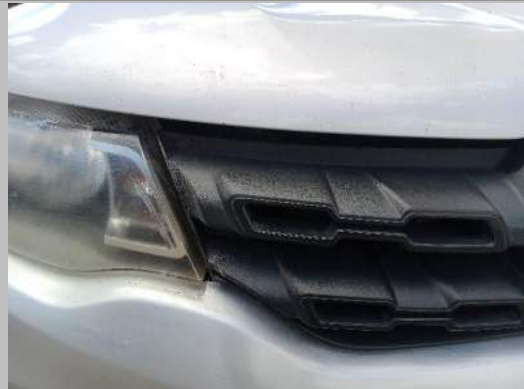
| Damage | Repair Way |
|---|---|
| Grill Damaged | Replace |

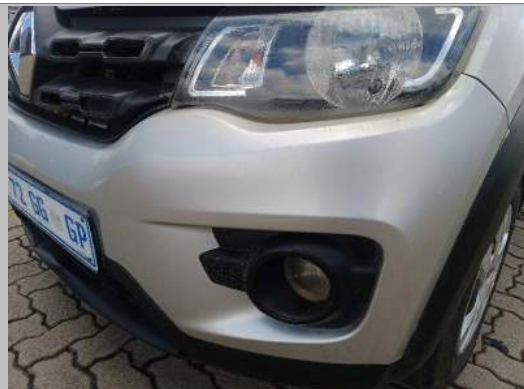
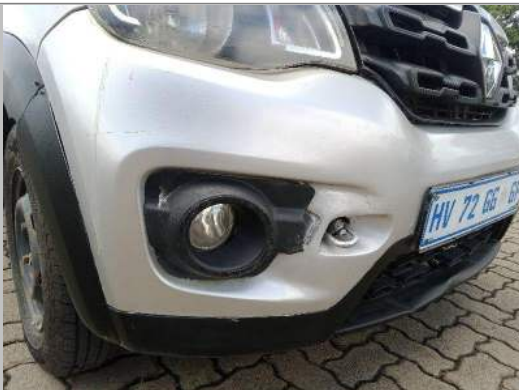
| Damage | Repair Way |
|---|---|
| Front Bumper Damaged | Replace |

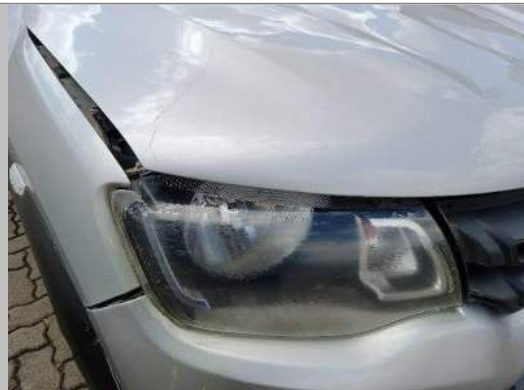
| Damage | Repair Way |
|---|---|
| Headlight Right Damaged | Replace |

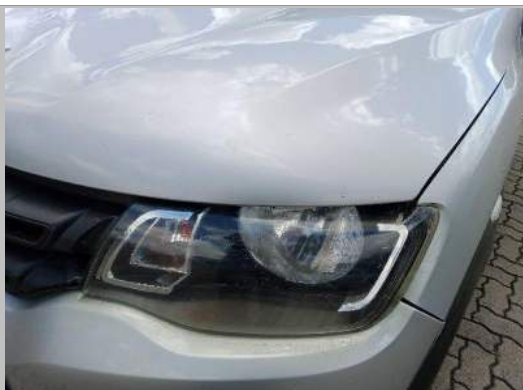
| Damage | Repair Way |
|---|---|
| Headlight Left Damaged | Replace |

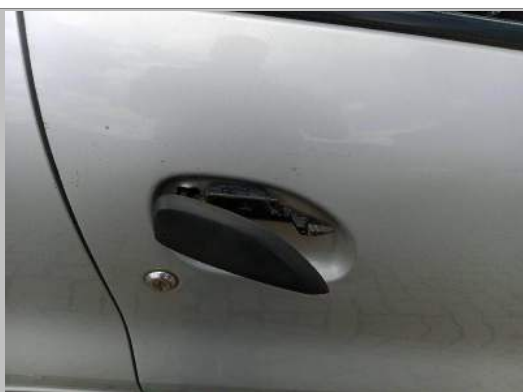
| Damage | Repair Way |
|---|---|
| Door Handle Front Right Damaged | Replace |

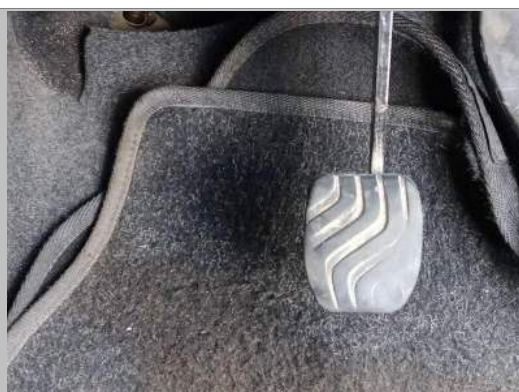
| Damage | Repair Way |
|---|---|
| Brake Pedal Rubber Damaged | Replace |

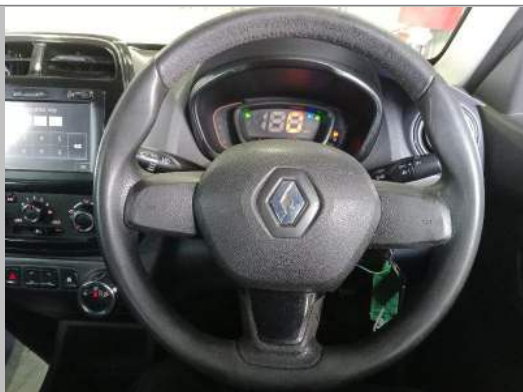
| Damage | Repair Way |
|---|---|
| Steering Wheel Trim Excessive Wear & Tear | Repair |

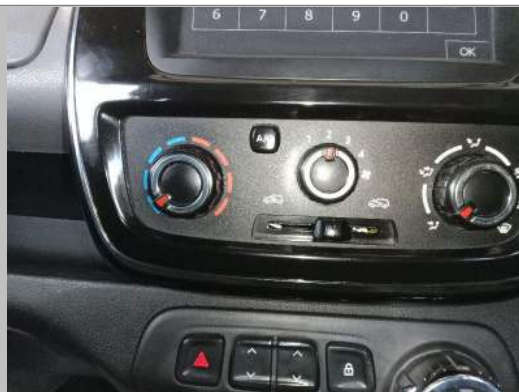
| Damage | Repair Way |
|---|---|
| Air Conditioner Insufficient | Replace |

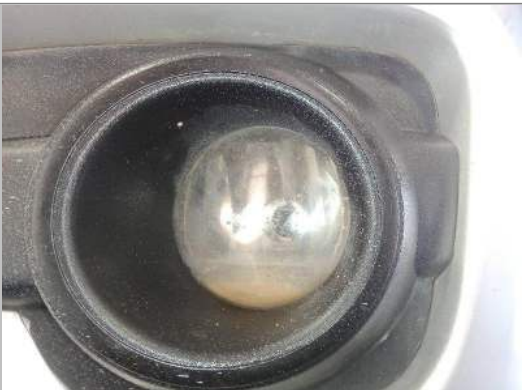
| Damage | Repair Way |
|---|---|
| Fog Light Front Left Defective | Repair |

General Comments: ACCORDING TO THE AGE AND MILEAGE OF THE VEHICLE, NORMAL WEAR AND TEAR MARKS ARE VISIBLE ON THE INTERIOR, EXTERIOR, ELECTRICAL AND MECHANICAL PARTS. VEHICLE LICENSE DISK NOT AN ORIGINAL COPY.Lights: Front left and right fog light bulbs missing.  
Interior: Vehicle interior dirty and panels scratched.Front and rear seats fully covered.Boot release handle not opening.  
Body • Exterior: Poor residual traces of repair on body panels.Body panels misaligned.Stone chips and spray work on body panels.Dents and scratches on body panels.Signs of impact damage to front of vehicle.Vehicle safety integrity compromised.

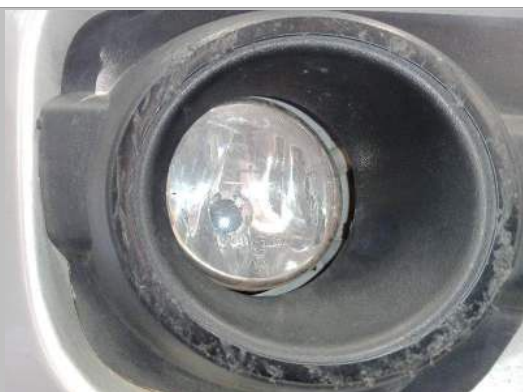
| Damage | Repair Way |
|---|---|
| Fog Light Front Right Defective | Repair |

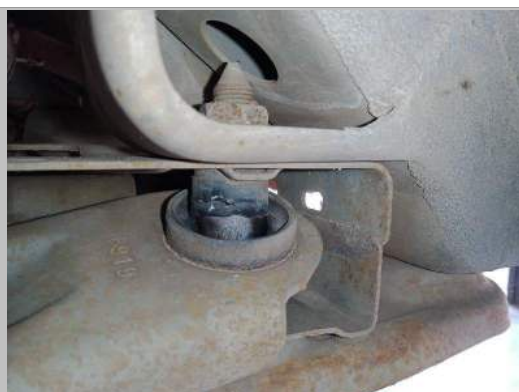
| Damage | Repair Way |
|---|---|
| Control Arm Bush(es) Front Axle Left Damaged | Replace |

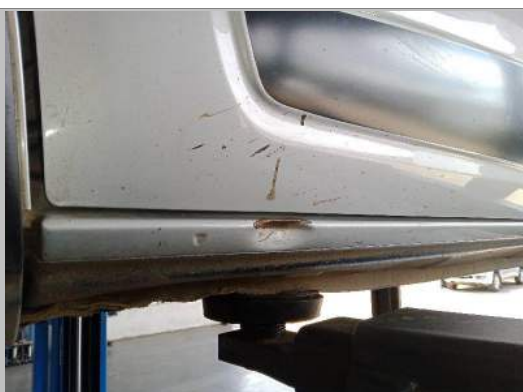
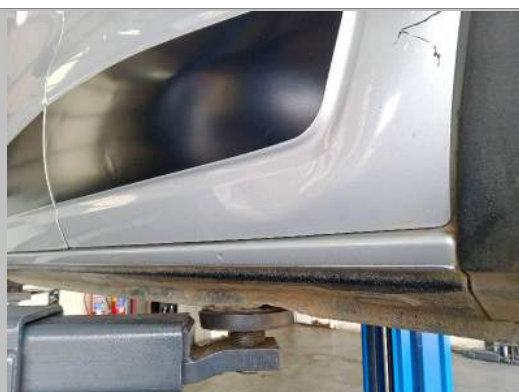
| Damage | Repair Way |
|---|---|
| Sill Panel Left Damaged | Repair |

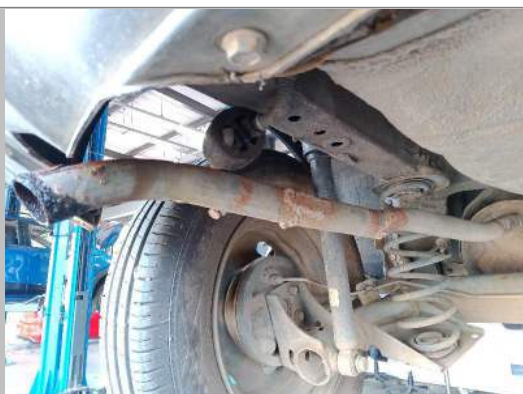
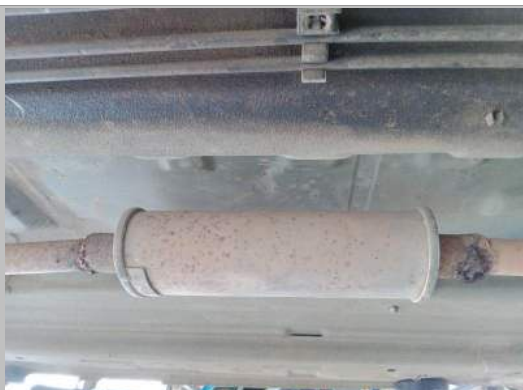
| Damage | Repair Way |
|---|---|
| Engine to silencer pipe Welded | Replace |

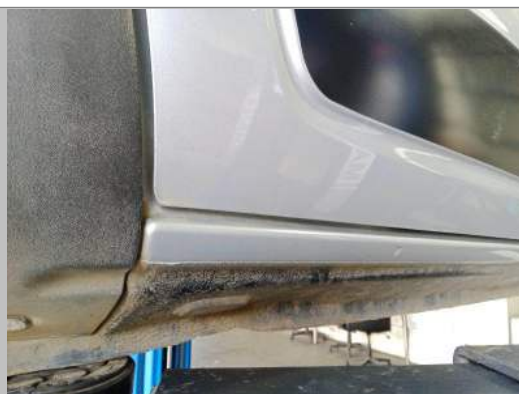
| Damage | Repair Way |
|---|---|
| Sill Panel Right Damaged | Repair |

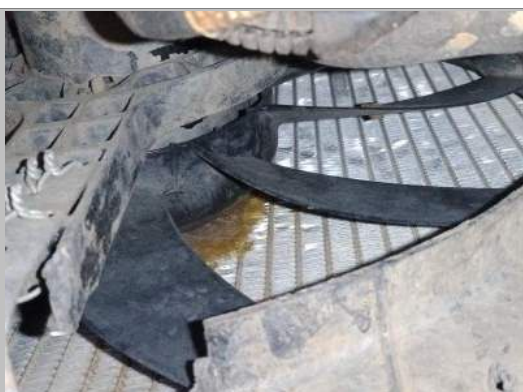
| Damage | Repair Way |
|---|---|
| Radiator Defective | Replace |

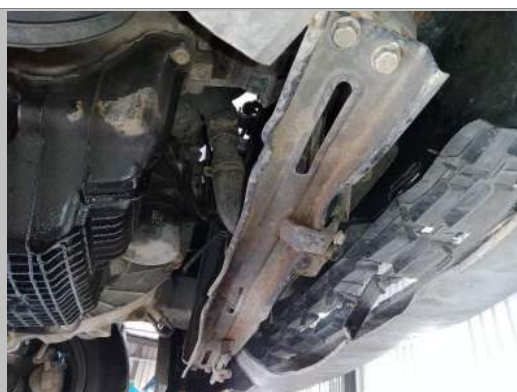
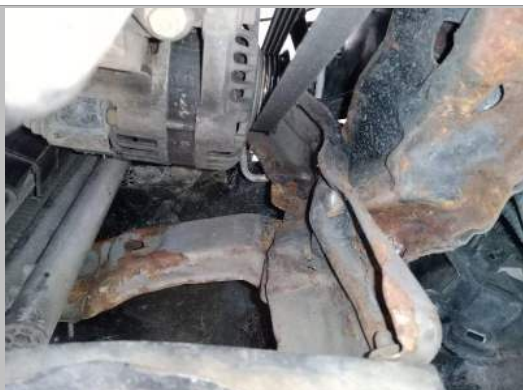
| Damage | Repair Way |
|---|---|
| Radiator Cradle Damaged | Replace |

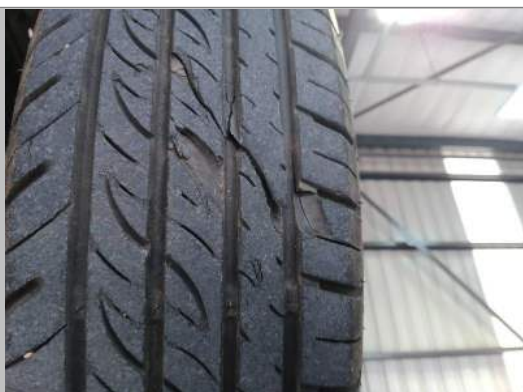
| Damage | Repair Way |
|---|---|
| Tyre Front Right Damaged | Replace |

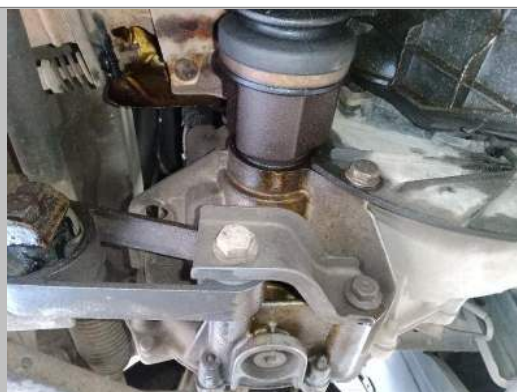
| Damage | Repair Way |
|---|---|
| Gearbox Oil Leak | Repair |

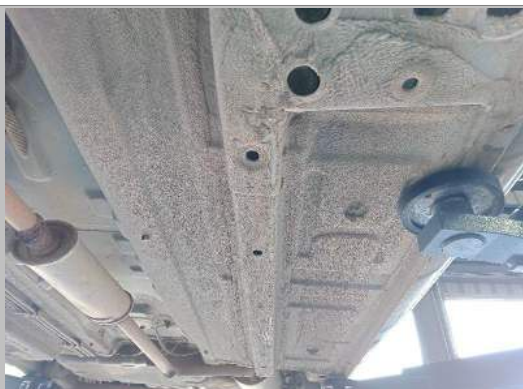
| Damage | Repair Way |
|---|---|
| Chassis Scratched | Repair |

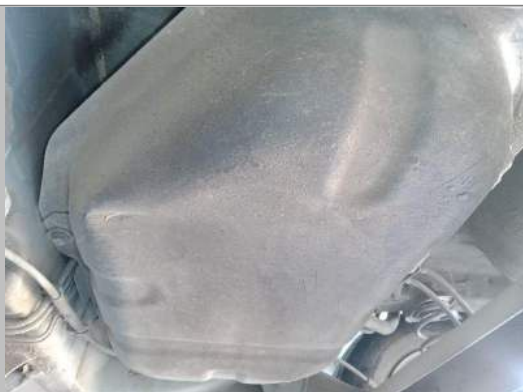
| Damage | Repair Way |
|---|---|
| Fuel Tank Damaged | Replace |

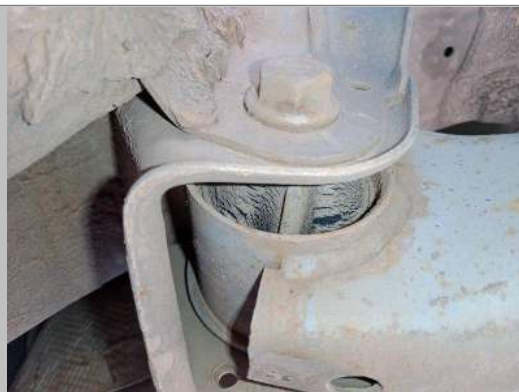
| Damage | Repair Way |
|---|---|
| Mounting Rubber(s) Rear Axle Left Cracked | Replace |

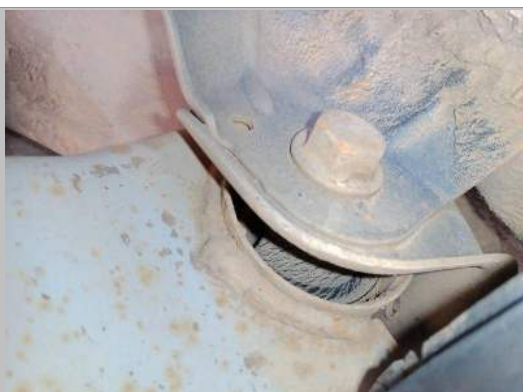
| Damage | Repair Way |
|---|---|
| Mounting Rubber(s) Rear Axle Right Cracked | Replace |

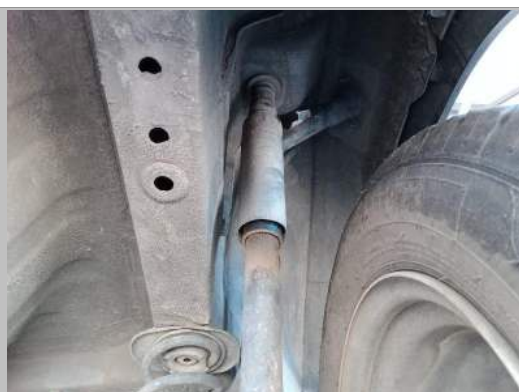
| Damage | Repair Way |
|---|---|
| Shock Absorber Rear Right Sweat | Replace |

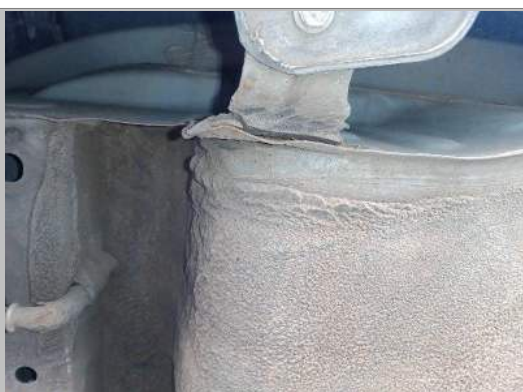
| Damage | Repair Way |
|---|---|
| Inner Boot Floor Pan and Spare Wheel Well Damaged | Repair |

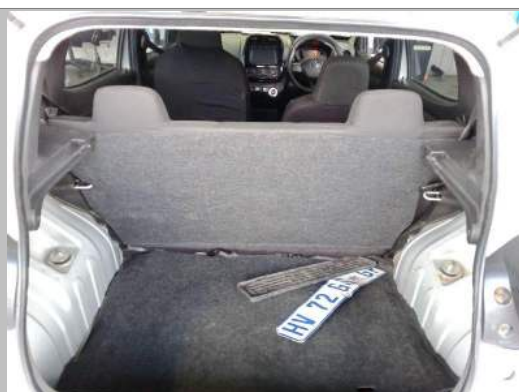
| Damage | Repair Way |
|---|---|
| Parcel Tray Missing | Repair |

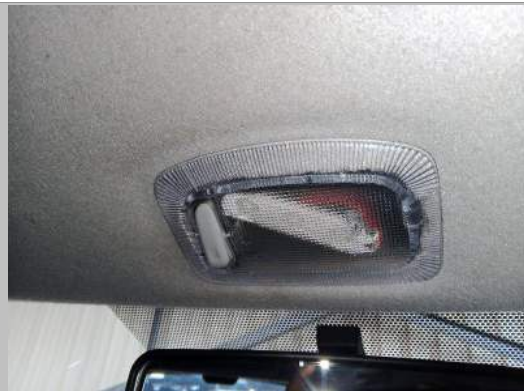
| Damage | Repair Way |
|---|---|
| Interior Lights Defective | Replace |
