## CONDITION REPORT

Report No:  
2017295668  
DATE  
09/09/2026

| Manufacturer | RENAULT | Registration Number | JJ82KMGP |
| Model | KWID 1.0 DYNAMIQUE 5-DR [2016-2019] | Register Number | |

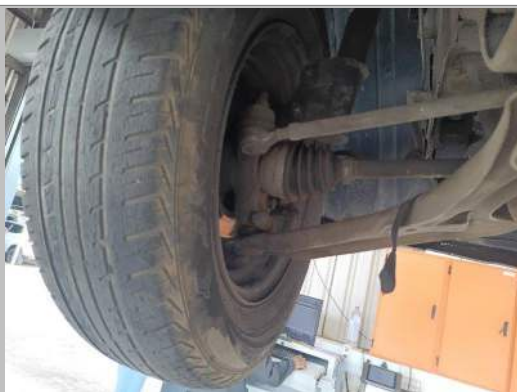
LF TYRE TREAD

| | Size | Load/Speed Index | Manufacture | Model | Type* | Production Date | Tread Depth (mm) |
|---|---|---|---|---|---|---|---|
| Front Left | 155/80R13 | 79T | Jk tyre | Ultima neo | V | 1417 | 2 mm |

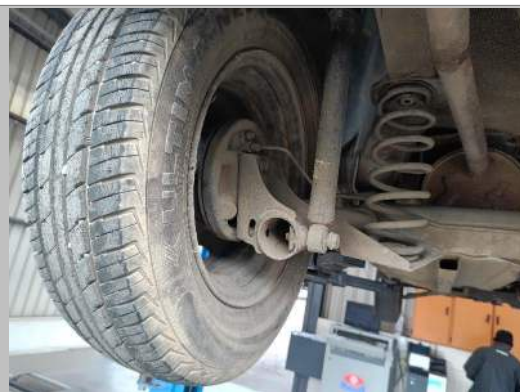
LR TYRE TREAD

| | Size | Load/Speed Index | Manufacture | Model | Type* | Production Date | Tread Depth (mm) |
|---|---|---|---|---|---|---|---|
| Rear Left | 155/80R13 | 79T | Jk tyre | Ultima neo | V | 1417 | 5 mm |

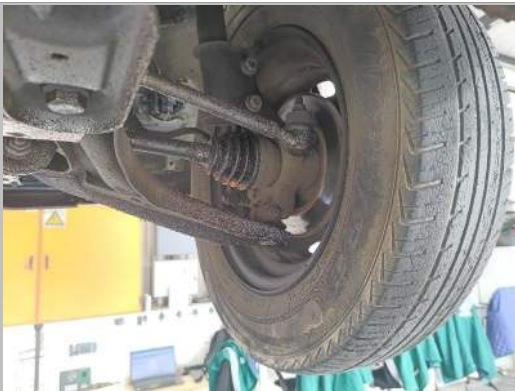
RF TYRE TREAD

| | Size | Load/Speed Index | Manufacture | Model | Type* | Production Date | Tread Depth (mm) |
|---|---|---|---|---|---|---|---|
| Front Right | 155/80R13 | 79T | Jk tyre | Ultima neo | V | 1417 | 2 mm |

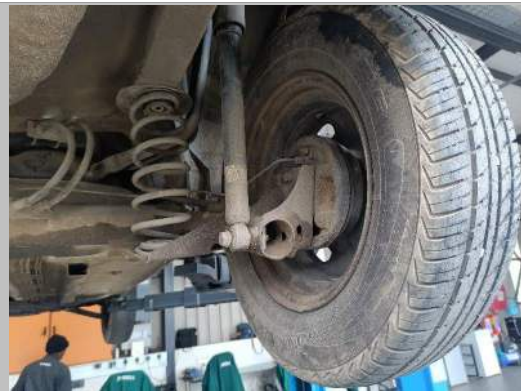
RR TYRE TREAD

| | Size | Load/Speed Index | Manufacture | Model | Type* | Production Date | Tread Depth (mm) |
|---|---|---|---|---|---|---|---|
| Rear Right | 155/80R13 | 79T | Jk tyre | Ultima neo | V | 1417 | 6 mm |

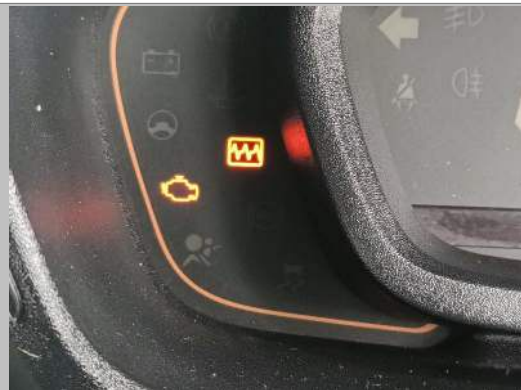
| Warning lights illuminated | Repair |

warning lights illuminated

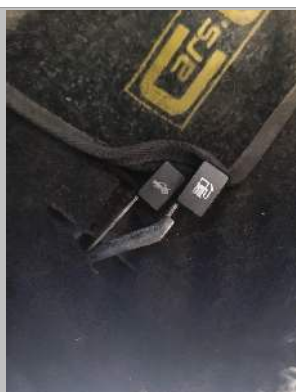
Both levers not working

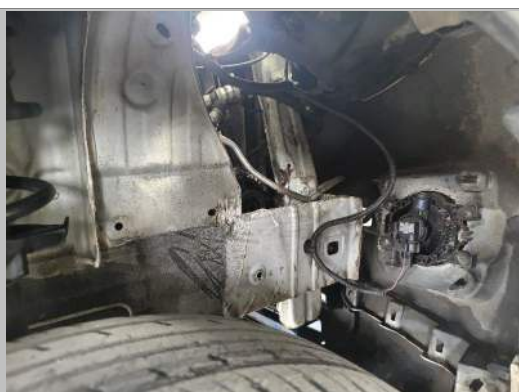
R/F fender liner missing

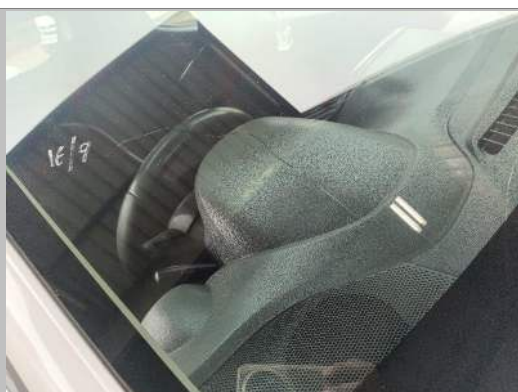
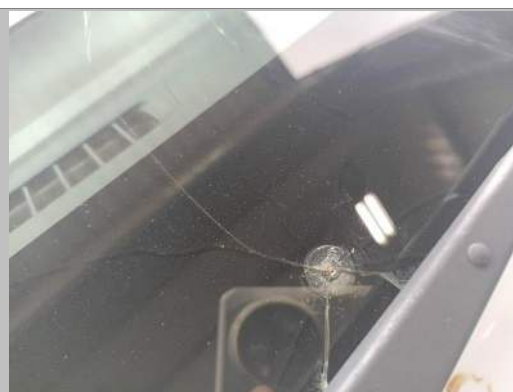
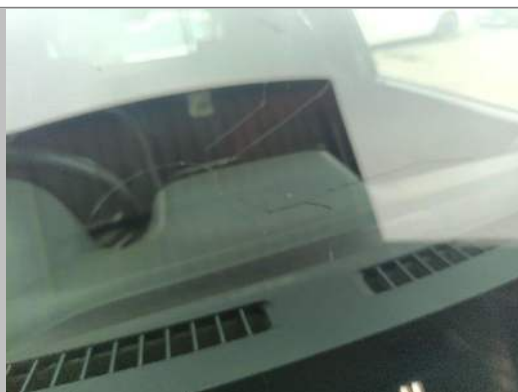
| Windscreen Cracked | Replace |

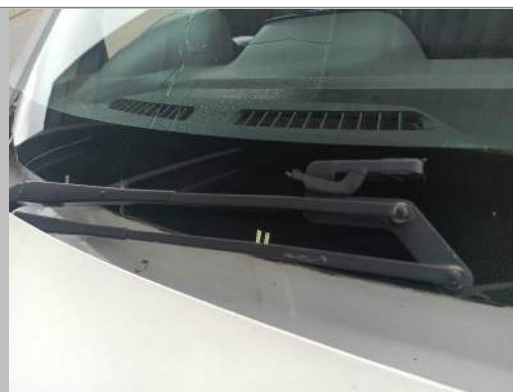
| Windscreen Wiper Missing | Replace |

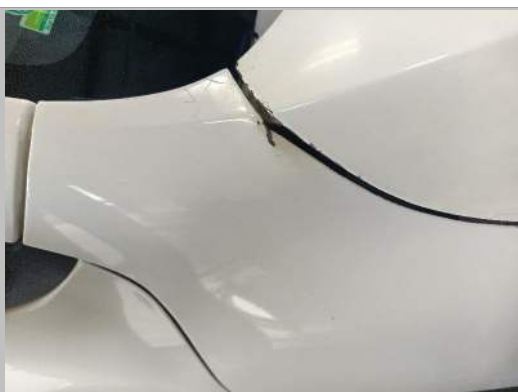
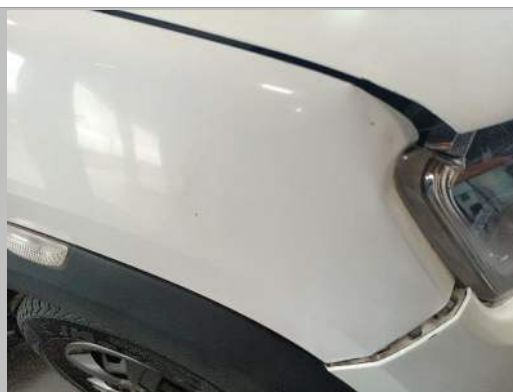
| Front Fender Right Dented | Repair |

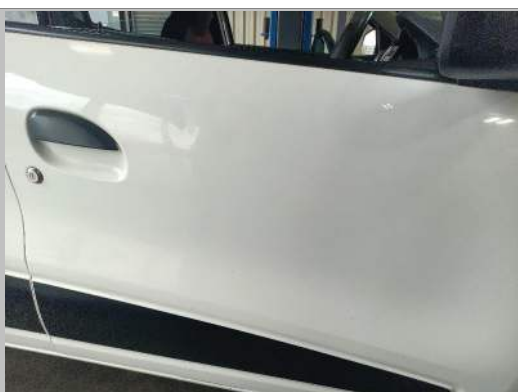
| Door Front Right Dented | Repair |

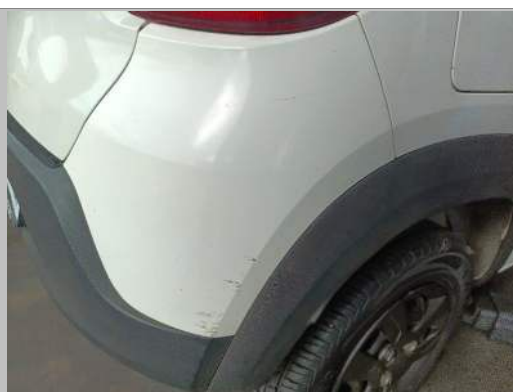
| Rear Fender Right Paintwork • Scratched | Repair |

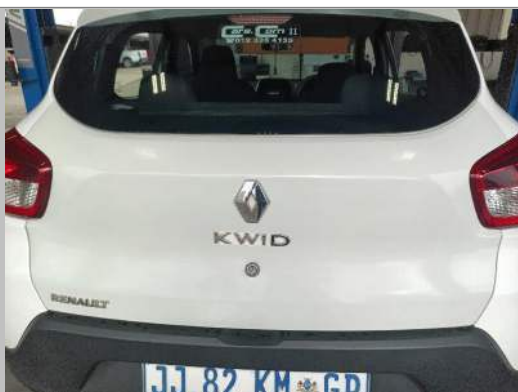
| Boot Lid / Hatch door Residual Traces of Repair | Repair |

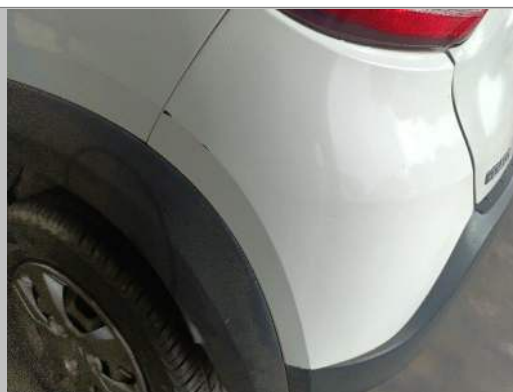
| Rear Fender Left Paintwork • Scratched | Repair |

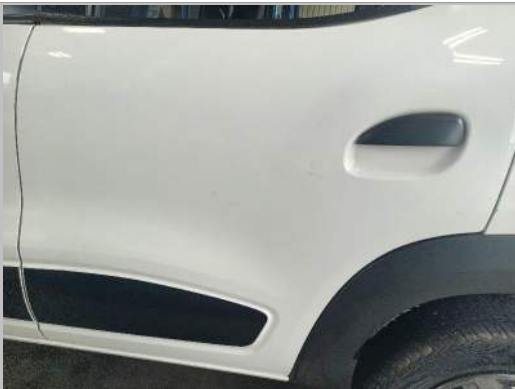
| Door Rear Left Paintwork • Scratched | Repair |

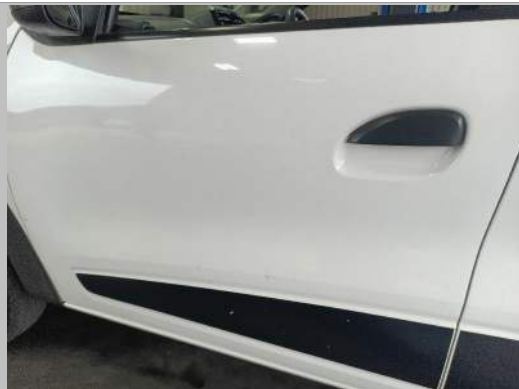
| Door Front Left Paintwork • Scratched | Repair |

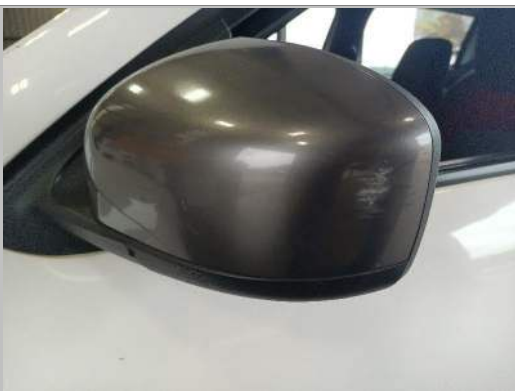
| Side Mirror Left Paintwork • Scratched | Repair |

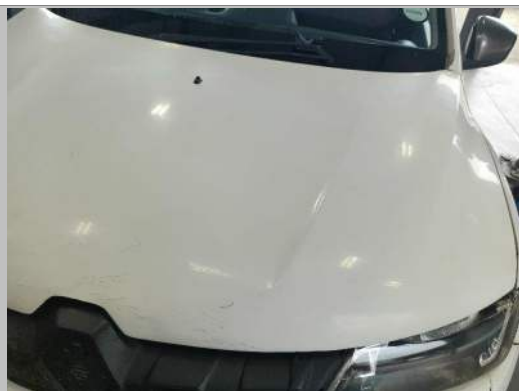
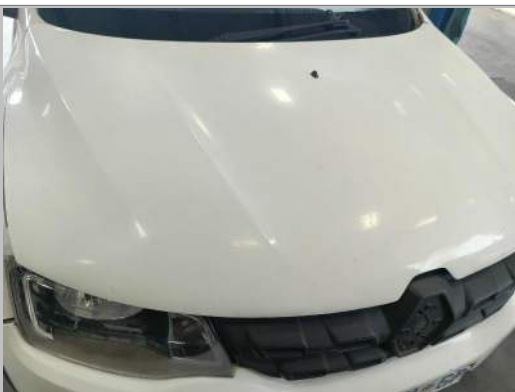
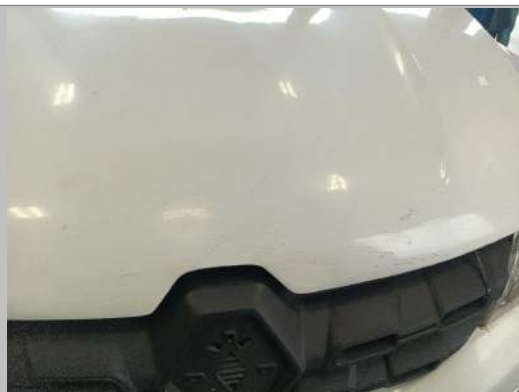
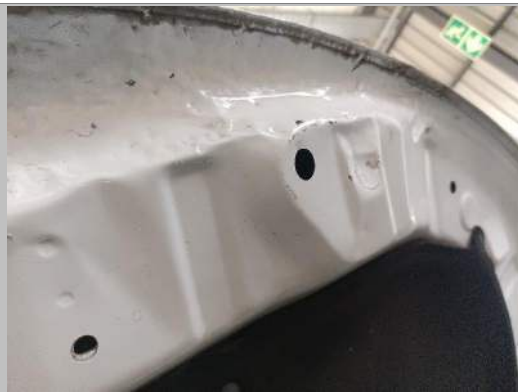
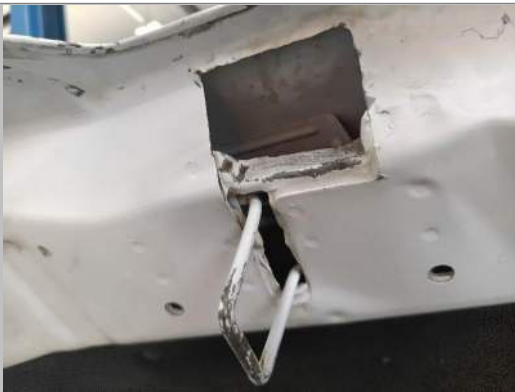
| Bonnet Residual Traces of Repair | Repair |

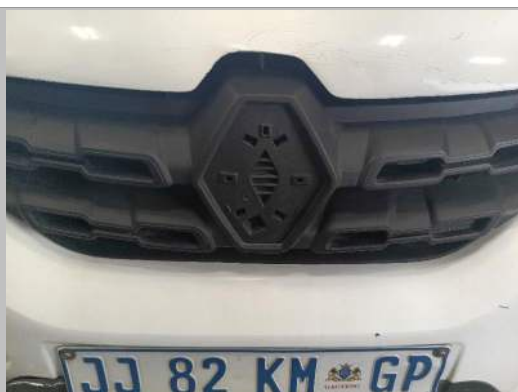
| Grill Damaged | Replace |

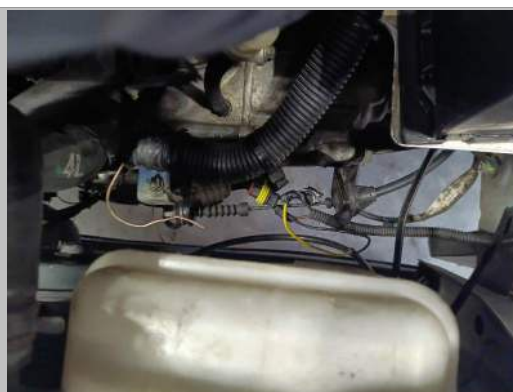
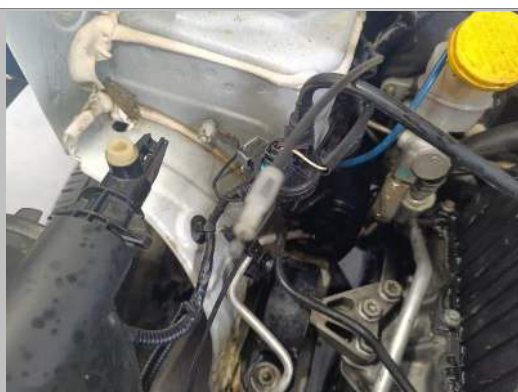
| Engine Wiring Defective | Repair |

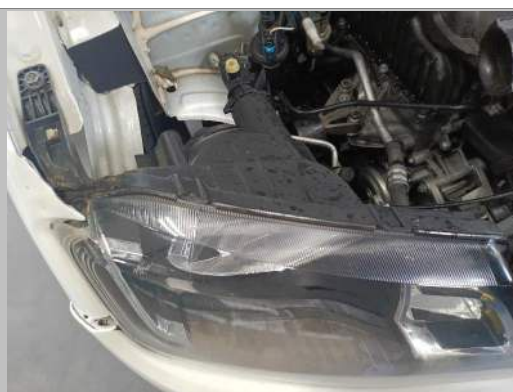
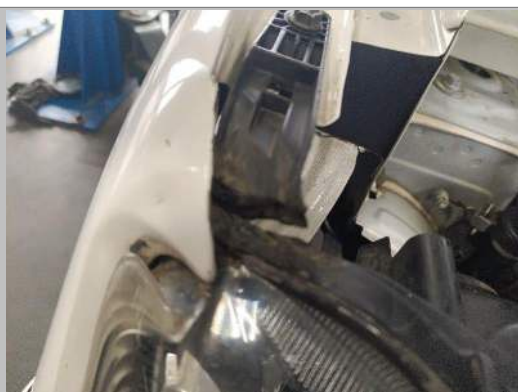
| Headlight Right Damaged | Replace |

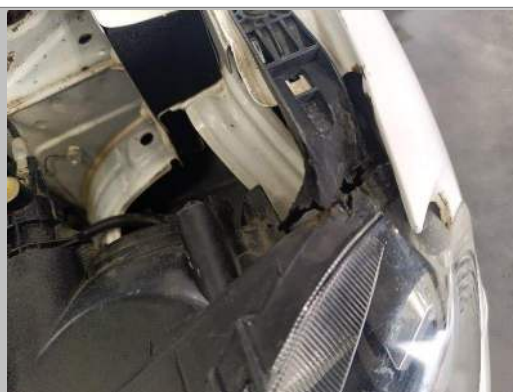
| Headlight Left Damaged | Replace |

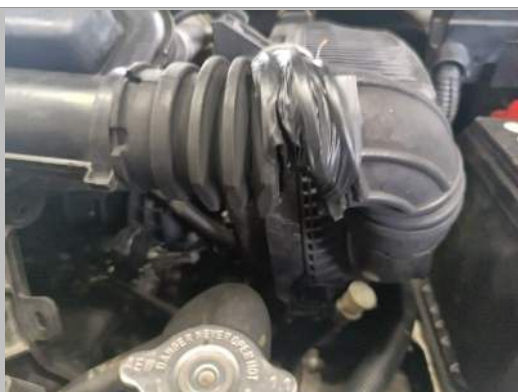
| Air cleaner Damaged | Replace |

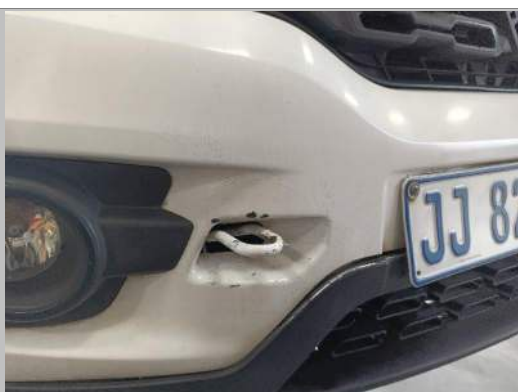
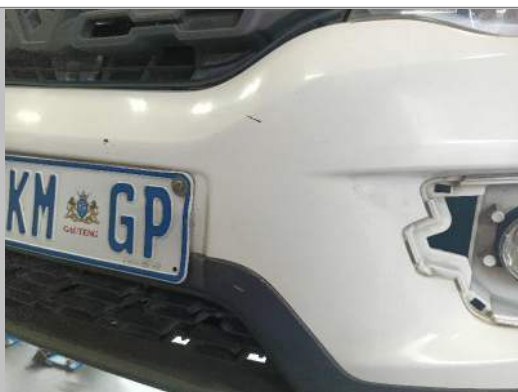
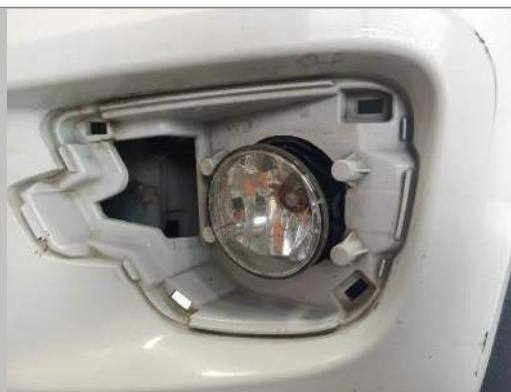
| Front Bumper Cracked | Replace |

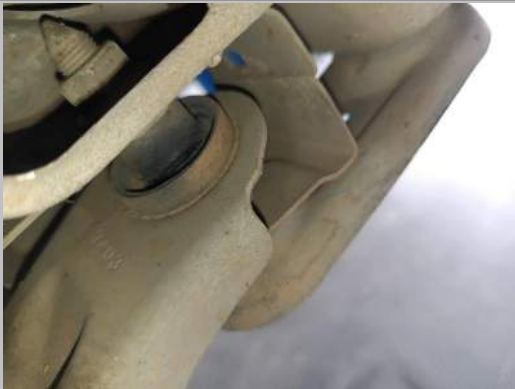
| Control Arm Bush(es) Front Axle Left Cracked | Replace |

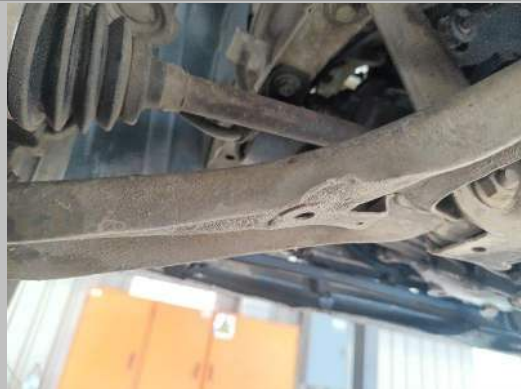
| Control Arm(s) Front Axle Left Deformed | Repair |

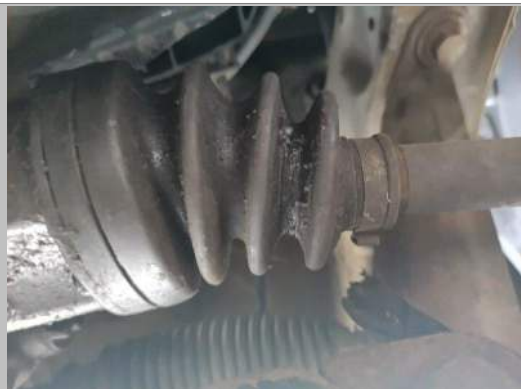
| CV Joint(s) Boot(s) Front Left (inner/outer) Damaged | Replace |

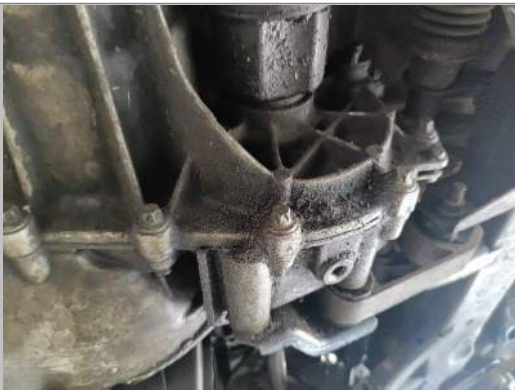
| Gearbox Oil Sweat | Repair |

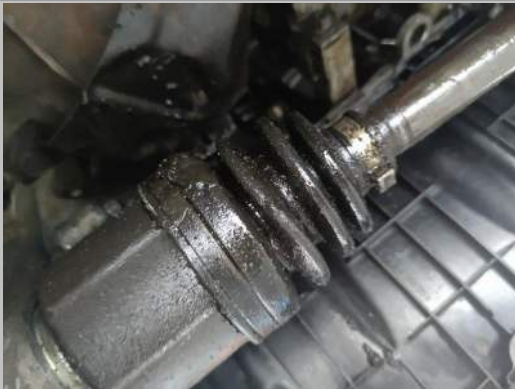
| CV Joint(s) Boot(s) Front Right (inner/outer) Damaged | Replace |

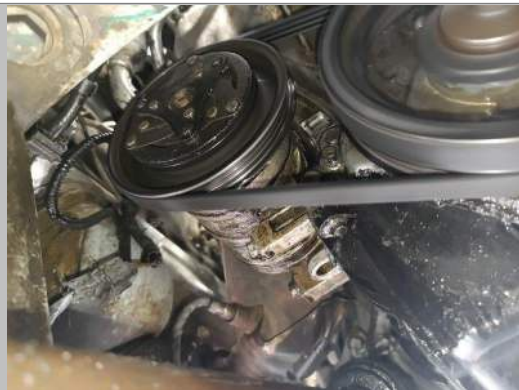
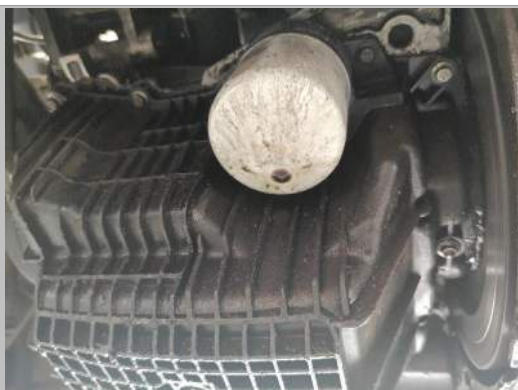
| Engine Oil Leak | Repair |

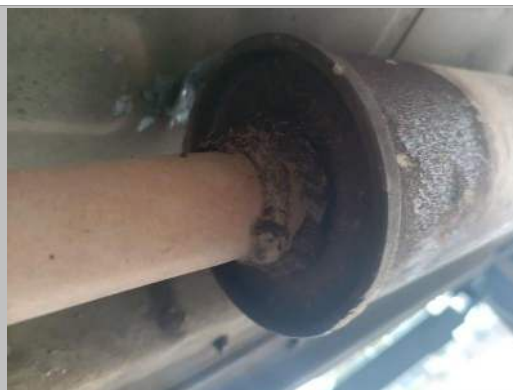
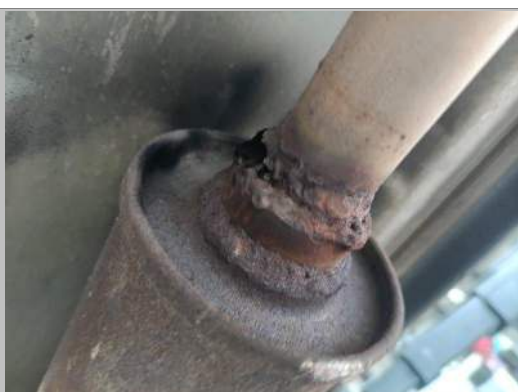
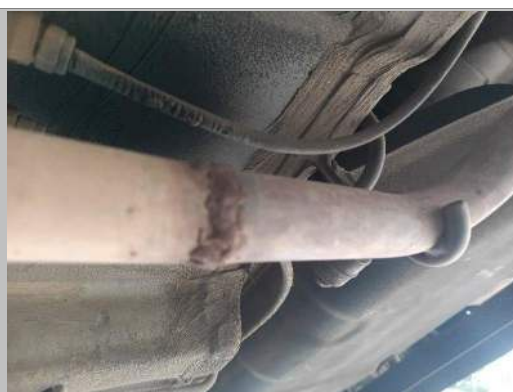
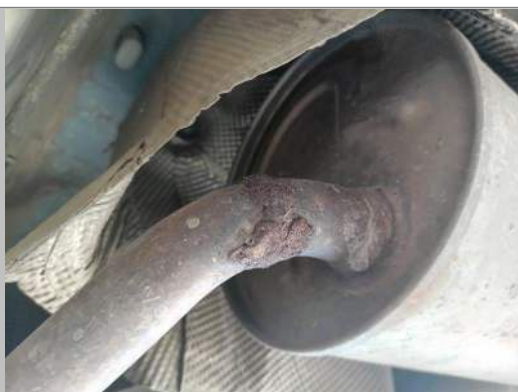
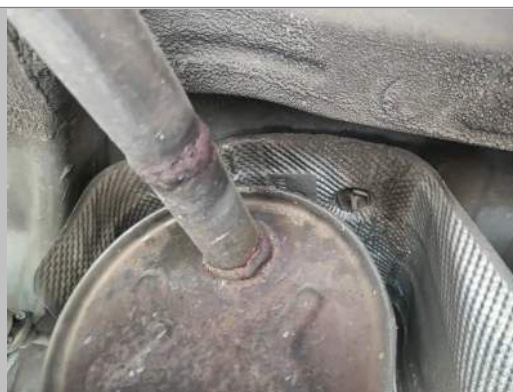
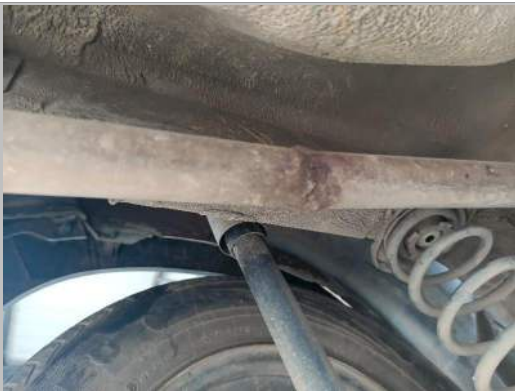
| Engine to silencer pipe Welded | Repair |

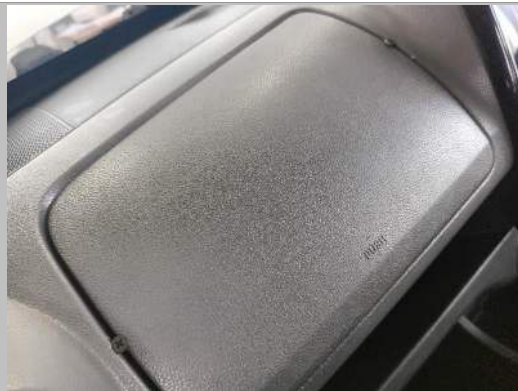
| Dash Padding Damaged | Repair |

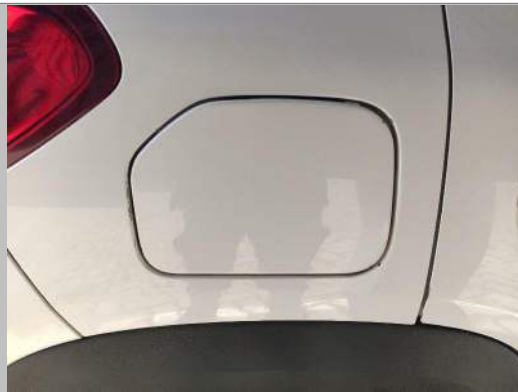
| Fuel Flap Defective | Repair |

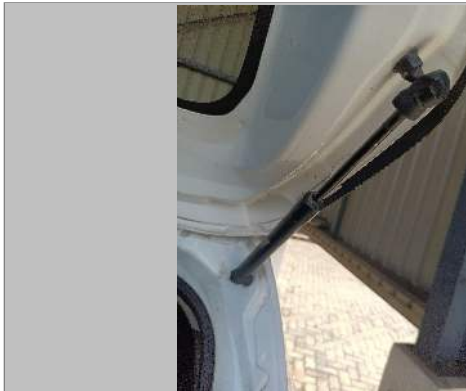
| Boot Lid / Hatch Door Shock Right Defective | Replace |

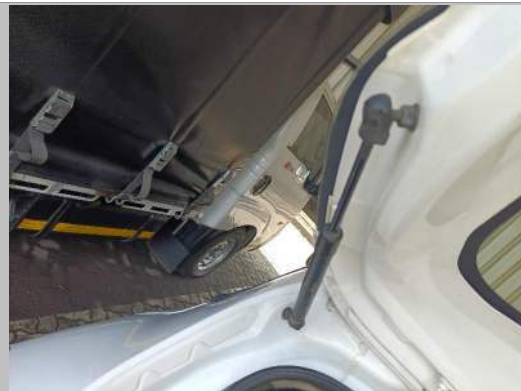
| Boot Lid / Hatch Door Shock Left Defective | Replace |
