## CONDITION REPORT

Report No:  
2017305129  
DATE  
30/09/2026

| Manufacturer | RENAULT | Registration Number | KD30WKGP |
| Model | KWID | Register Number | |

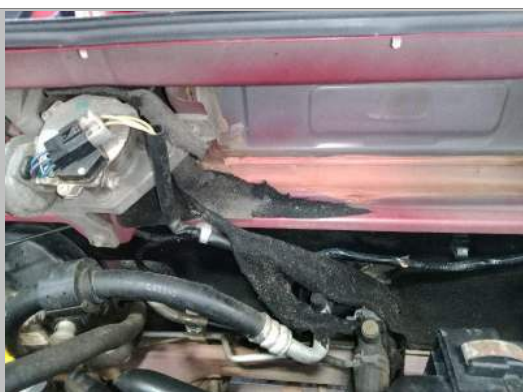
| Damage | Repair Way |
|---|---|
| Firewall insulation cover damaged | Replace |

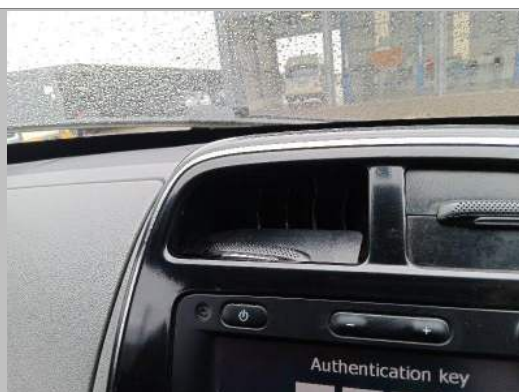
| Damage | Repair Way |
|---|---|
| Central Air Vent Damaged | Replace |

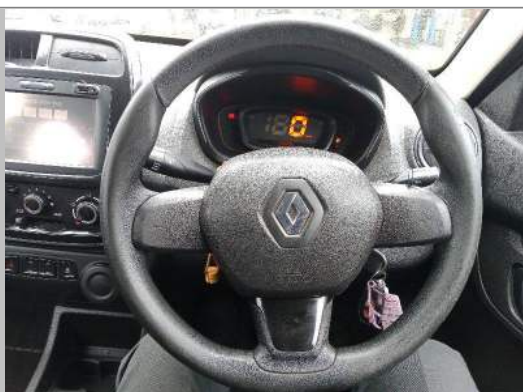
| Damage | Repair Way |
|---|---|
| Steering Wheel Trim Excessive Wear & Tear | Repair |

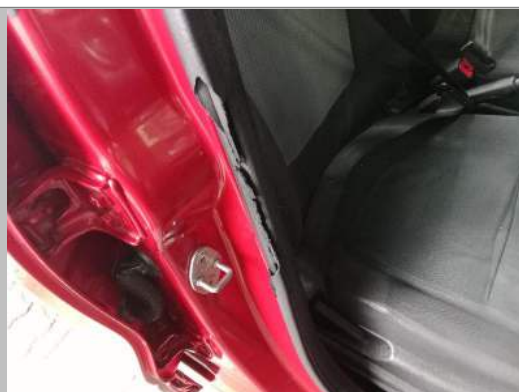
| Damage | Repair Way |
|---|---|
| Door Sealing Rubber Front Right Damaged | Replace |

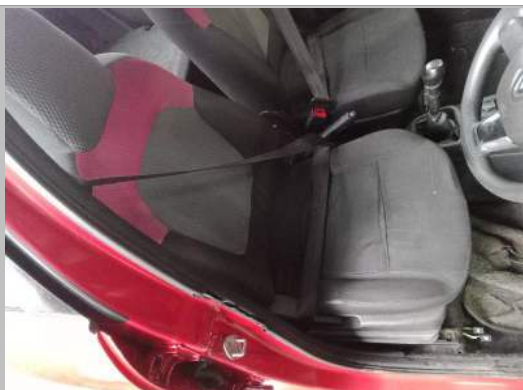
| Damage | Repair Way |
|---|---|
| Seat Front Right Damaged | Repair |

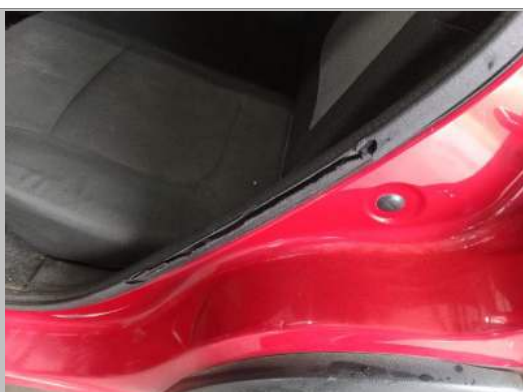
| Damage | Repair Way |
|---|---|
| Door Sealing Rubber Rear Left Damaged | Replace |

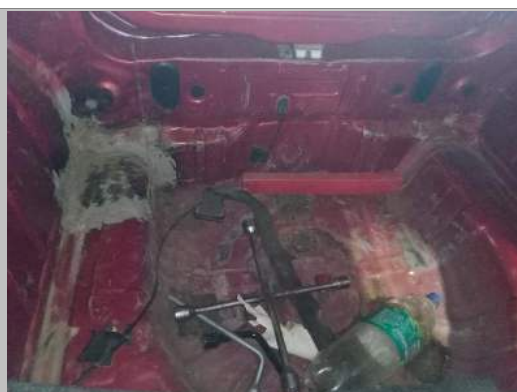
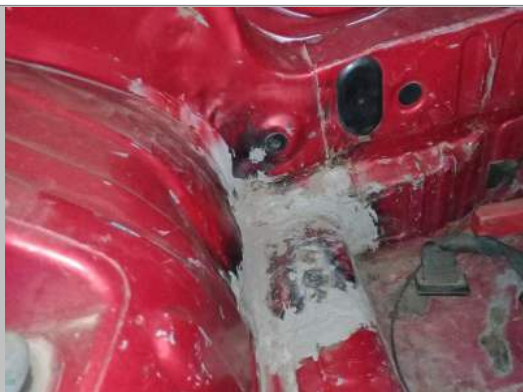
| Damage | Repair Way |
|---|---|
| Inner Boot Floor Pan and Spare Wheel Well Residual Traces of Repair | Repair |

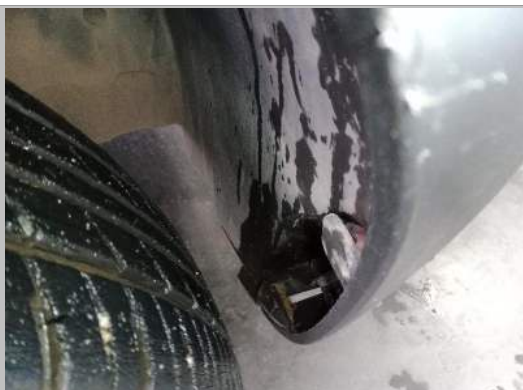
| Damage | Repair Way |
|---|---|
| Front Fender Right / Inner Tray Damaged | Replace |

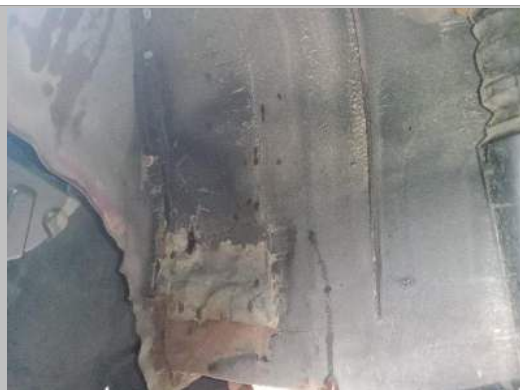
| Damage | Repair Way |
|---|---|
| Rear Fender Right / Inner Tray Damaged | Repair |

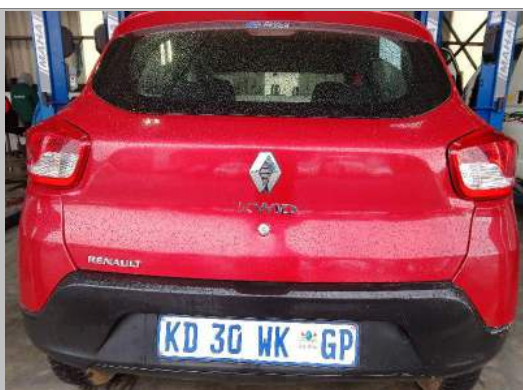
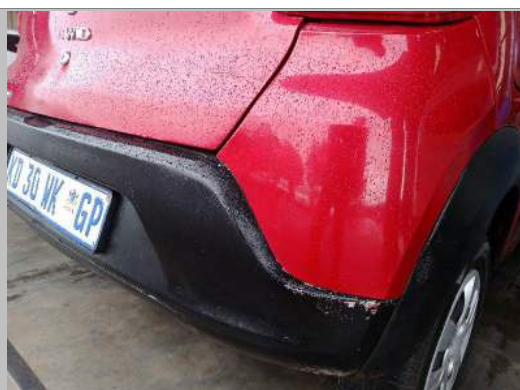
| Damage | Repair Way |
|---|---|
| Rear bumper Damaged | Repair |

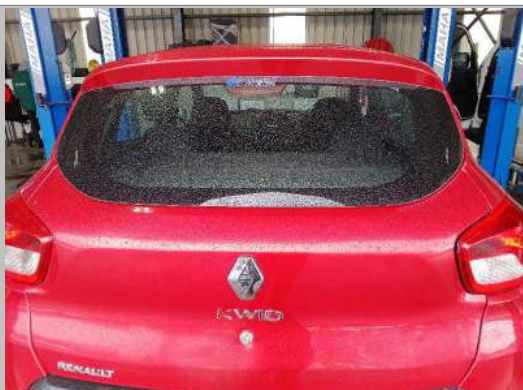
| Damage | Repair Way |
|---|---|
| Boot Lid / Hatch door Residual Traces of Repair | Replace |

Body • Exterior: Poor residual traces of repair on body panels. Body panels misaligned. Stone chips and spray work on body panels. Dents and scratches on body panels. Signs of damage to front and rear of vehicle. Boot does not open.

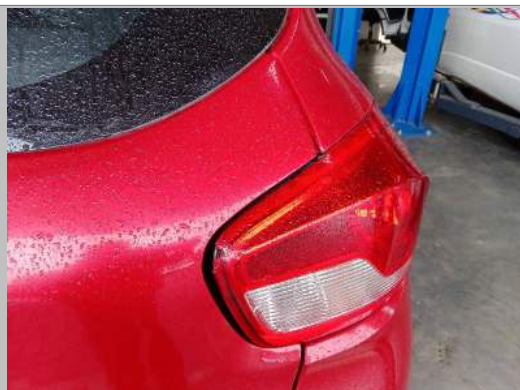
| Damage | Repair Way |
|---|---|
| Tail Light Right Damaged | Replace |

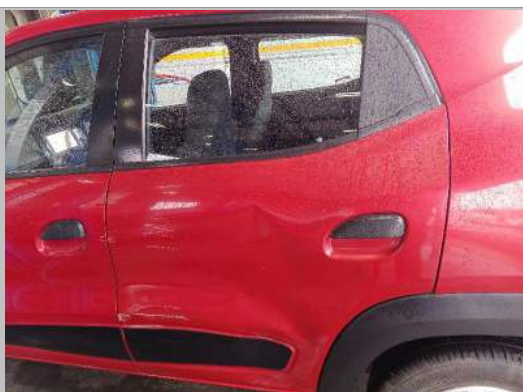
| Damage | Repair Way |
|---|---|
| Door Rear Left Damaged | Repair |

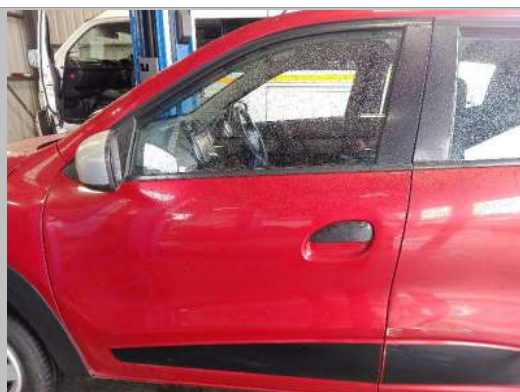
| Damage | Repair Way |
|---|---|
| Door Front Left Damaged | Repair |

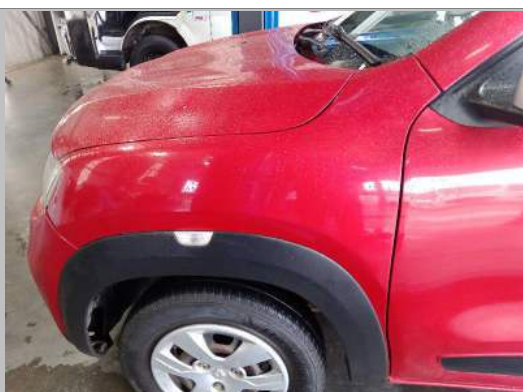
| Damage | Repair Way |
|---|---|
| Front Fender Left Dented | Repair |

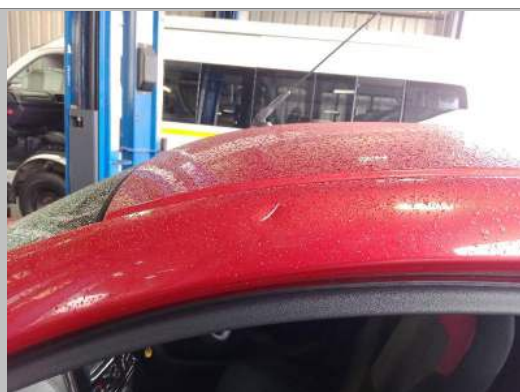
| Damage | Repair Way |
|---|---|
| B • Pillar Left Dented | Repair |

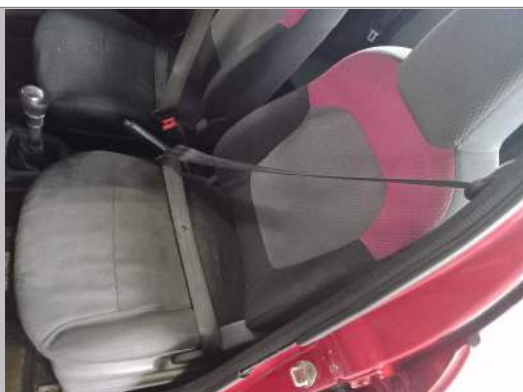
| Damage | Repair Way |
|---|---|
| Seat Front Left Dirty | Repair |

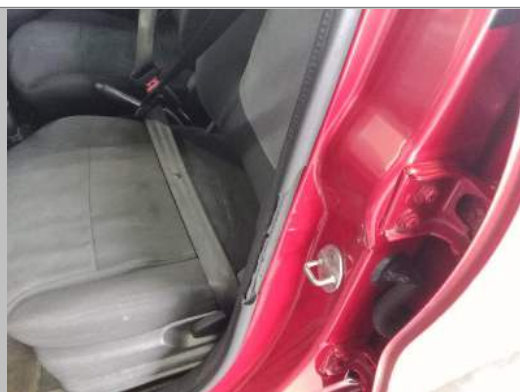
| Damage | Repair Way |
|---|---|
| Door Sealing Rubber Front Left Damaged | Replace |

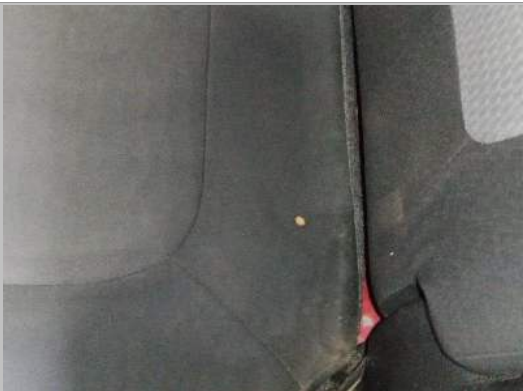
| Damage | Repair Way |
|---|---|
| Seat Rear Damaged | Repair |

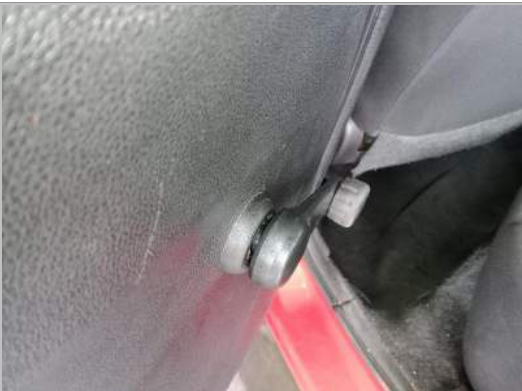
| Damage | Repair Way |
|---|---|
| Window Winder rear left Defective | Repair |

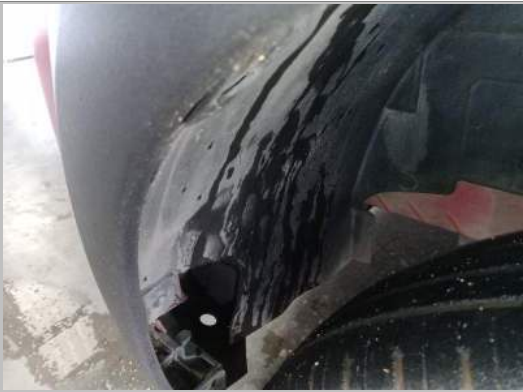
| Damage | Repair Way |
|---|---|
| Front Fender Left / Inner Tray Damaged | Replace |

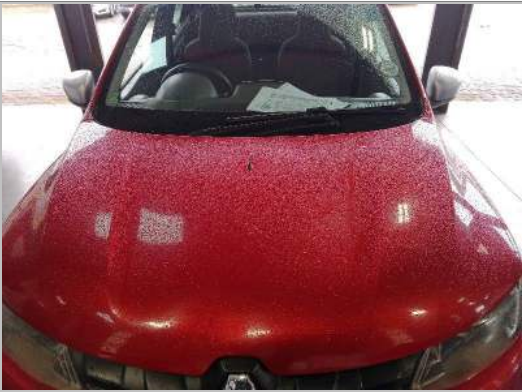
| Damage | Repair Way |
|---|---|
| Bonnet Damaged | Repair |

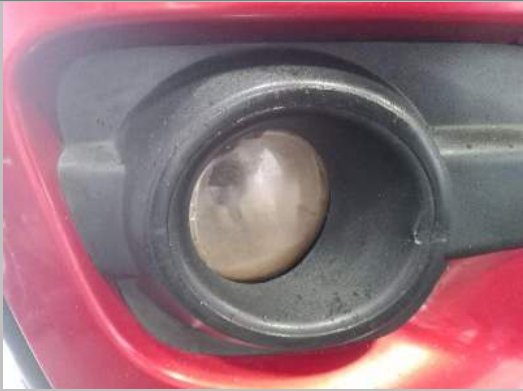
| Damage | Repair Way |
|---|---|
| Fog Light Front Right Defective | Repair |

Lights: Front right fog light lens faded.

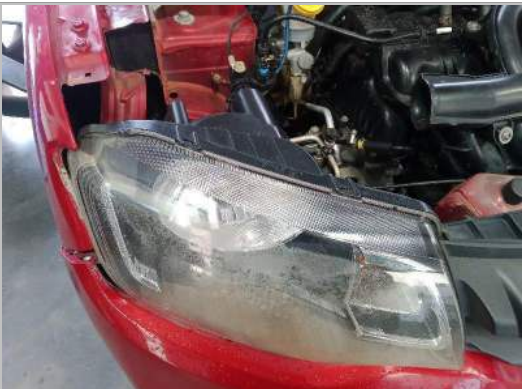
| Damage | Repair Way |
|---|---|
| Headlight Right Damaged | Replace |

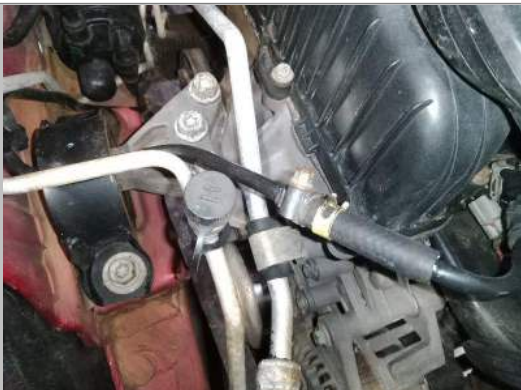
| Damage | Repair Way |
|---|---|
| Hoses Damaged | Replace |

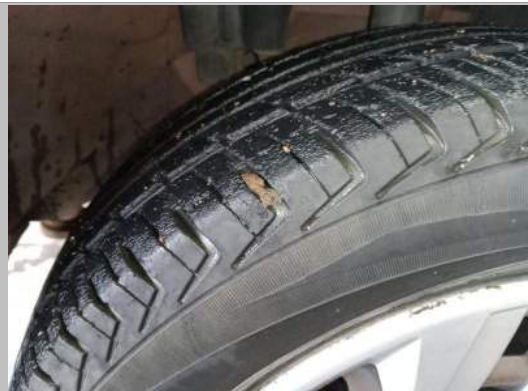
| Damage | Repair Way |
|---|---|
| Tyre Front Right Damaged | Replace |

| | Size | Load/Speed Index | Manufacture | Model | Type* | Production Date | Tread Depth (mm) |
|---|---|---|---|---|---|---|---|
| Front Right | 155/80 R13 | 79T | Jk tyre | Ultima-Neo | V | 1018 | 2 mm |

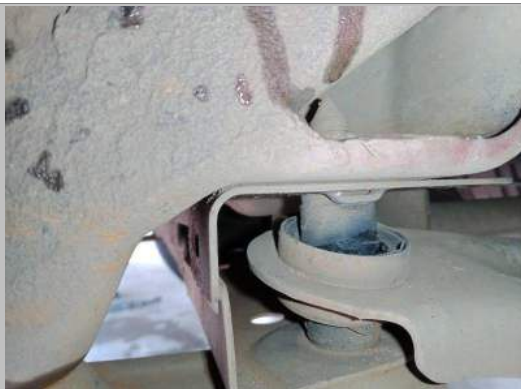
| Damage | Repair Way |
|---|---|
| Control Arm Bush(es) Front Axle Right Damaged | Replace |

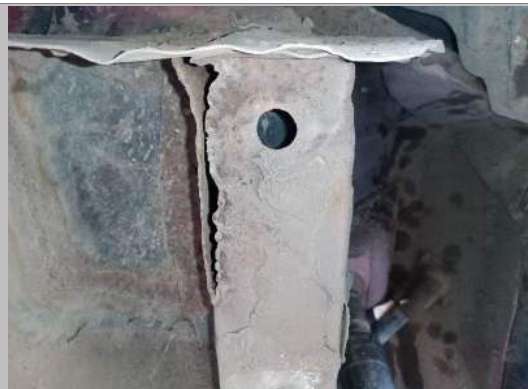
| Damage | Repair Way |
|---|---|
| Main Beam Right Damaged | Repair |

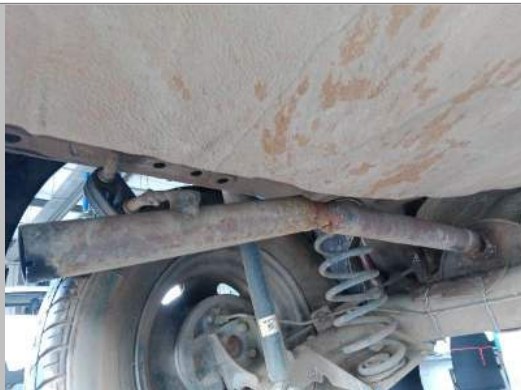
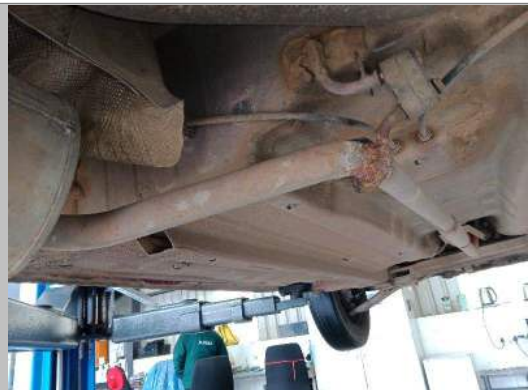
| Damage | Repair Way |
|---|---|
| Engine to silencer pipe Welded | Replace |

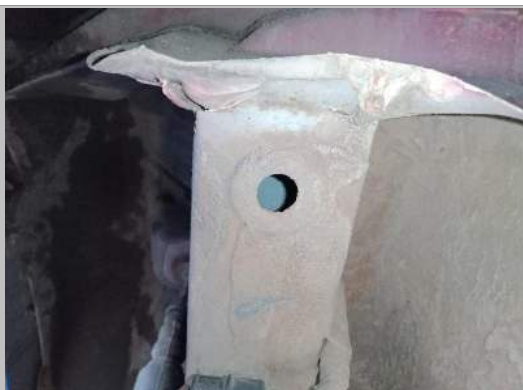
| Damage | Repair Way |
|---|---|
| Main Beam Left Damaged | Repair |

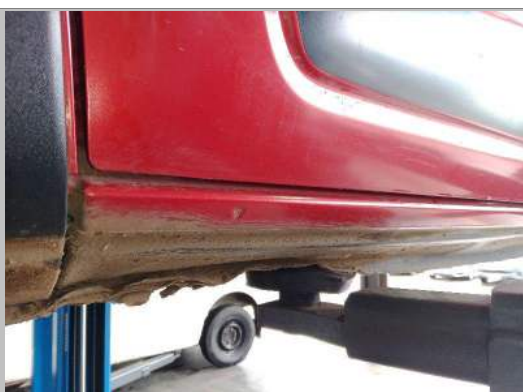
| Damage | Repair Way |
|---|---|
| Sill Panel Left Damaged | Repair |

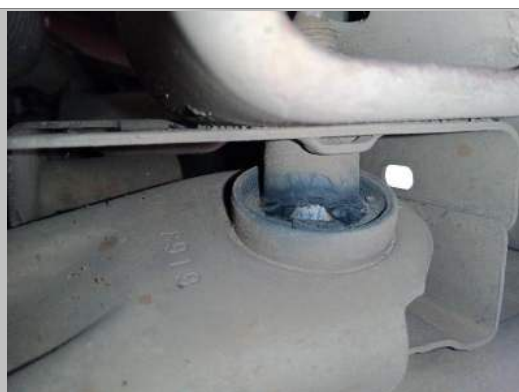
| Damage | Repair Way |
|---|---|
| Control Arm Bush(es) Front Axle Left Damaged | Replace |

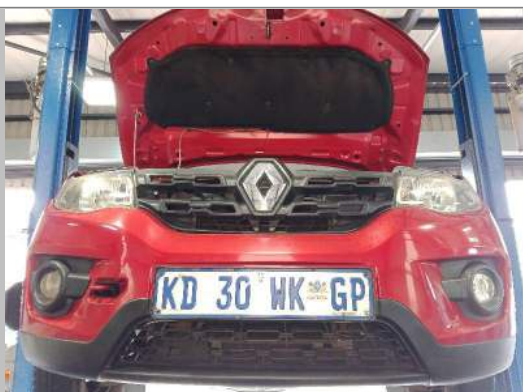
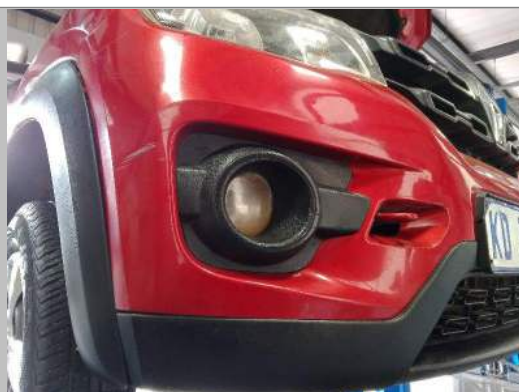
| Damage | Repair Way |
|---|---|
| Front Bumper Paintwork • Scratched | Repair |

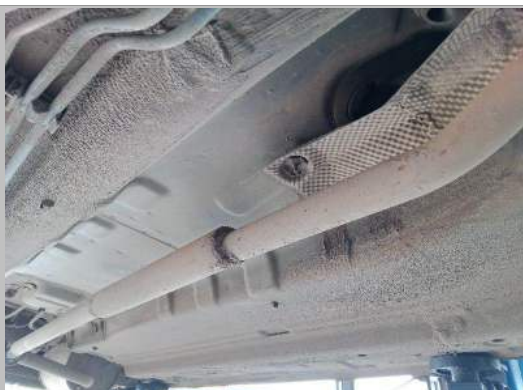
| Damage | Repair Way |
|---|---|
| Silencer Missing | Replace |

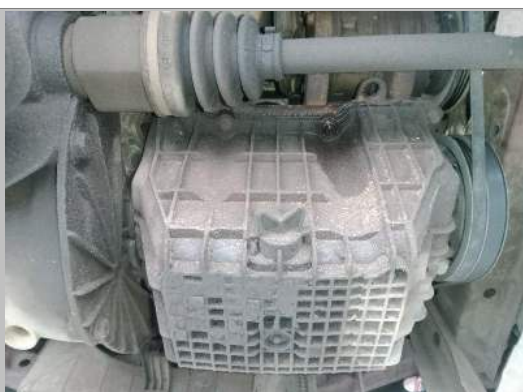
| Damage | Repair Way |
|---|---|
| Engine Oil Leak | Repair |

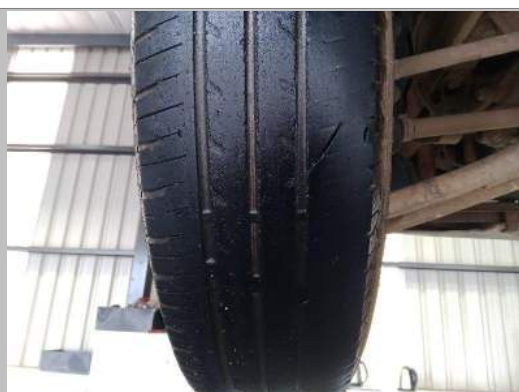
| Damage | Repair Way |
|---|---|
| Tyre Front Left Worn | Replace |

| | Size | Load/Speed Index | Manufacture | Model | Type* | Production Date | Tread Depth (mm) |
|---|---|---|---|---|---|---|---|
| Front Left | 155/80 R13 | 79T | Firestone | Touring | V | 1418 | 0 mm |

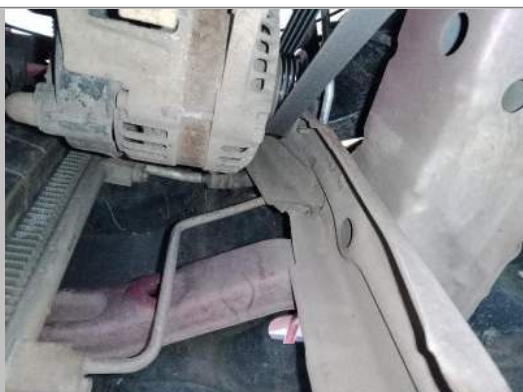
| Damage | Repair Way |
|---|---|
| Radiator Cradle Damaged | Replace |

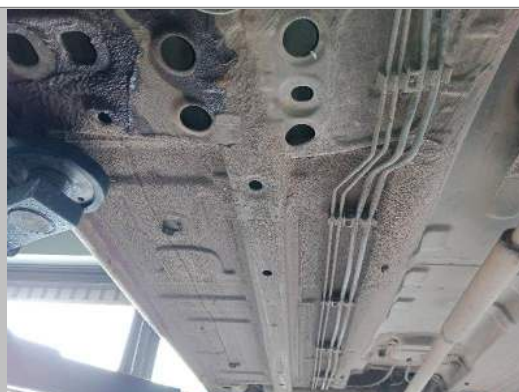
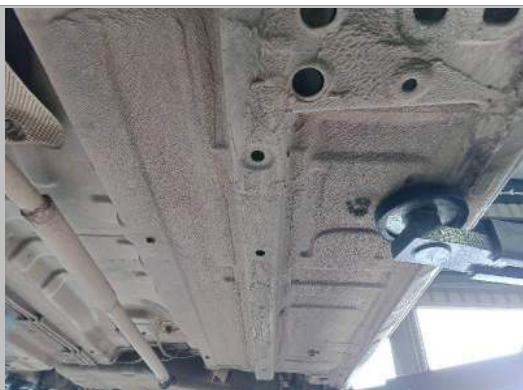
| Damage | Repair Way |
|---|---|
| Chassis Dented | Repair |

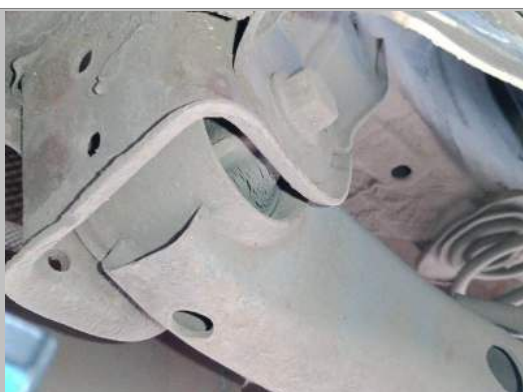
| Damage | Repair Way |
|---|---|
| Mounting Rubber(s) Rear Axle Left Cracked | Replace |

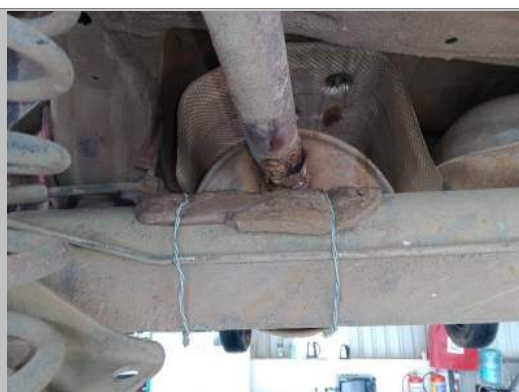
| Damage | Repair Way |
|---|---|
| Rear Axle Defective | Repair |

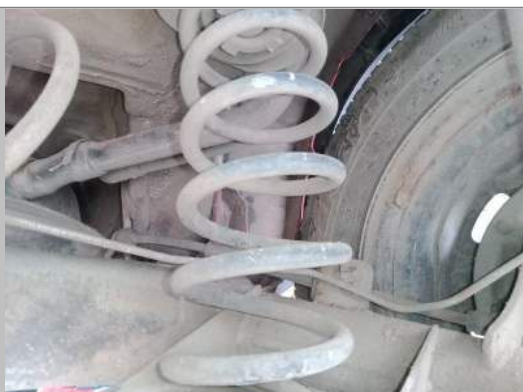
| Damage | Repair Way |
|---|---|
| Brake Piping Damaged | Repair |

Brakes: Rear right brake piping bend

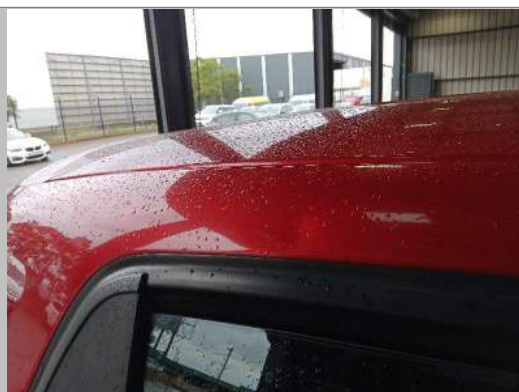
| Damage | Repair Way |
|---|---|
| C • Pillar Right Dented | Repair |

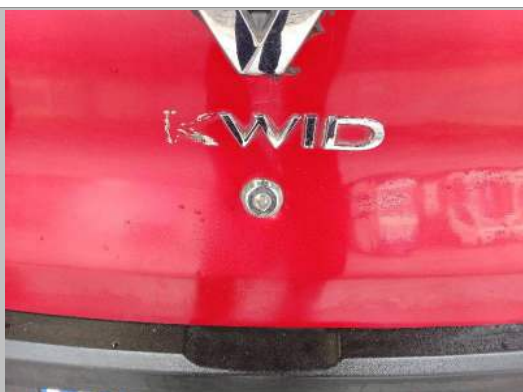
| Damage | Repair Way |
|---|---|
| Door Lock Boot Lid Damaged | Replace |

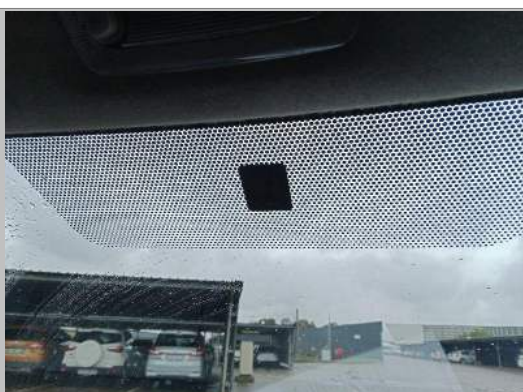
| Damage | Repair Way |
|---|---|
| Interior Mirror Missing | Replace |

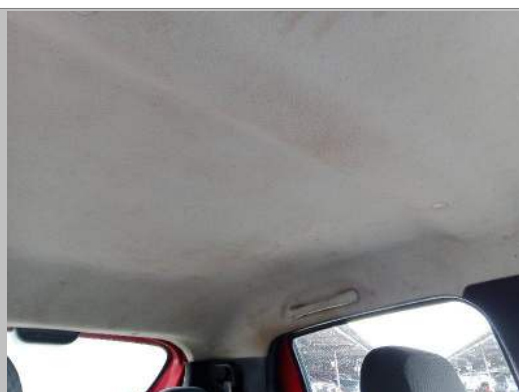
| Damage | Repair Way |
|---|---|
| Hood Lining Dirty | Repair |

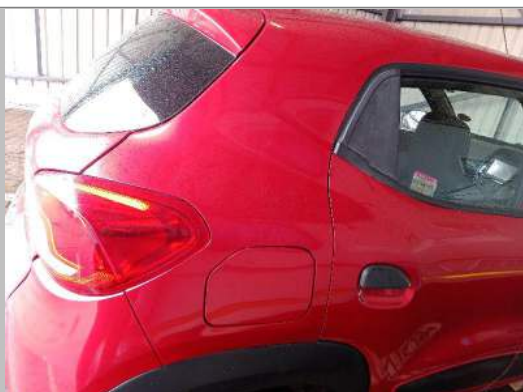
| Damage | Repair Way |
|---|---|
| Rear Fender Right Dented | Repair |
