CONDITION REPORT

Report No:
2016963111
DATE
30/07/2025

Vehicle Type	PASSENGER VEHICLE	Registered Owner	MFC
Manufacturer	RENAULT	Registration Number	JF73NHGP
Model	KWID	Register Number	
VIN	MEEBBA007K7677937	Date Of First Licensing	
Engine Number		Last COR	
Doors	5	License Expiry Date	31/05/2022
Color	WHITE	Power / Displacement	
Year Model		Paint Finish	C - COMMON
Km Reading	137,839 KM	Fuel	PETROL
Cab / Body Type	HATCHBACK	Transmission	MANUAL

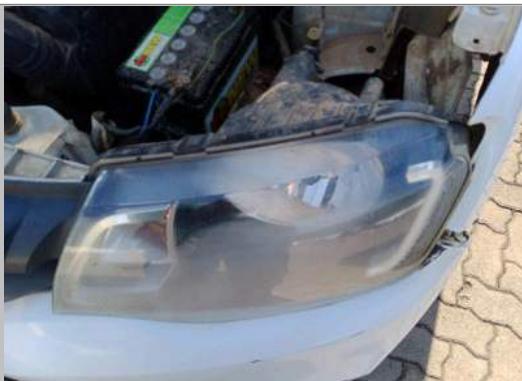
L/F headlight clips broken

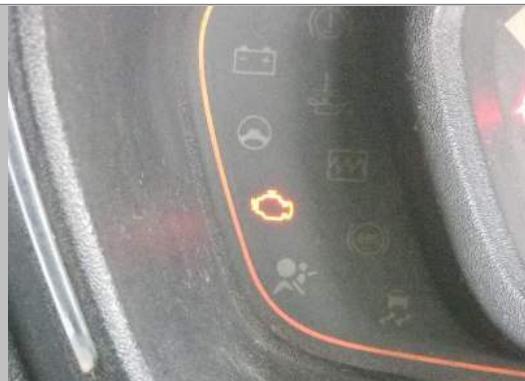
Warning lights illuminated

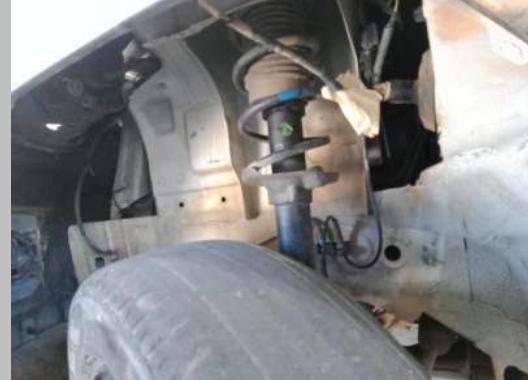
L/F fender liner missing
