MFC Auction House
M57 Pretoria Rd, Glenmarais, KEMPTON PARK
Gauteng

CONDITION REPORT

Report No: 2016524714

DATE
09/09/2024

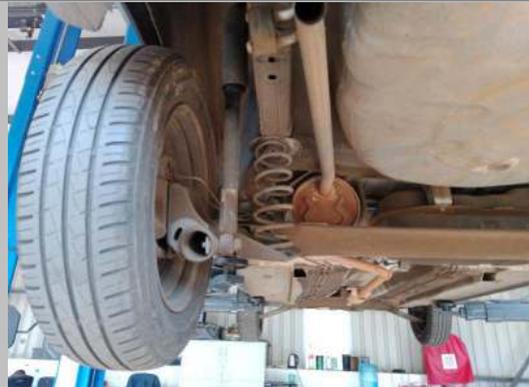
LR TYRE TREAD

Size	Load/Speed Index	Manufacture	Model	Type*	Production Date	Tread Depth (mm)
Front Left	185/70 R14	81T	Ceat	Fuelsmart	V	3720	4 mm
Front Right	165/70 R14	81T	Ceat	Fuelsmart	V	3820	4 mm
Rear Left	185/70 R14	81T	Ceat	Fuelsmart	V	3820	2 mm
Rear Right	185/70 R14	81T	Ceat	Fuelsmart	V	3820	1 mm

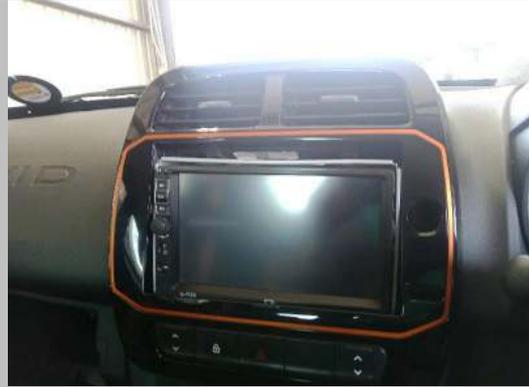
Damage	Repair Way
Radio/CD/USB Defective	Repair
Parcel Tray Damaged	Repair
Front Bumper Paintwork • Scratched	Repair
Bonnet Paintwork • Chipmarks	Repair
B • Pillar Right Paintwork • Scratched	Replace
Rear Fender Left Paintwork • Scratched	Repair
Door Front Left Paintwork • Scratched	Repair
Door Front Right Paintwork • Scratched	Repair
Door Rear Left Paintwork • Scratched	Repair
Boot Lid / Hatch door Dented	Repair
Rocker Panel Left Dented	Repair
Roof Paintwork • Scratched	Repair
Windscreen Chipped	Repair
Caliper 1. Axle left Sweat	Repair
Caliper 1. Axle right Sweat	Repair
Chassis Dented	Repair
Tyres and rims	Spare wheel missing
Engine	Engine bay dirty
Engine	Firewall insulation cover damaged
Engine	Brake fluid reservoir defective.
Tyres and rims	Front and rear hubcaps scratched.
Body and Exterior	Minor dents and scratches on some body panels
Interior	Vehicle interior dirty and some panels scratched
