## CONDITION REPORT

Report No:  
2017302308  
DATE  
22/09/2026

| Manufacturer | RENAULT | Registration Number | KJ76TYGP |
| Model | KIGER | Register Number | |

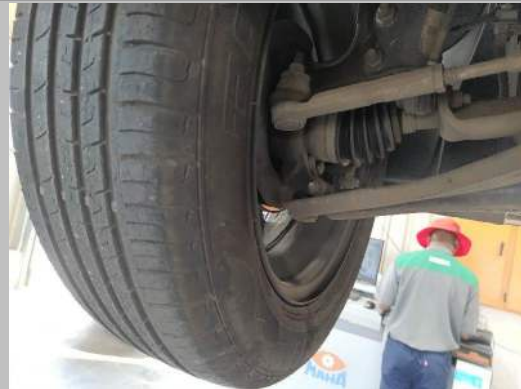
LF TYRE TREAD

| | Size | Load/Speed Index | Manufacture | Model | Type* | Production Date | Tread Depth (mm) |
|---|---|---|---|---|---|---|---|
| Front Left | 195/60R16 | 89H | Royal black | Mile | V | 3325 | 2 mm |

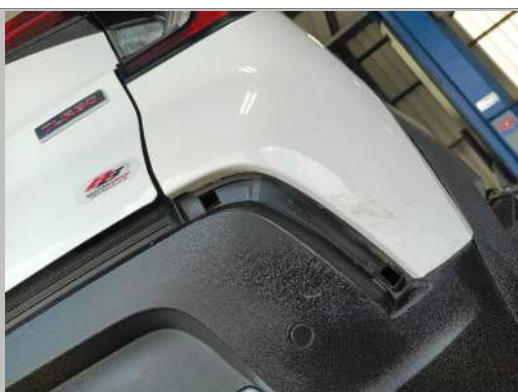
| R/R reflector missing | Replace |

R/R reflector missing

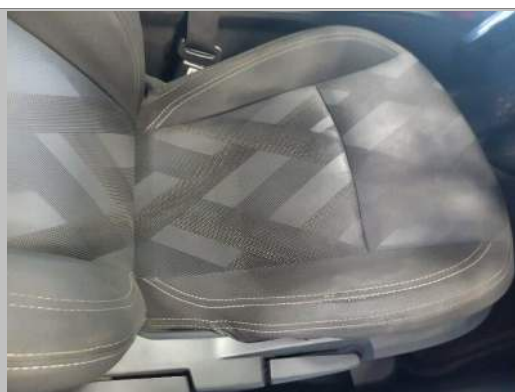
| Seat Front Right Torn / Cut | Repair |

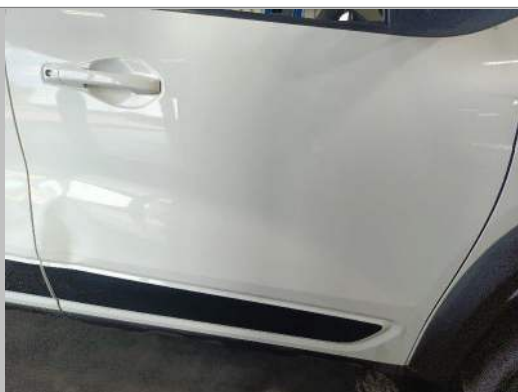
| Door Front Right Dented | Repair |

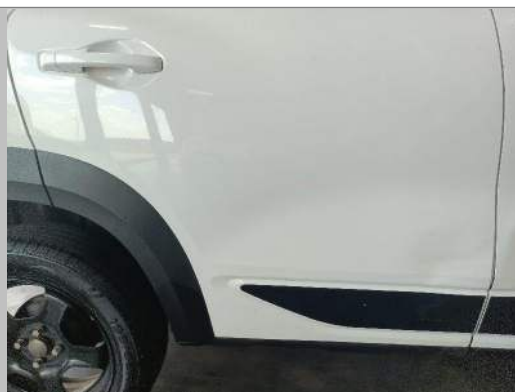
| Door Rear Right Paintwork • Scratched | Repair |

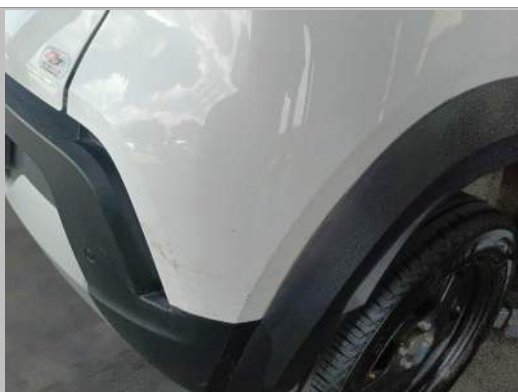
| Rear Fender Right Paintwork • Scratched | Repair |

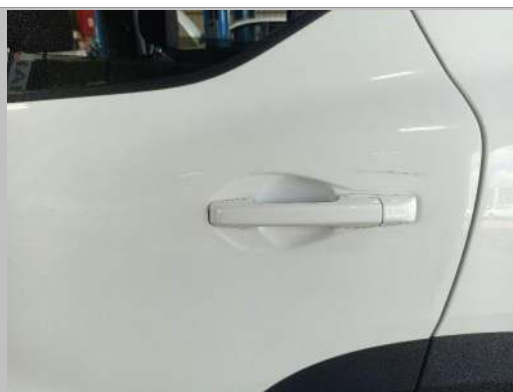
| Door Rear Left Paintwork • Scratched | Repair |

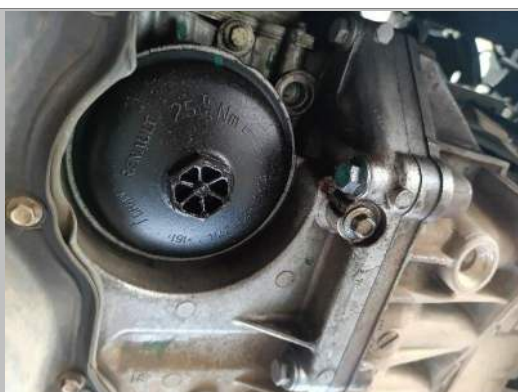
| Engine Oil Sweat | Repair |

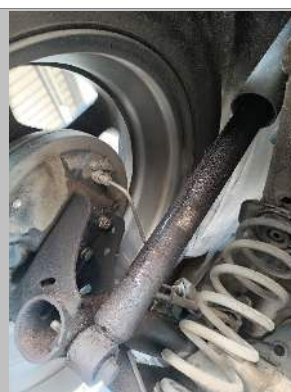
| Shock Absorber Rear Left Leak | Replace |
