## CONDITION REPORT

2017304888

| Manufacturer | REANULT | Registration Number | KM34JZGP |
| Model | KIGER | Register Number | |

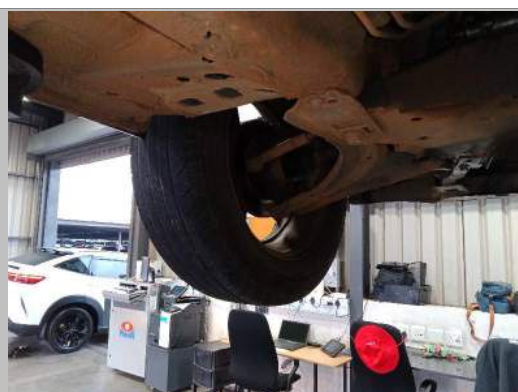
LF TYRE TREAD

| Tyre Front Left Defective | Replace |

| | Size | Load/Speed Index | Manufacture | Model | Type* | Production Date | Tread Depth (mm) |
|---|---|---|---|---|---|---|---|
| Front Left | 205/60R16 | 92H | Autogrip | P308 plus | V | 3024 | 1 mm |

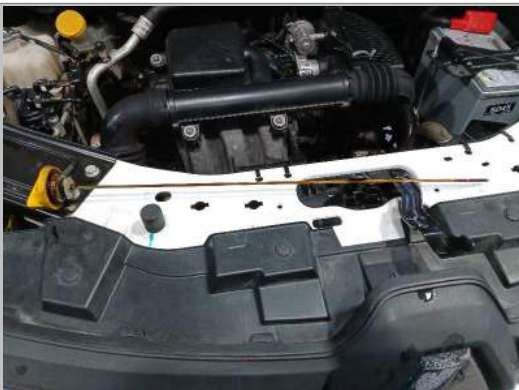
Oil cap and dipstick

| Foreign substance on oil cap | Repair |

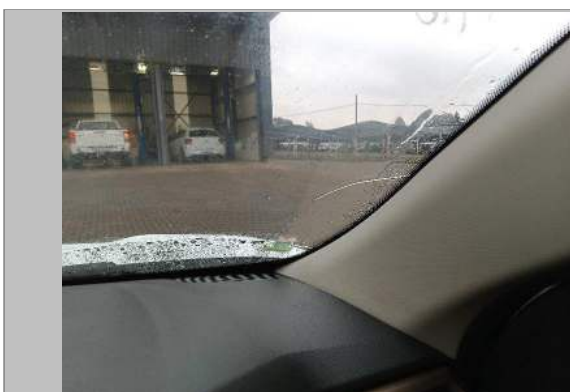
| Windscreen Cracked | Replace |

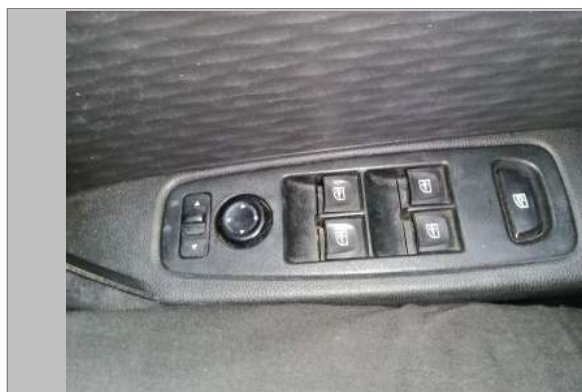
| Switch Electrical Window Winder front right Malfunction | Repair |

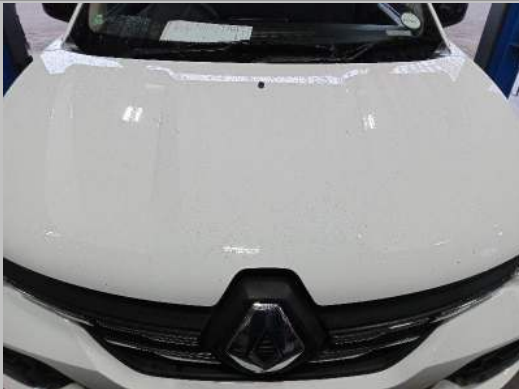
| Bonnet Paintwork • Chipmarks | Repair |

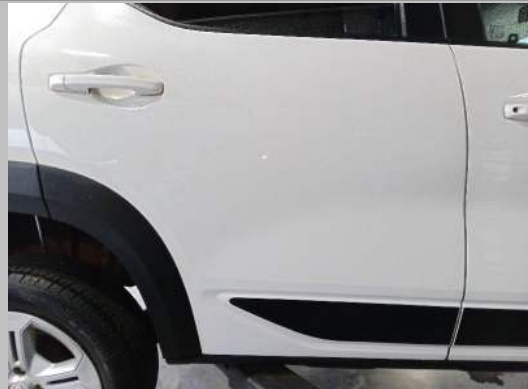
| Door Rear Right Dented | Repair |

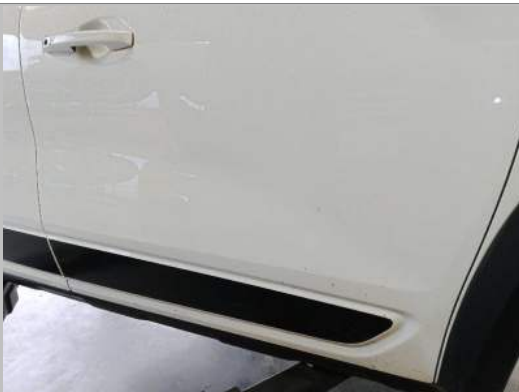
| Door Front Right Paintwork • Chipmarks | Repair |

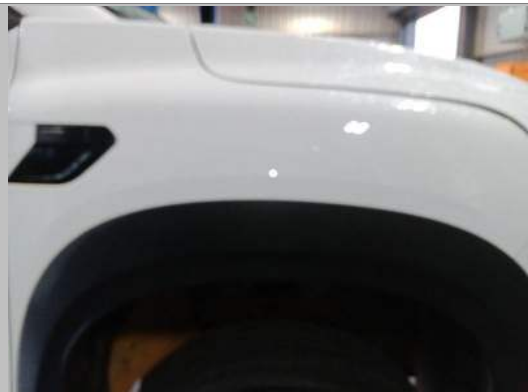
| Front Fender Right Paintwork • Scratched | Repair |

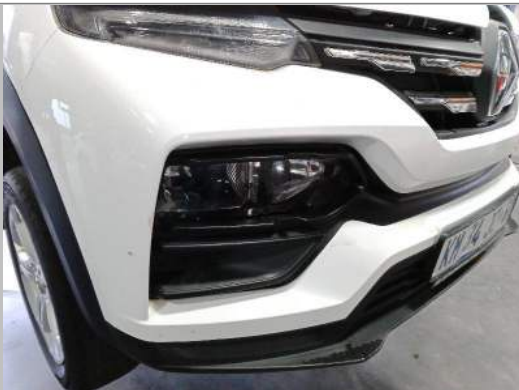
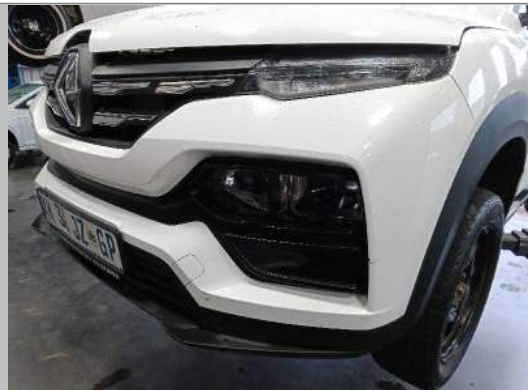
| Front Bumper Paintwork • Scratched | Repair |

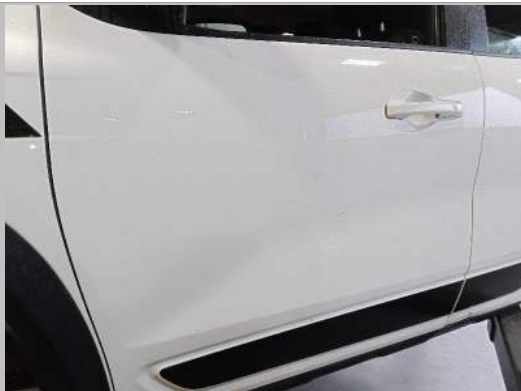
| Door Front Left Paintwork • Scratched | Repair |

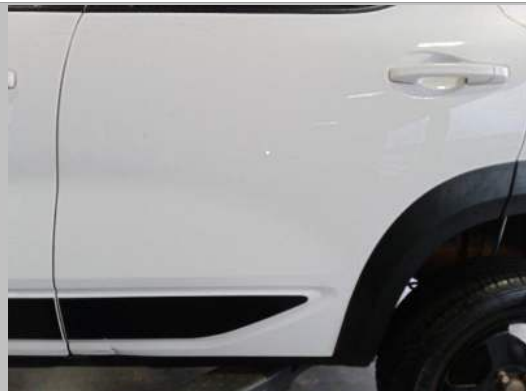
| Door Rear Left Dented | Repair |

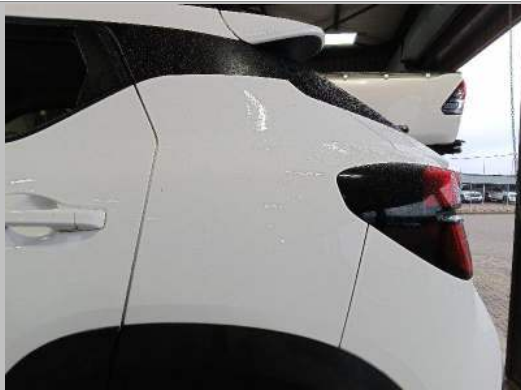
| Rear Fender Left Paintwork • Scratched | Repair |

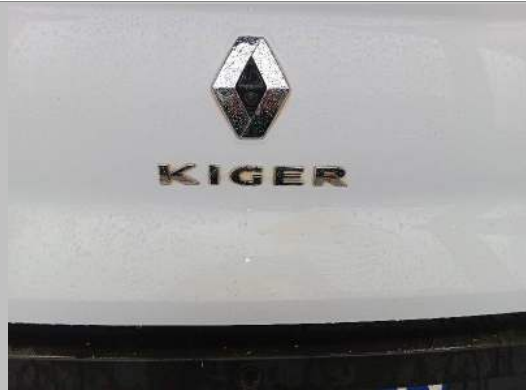
| Boot Lid / Hatch door Paintwork • Discoloured | Repair |

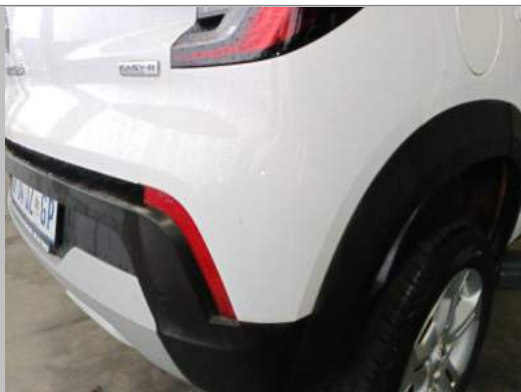
| Rear bumper Paintwork • Scratched | Repair |

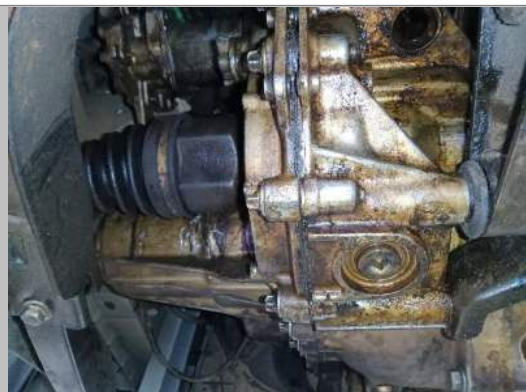
| Gearbox Oil Sweat | Repair |
