CONDITION REPORT

Report No:
2016958188
DATE
25/07/2025

| Manufacturer | RENAULT | Registration Number | LB77HTGP |
| Model | TRIBIER | Register Number | |

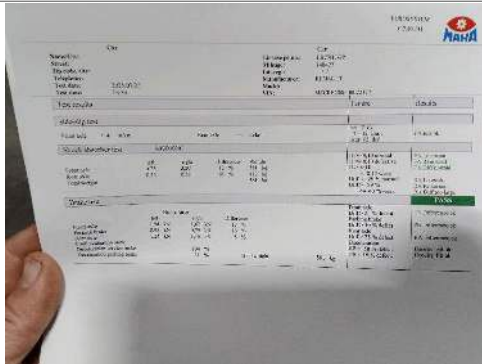
Brake test.

Brakes

| | Left | Right | | |
|---|---|---|---|---|
| Front | 1.94 | 1.62 | - | |
| Rear | 1.24 | 1.16 | - | |
| Emergency / Parking | 0.95 | 0.79 | - | |

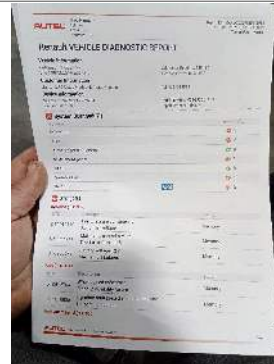
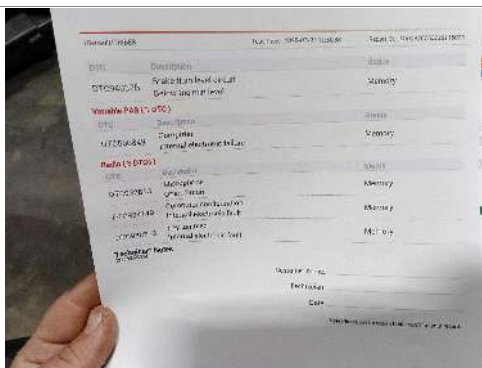
Diagnostic.

During the diagnostic no active error messages were detected. (See also attached Diagnostic Report. For more information regarding the Fault Codes (DTC) and the recommended rectifications please contact the workshops of the vehicle manufacture).

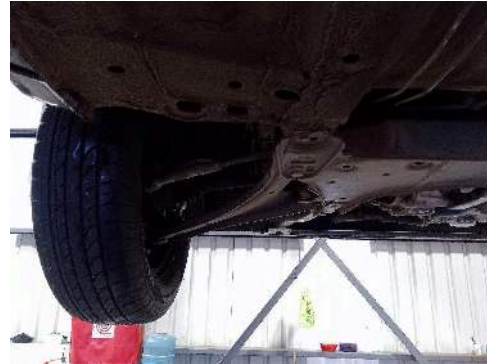
LF TYRE TREAD

| | Size | Load/Speed Index | Manufacture | Model | Type* | Production Date | Tread Depth (mm) |
|---|---|---|---|---|---|---|---|
| Front Left | 175/65R14 | 82H | Royal | Radial | V | 2920 | 2 mm |

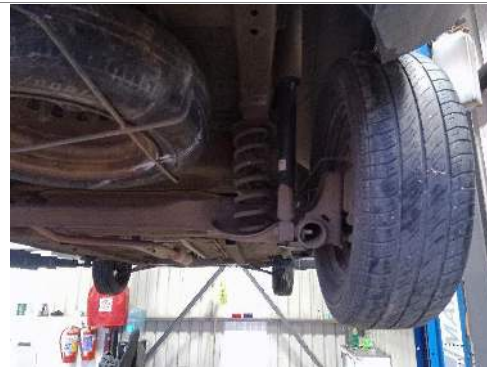
LR TYRE TREAD

| | Size | Load/Speed Index | Manufacture | Model | Type* | Production Date | Tread Depth (mm) |
|---|---|---|---|---|---|---|---|
| Rear Left | 185/65R14 | 82H | Hankook | Radial | V | 5211 | 0 mm |

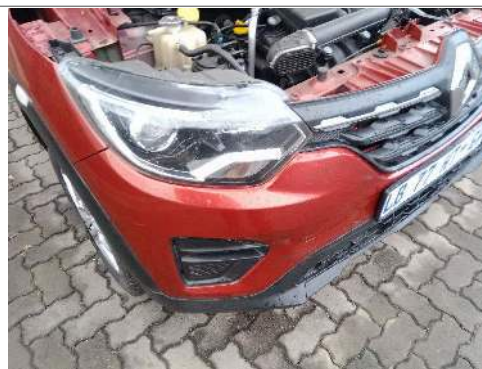
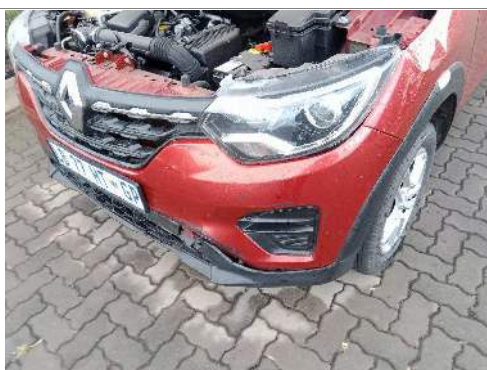
| Front Bumper Damaged | Repair |

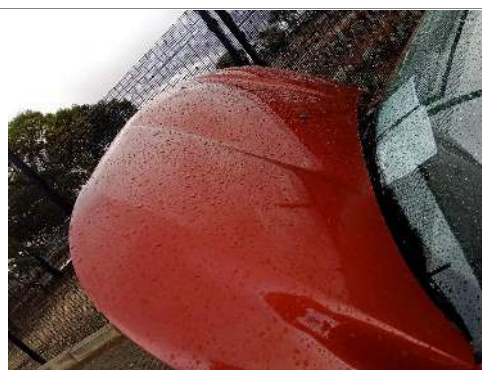
| Bonnet Damaged | Repair |

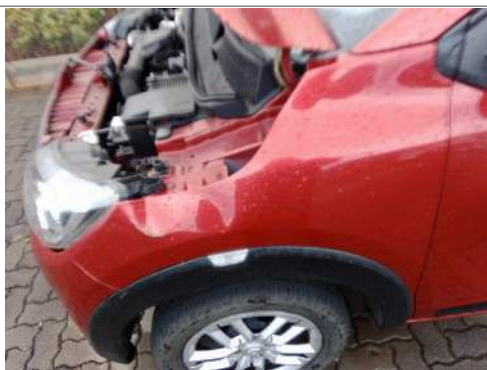
| Front Fender Left Damaged | Repair |

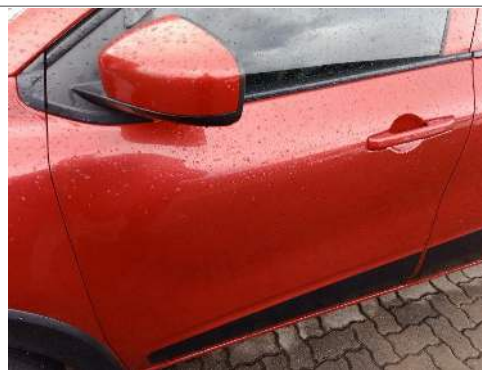
| Door Front Left Damaged | Repair |

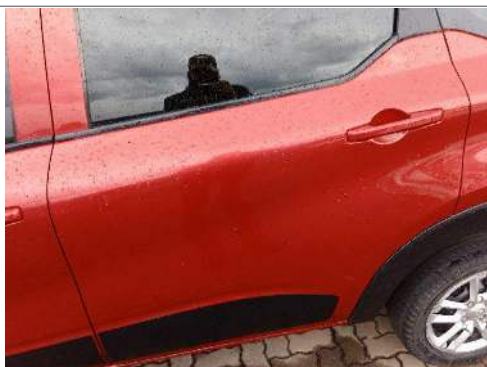
| Door Rear Left Damaged | Repair |

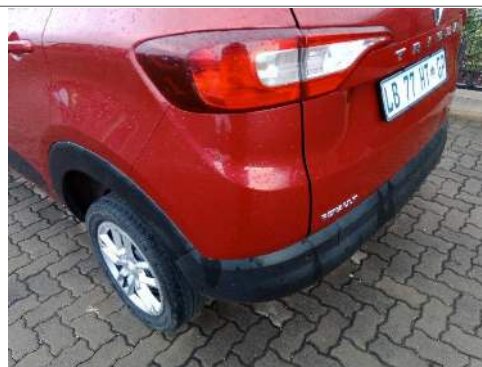
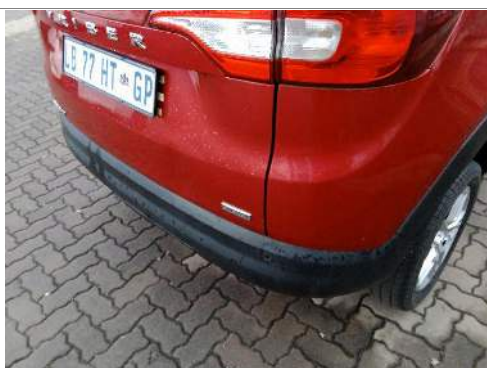
| Rear bumper Damaged | Repair |

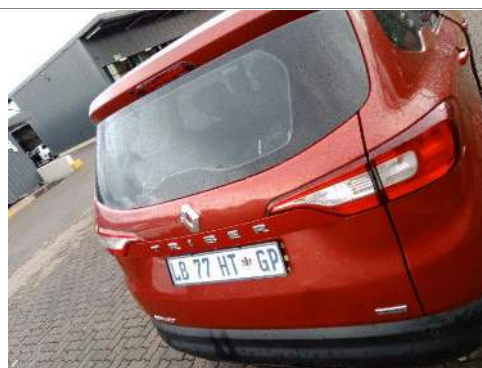
| Boot Lid / Hatch door Damaged | Repair |

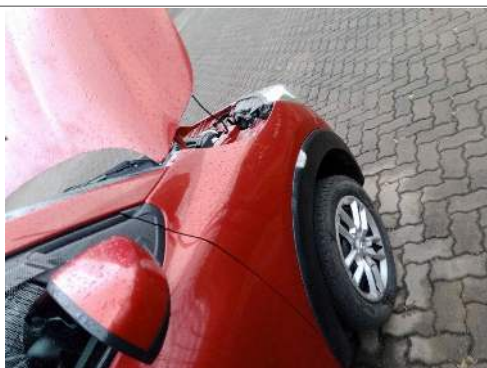
| Front Fender Right Damaged | Repair |

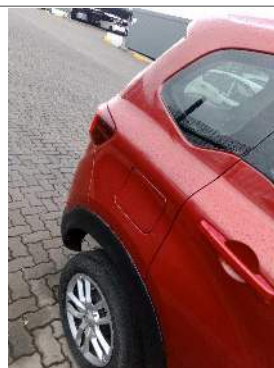
| Rear Fender Right Damaged | Repair |

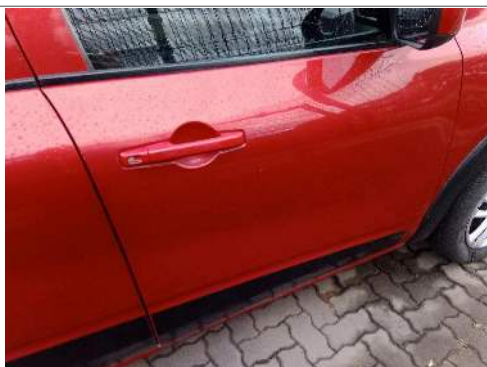
| Door Front Right Damaged | Repair |

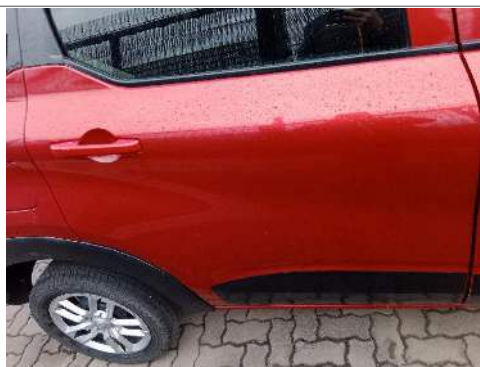
| Door Rear Right Damaged | Repair |

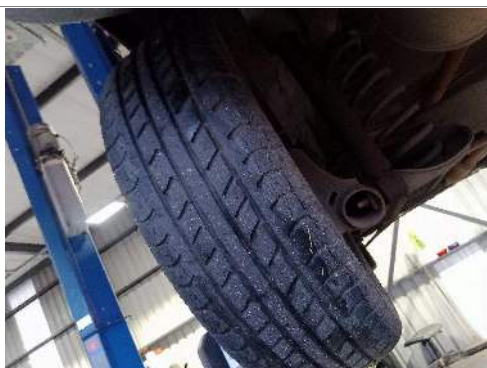
| Tyre Rear Left Worn | Replace |

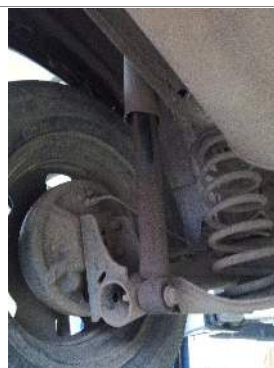
| Shock Absorber Rear Left Damaged | Replace |

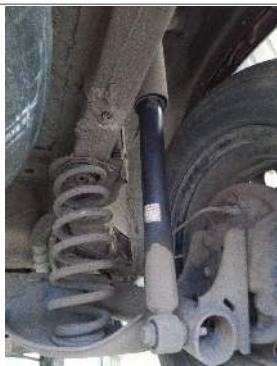
| Shock Absorber Rear Right Damaged | Replace |

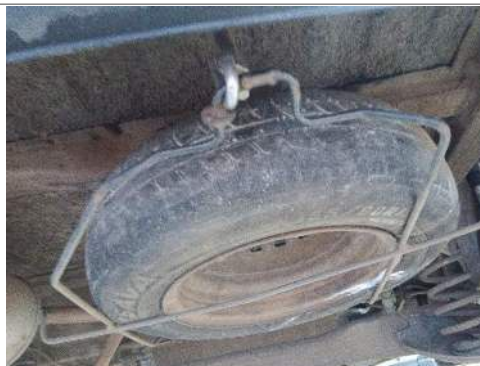
| Spare Tyre Worn | Replace |

| | Size | Load/Speed Index | Manufacture | Model | Type* | Production Date | Tread Depth (mm) |
|---|---|---|---|---|---|---|---|
| Spare | 155/80R13 | 79T | Sava | Radial | V | 0000 | 0 mm |
