## CONDITION REPORT

Report No:  
2017306419  
DATE  
02/10/2026

| Manufacturer | RENAULT | Registration Number | LW91TRGP |
| Model | TRIBER | Register Number | |

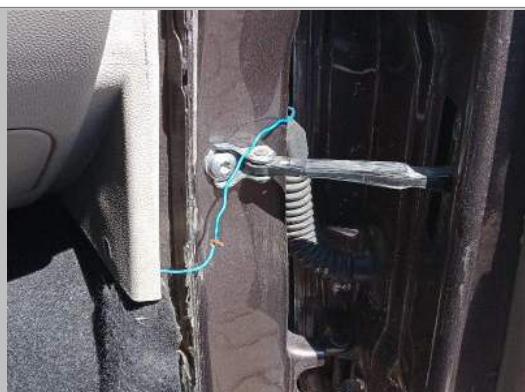
| Damage | Repair Way |
|---|---|
| Loose wiring inside of vehicle | Replace |

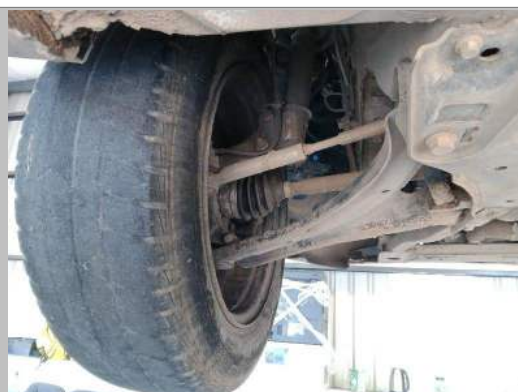
LF TYRE TREAD

| | Size | Load/Speed Index | Manufacture | Model | Type* | Production Date | Tread Depth (mm) |
|---|---|---|---|---|---|---|---|
| Front Left | 165/65 R15 | 92T | Barum | Brillantis | V | 4920 | 0 mm |

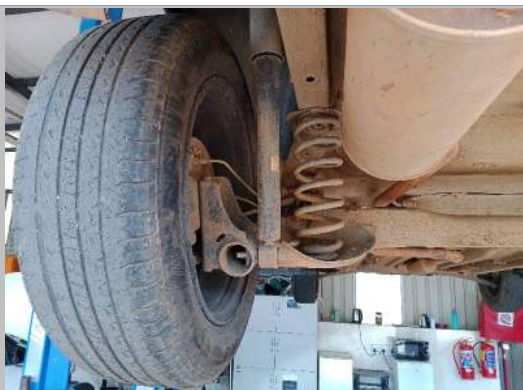
LR TYRE TREAD

| | Size | Load/Speed Index | Manufacture | Model | Type* | Production Date | Tread Depth (mm) |
|---|---|---|---|---|---|---|---|
| Rear Left | 185/60 R15 | 84H | Anchee | AC808 | V | 0124 | 0 mm |

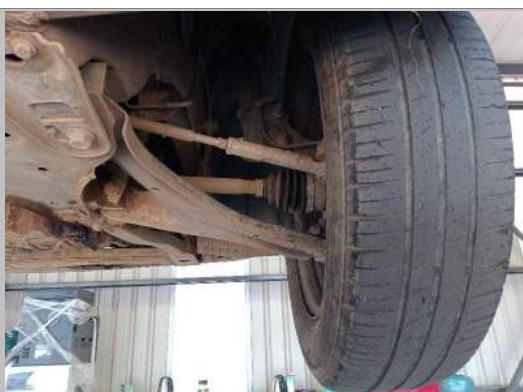
RF TYRE TREAD

| | Size | Load/Speed Index | Manufacture | Model | Type* | Production Date | Tread Depth (mm) |
|---|---|---|---|---|---|---|---|
| Front Right | 185/65 R15 | 88H | Ceat | Secure drive | V | 4622 | 0 mm |

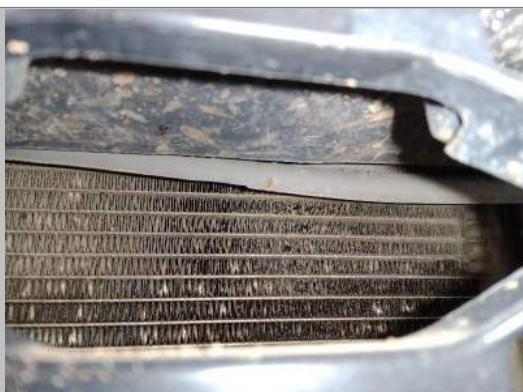
| Damage | Repair Way |
|---|---|
| Front bumper stiffener dented | Repair |

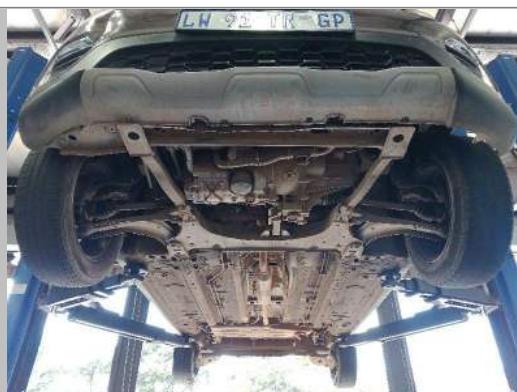
Front chassis

| Damage | Repair Way |
|---|---|
| Chassis Dented | Repair |

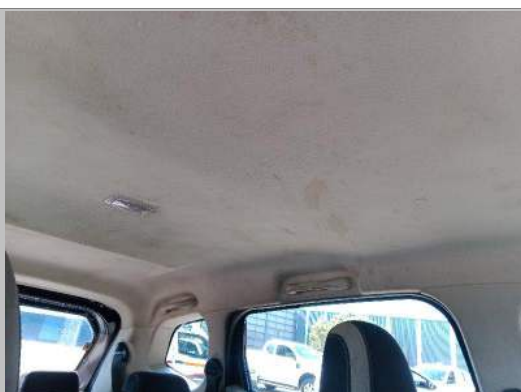
| Damage | Repair Way |
|---|---|
| Hood Lining Dirty | Repair |

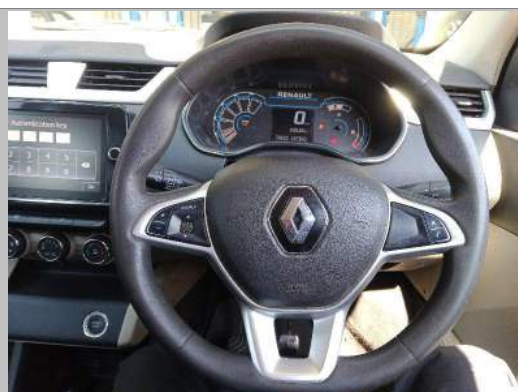
| Damage | Repair Way |
|---|---|
| Steering Wheel Trim Excessive Wear & Tear | Repair |

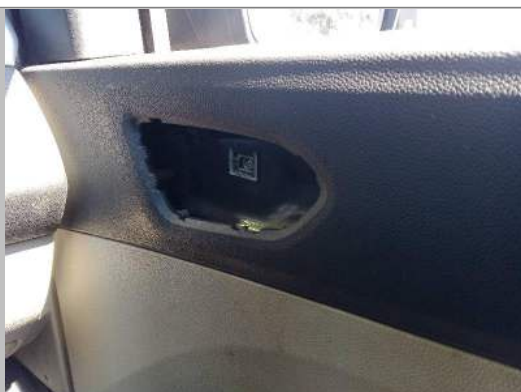
| Damage | Repair Way |
|---|---|
| Door Handle Front Right Missing | Replace |

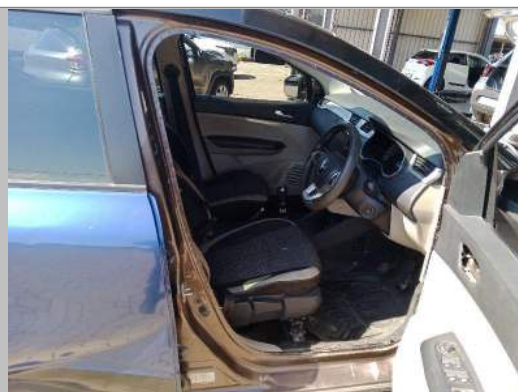
| Damage | Repair Way |
|---|---|
| Door Sealing Rubber Front Right Missing | Replace |

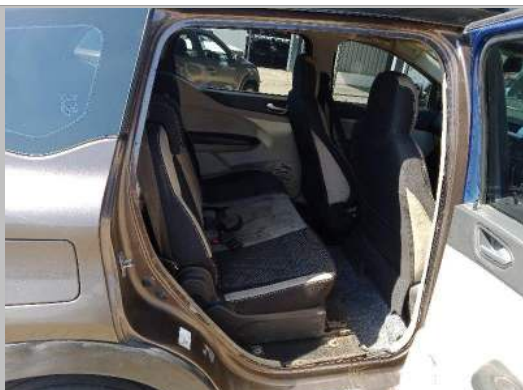
| Damage | Repair Way |
|---|---|
| Door Sealing Rubber Rear Right Missing | Replace |

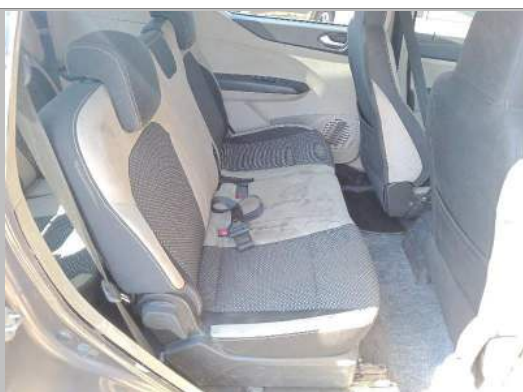
| Damage | Repair Way |
|---|---|
| Seat Rear Dirty | Repair |

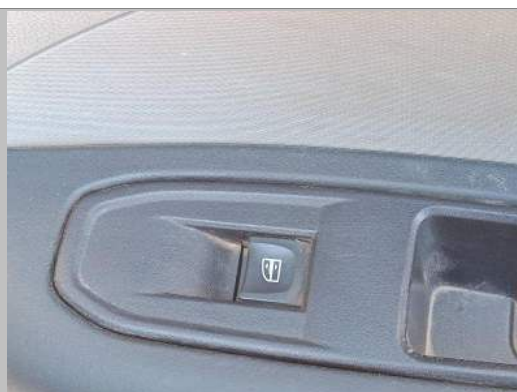
| Damage | Repair Way |
|---|---|
| Switch Electrical Window Winder rear right Damaged | Replace |

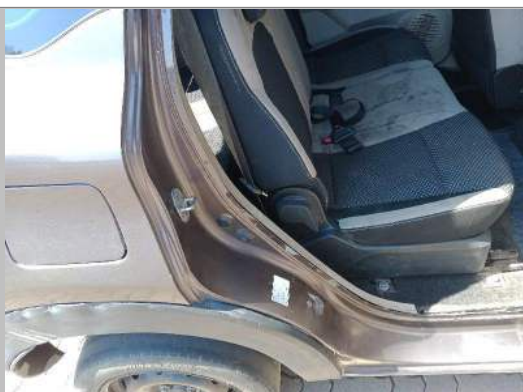
| Damage | Repair Way |
|---|---|
| C • Pillar Right Damaged | Repair |

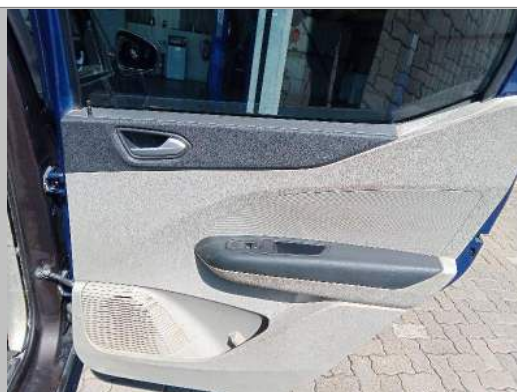
| Damage | Repair Way |
|---|---|
| Door Panel Rear Right Damaged | Repair |

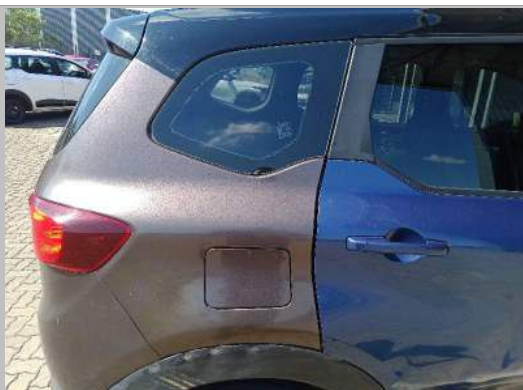
| Damage | Repair Way |
|---|---|
| Rear Fender Right Residual Traces of Repair | Repair |

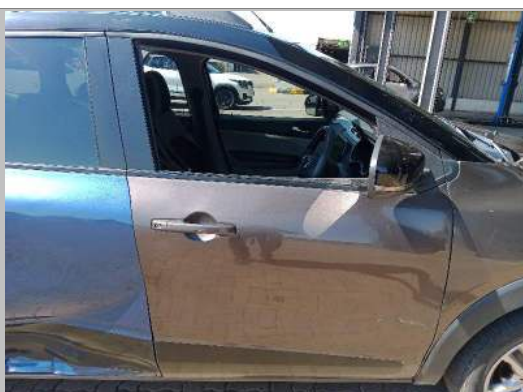
| Damage | Repair Way |
|---|---|
| Door Front Right Damaged | Repair |

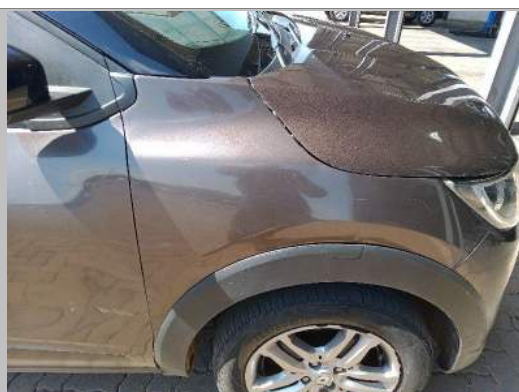
| Damage | Repair Way |
|---|---|
| Front Fender Right Damaged | Repair |

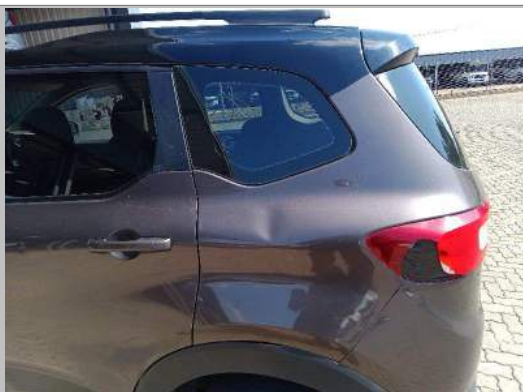
| Damage | Repair Way |
|---|---|
| Rear Fender Left Damaged | Repair |

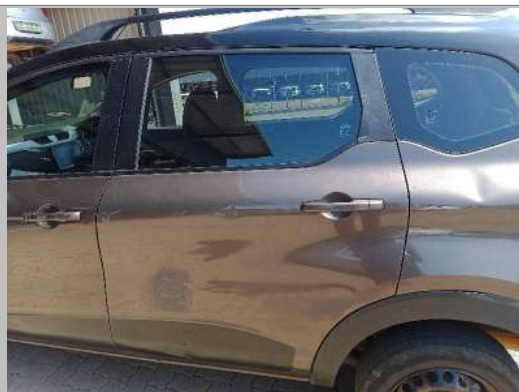
| Damage | Repair Way |
|---|---|
| Door Rear Left Damaged | Repair |

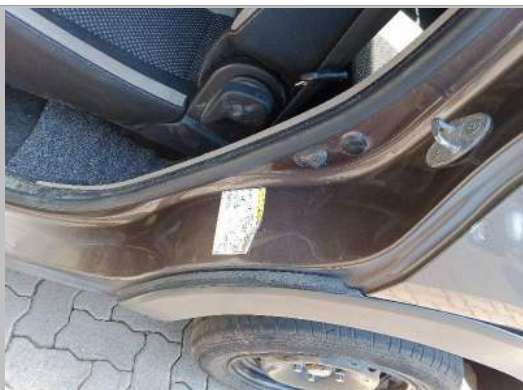
| Damage | Repair Way |
|---|---|
| C • Pillar Left Damaged | Repair |

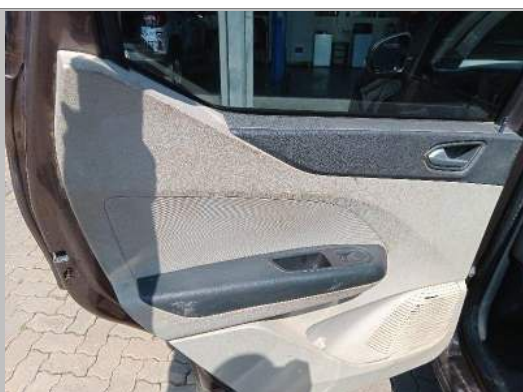
| Damage | Repair Way |
|---|---|
| Door Panel Rear Left Damaged | Repair |

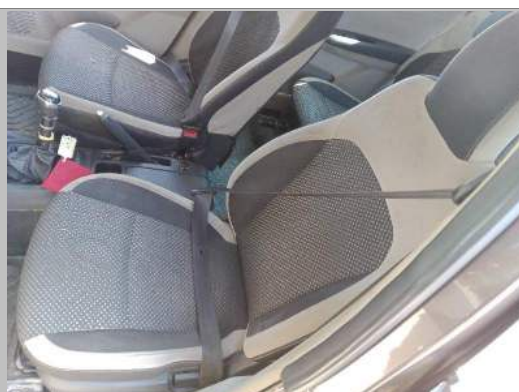
| Damage | Repair Way |
|---|---|
| Seat Front Left Dirty | Repair |

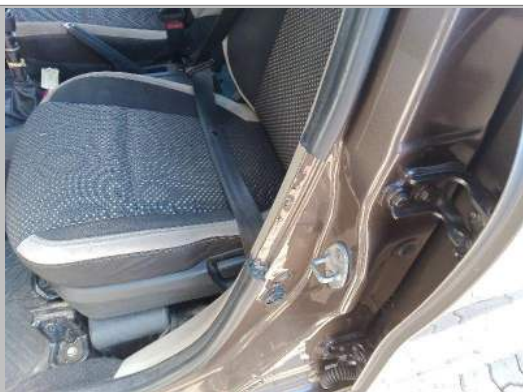
| Damage | Repair Way |
|---|---|
| Door Sealing Rubber Front Left Damaged | Replace |

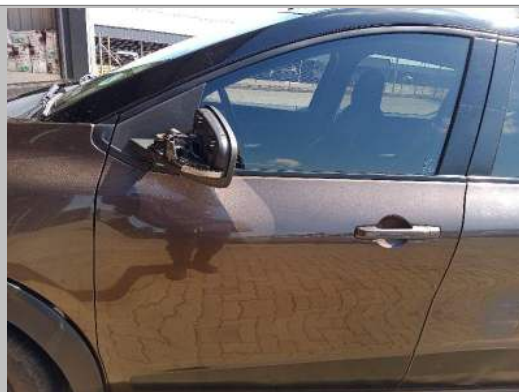
| Damage | Repair Way |
|---|---|
| Door Front Left Dented | Repair |

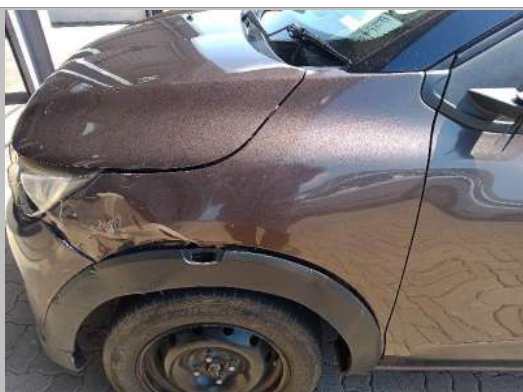
| Damage | Repair Way |
|---|---|
| Front Fender Left Damaged | Replace |

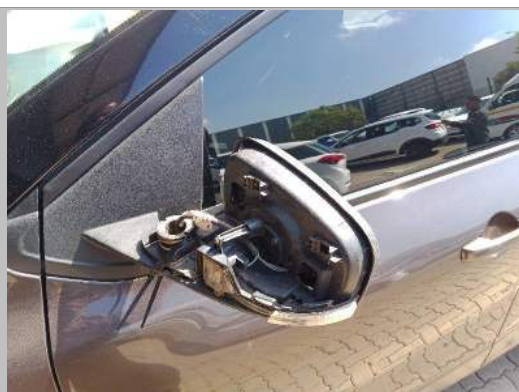
| Damage | Repair Way |
|---|---|
| Side Mirror Left Damaged | Replace |

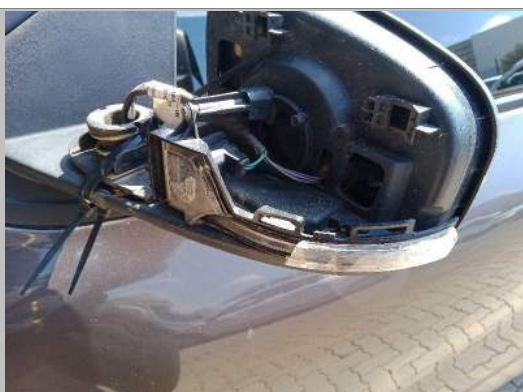
| Damage | Repair Way |
|---|---|
| Indicator Light Front Left Damaged | Replace |

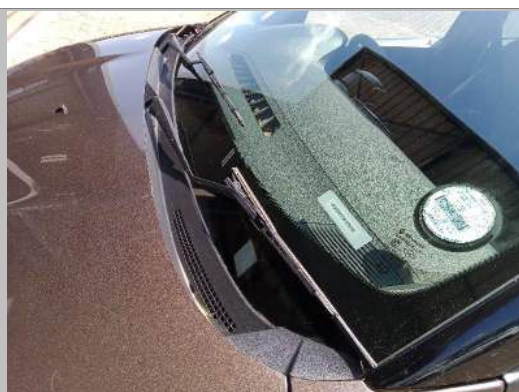
| Damage | Repair Way |
|---|---|
| Windscreen Wiper Damaged | Replace |

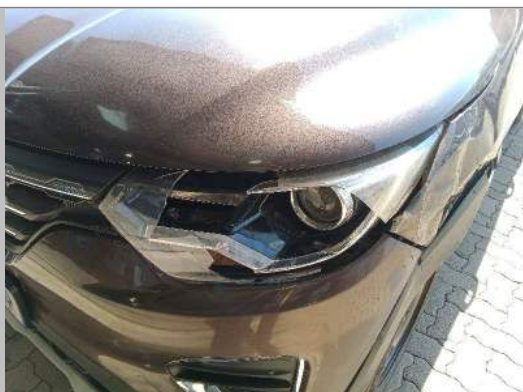
| Damage | Repair Way |
|---|---|
| Headlight Left Damaged | Replace |

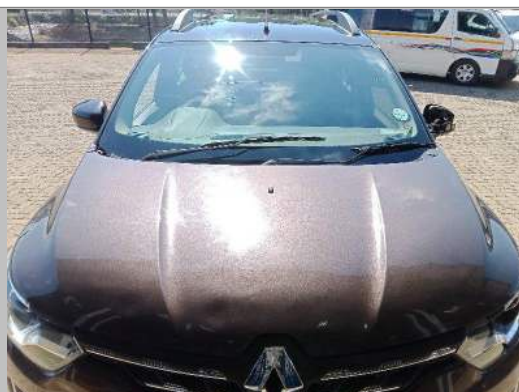
| Damage | Repair Way |
|---|---|
| Bonnet Damaged | Repair |

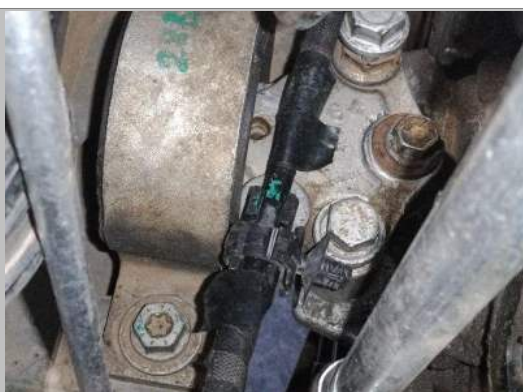
| Damage | Repair Way |
|---|---|
| Engine mountings Damaged | Replace |

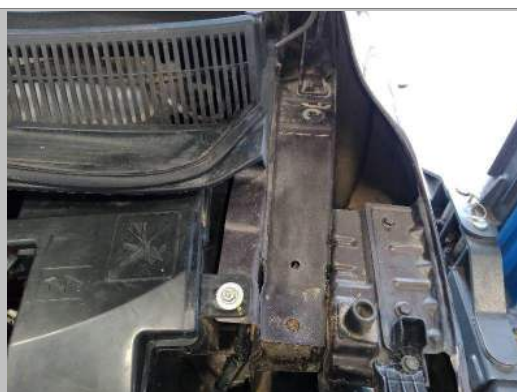
| Damage | Repair Way |
|---|---|
| Front Fender Left / Inner Tray Damaged | Repair |

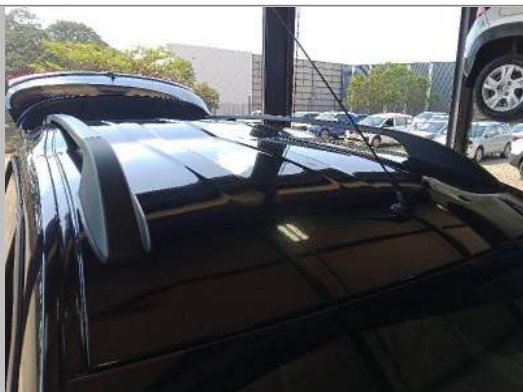
| Damage | Repair Way |
|---|---|
| Roof Dented | Repair |

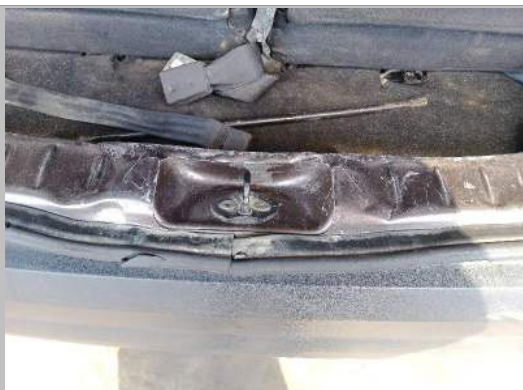
| Damage | Repair Way |
|---|---|
| Boot Lid / Hatch Door Rubbers Damaged | Replace |

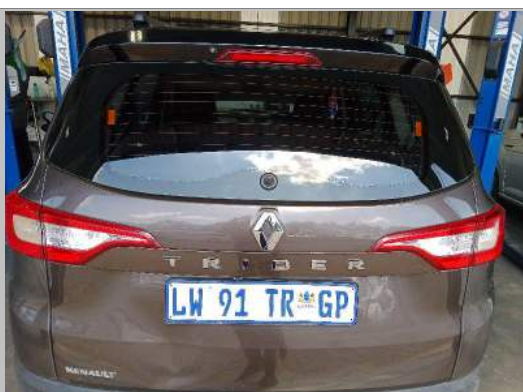
| Damage | Repair Way |
|---|---|
| Boot Lid / Hatch door Damaged | Repair |

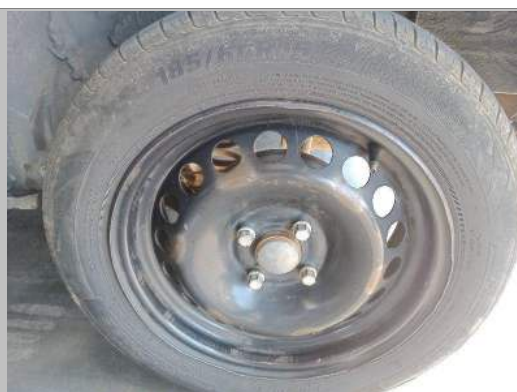
| Damage | Repair Way |
|---|---|
| Rim Rear Left Dented | Repair |

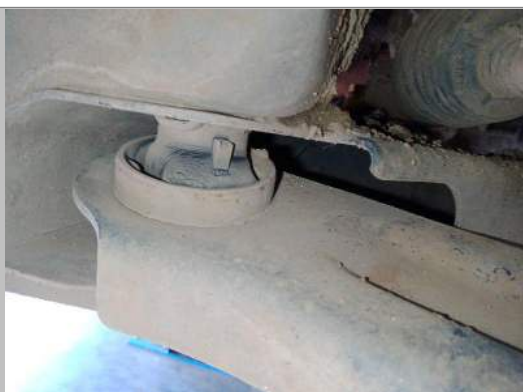
| Damage | Repair Way |
|---|---|
| Control Arm Bush(es) Front Axle Right Cracked | Replace |

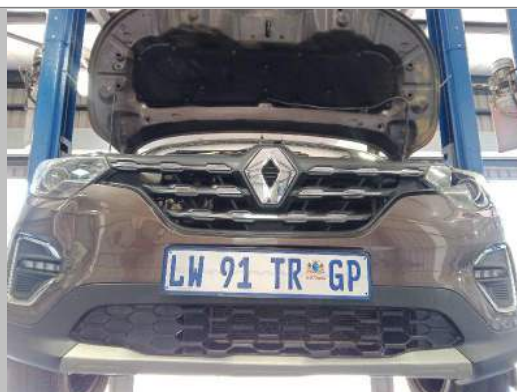
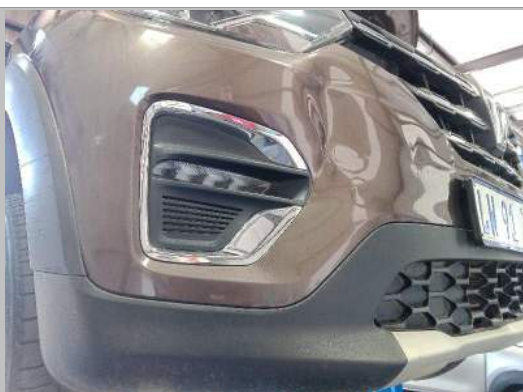
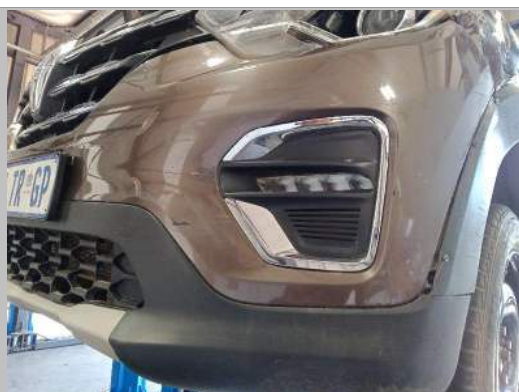
| Damage | Repair Way |
|---|---|
| Front Bumper Damaged | Repair |

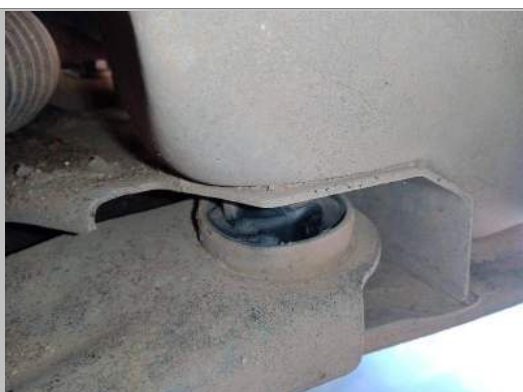
| Damage | Repair Way |
|---|---|
| Control Arm Bush(es) Front Axle Left Cracked | Replace |

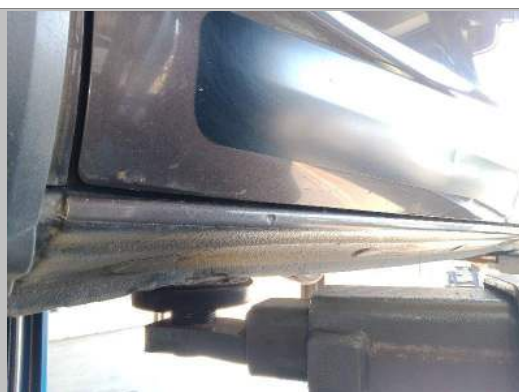
| Damage | Repair Way |
|---|---|
| Sill Panel Left Damaged | Repair |

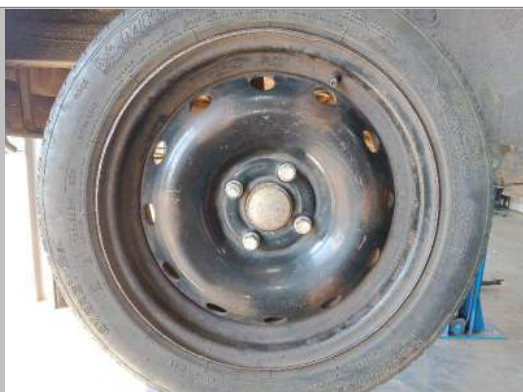
| Damage | Repair Way |
|---|---|
| Rim Rear Right Dented | Repair |

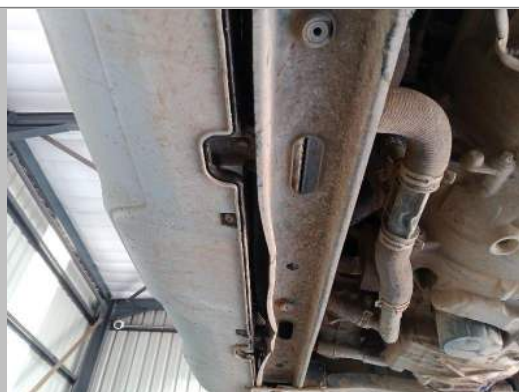
| Damage | Repair Way |
|---|---|
| Radiator Cradle Damaged | Repair |

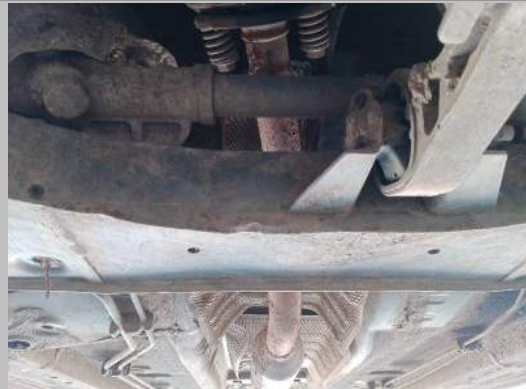
| Damage | Repair Way |
|---|---|
| Sub Frame Damaged | Repair |

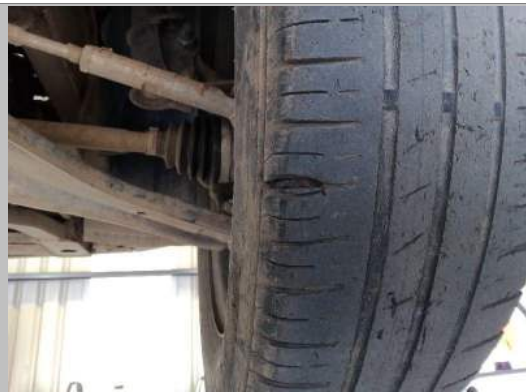
| Damage | Repair Way |
|---|---|
| Tyre Front Right Damaged | Replace |

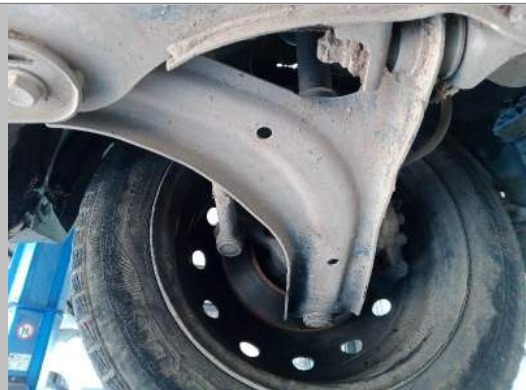
| Damage | Repair Way |
|---|---|
| Control Arm(s) Front Axle Left Damaged | Replace |

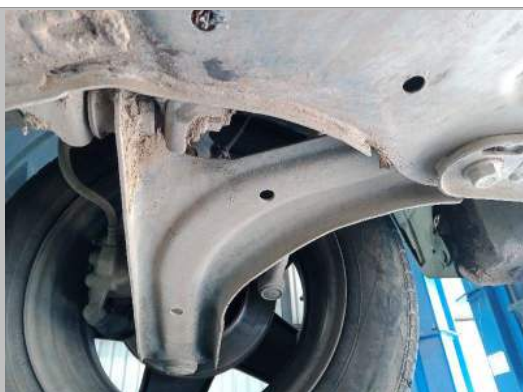
| Damage | Repair Way |
|---|---|
| Control Arm(s) Front Axle Right Damaged | Replace |

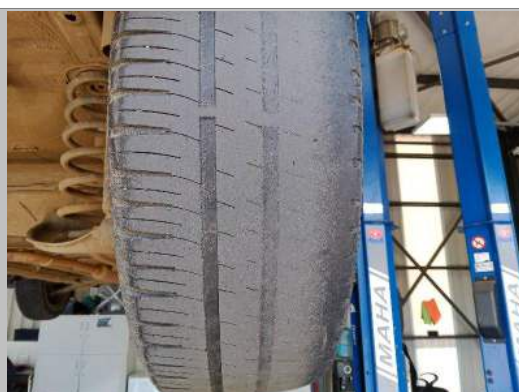
| Damage | Repair Way |
|---|---|
| Tyre Rear Right Worn | Replace |

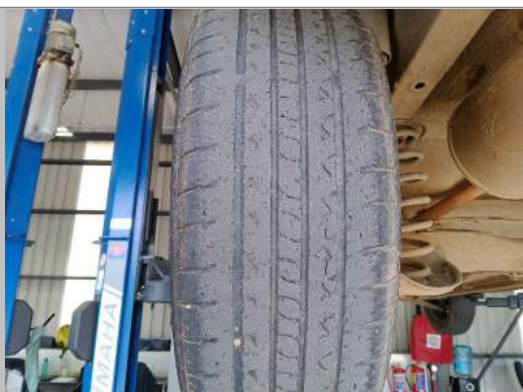
| Damage | Repair Way |
|---|---|
| Tyre Rear Left Worn | Replace |

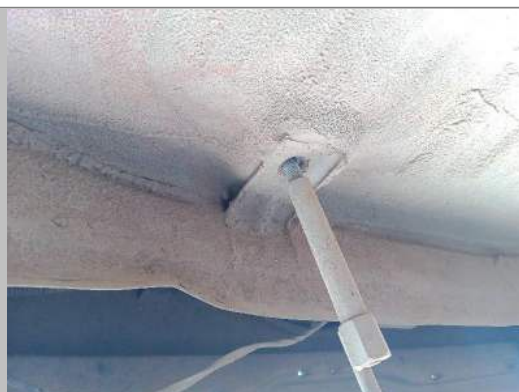
| Damage | Repair Way |
|---|---|
| Inner Boot Floor Pan and Spare Wheel Well Damaged | Repair |

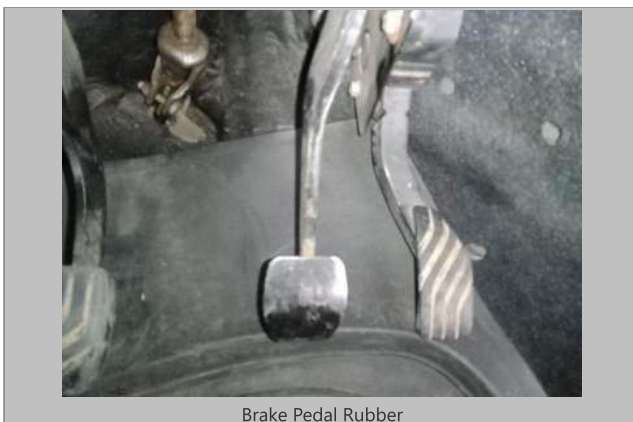
| Damage | Repair Way |
|---|---|
| Brake Pedal Rubber Missing | Replace |
