CONDITION REPORT

Report No: 2016480482

MFC Auction House
M57 Pretoria Rd, Glenmarais, KEMPTON PARK
Gauteng

Vehicle Type	PASSENGER VEHICLE	Registered Owner	
Manufacturer	TOYOTA	Registration Number	HL05PLGP
Model	AVANZA	Register Number	
VIN	MHKM5FA2N0K007803	Date Of First Licensing	
Engine Number		Last COR	
Doors	5	License Expiry Date	28/02/2022
Color	WHITE	Power / Displacement	
Year Model		Paint Finish	TWO COAT METALLIC
Km Reading	243,777 KM	Fuel	PETROL
Cab / Body Type	STATION WAGON	Transmission	MANUAL

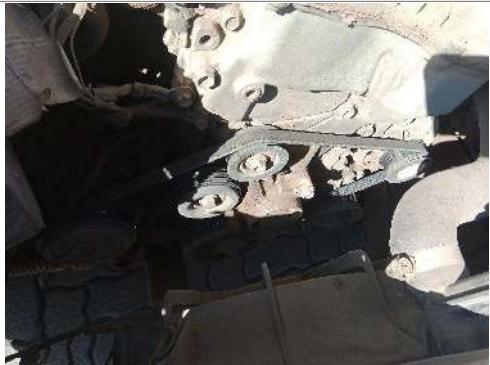
Damage	Repair Way
Engine Oil Leak	Repair
Fan Belt Damaged	Replace
Radiator Damaged	Replace
Air conditioner pipes Damaged	Replace
Engine Management Lights Set	Replace
Seat Front Left Damaged	Repair
Seat Front Right Damaged	Repair
Seat Rear Damaged	Repair
Seat Rear (2. Row) Damaged	Repair
Seat Belt Front Left Damaged	Repair
Seat Belt Front Right Damaged	Repair
Dash Padding Damaged	Repair
Carpet Front Damaged	Repair
Carpet Rear Damaged	Repair
Steering Wheel Trim Damaged	Repair
Side Mirror Left Damaged	Replace
Side Mirror Right Damaged	Replace
Front Bumper Damaged	Repair
Bonnet Damaged	Replace
Bonnet slam plate (Shock tower/ Inner tray) Damaged	Repair
Front Fender Left Damaged	Repair
Front Fender Right Damaged	Repair
Rear Fender Left Damaged	Repair
Rear Fender Right Damaged	Repair
Door Front Left Damaged	Repair
Door Front Right Damaged	Repair
Door Rear Left Damaged	Repair
Door Rear Right Damaged	Repair
Boot Lid / Hatch door Damaged	Repair

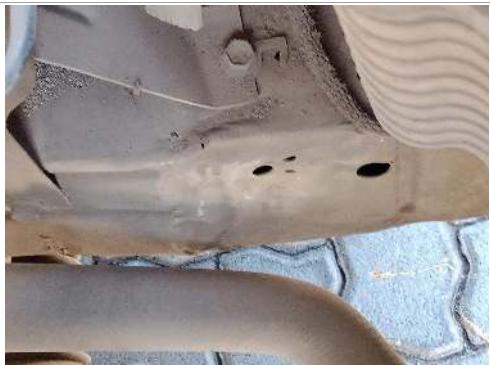
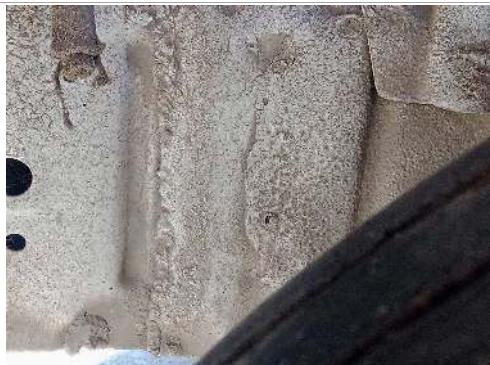
Damage	Repair Way
Rear bumper Damaged	Repair
Windscreen Damaged	Replace
Brake disc 1. Axle left Worn	Replace
Brake disc 1. Axle right Worn	Replace
Shock Absorber Rear Left Worn	Replace
Tyre Front Left Worn	Repair
Main Beam Left Welded	Repair
Gearbox Oil Leak	Repair
Radiator Cross Member Damaged	Replace
Brakes Insufficient	Repair
Engine Performance Insufficient	Repair
Clutch Operation Slippy Hesitation	Replace
Body and exterior	Cut and join
Engine	Battery loose
interior	vehicle air bags deployed
Body and exterior	Signs of stone chips to some body panels.
Body and exterior	Signs of repair work done to somebody panels.
Body and exterior	Signs of impact damage to front of vehicle

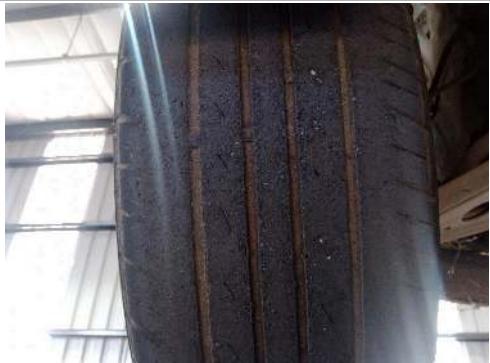
Tyre Front Left

Size	Load/Speed Index	Manufacture	Model	Type*	Production Date	Tread Depth (mm)
Front Left	185/70R14	88T	Zextour	Radial	V	0322	0 mm
Front Right	185/70R14	88T	Dunlop	Sp	V	1321	1 mm
Rear Left	185/70R14	88T	Tracmax	Radial	V	4722	2 mm
Rear Right	185/70R14	88T	Tracmax	Radial	V	4722	2 mm
