Vehicle Type	PASSENGER VEHICLE	Registered Owner	MFC
Manufacturer	TOYOTA	Registration Number	HP47DBGP
Model	AVANZA	Register Number	
VIN	MHKM5FA2N0K007975	Date Of First Licensing	
Engine Number		Last COR	
Doors	5	License Expiry Date	30/04/2023
Color	GOLDEN	Power / Displacement	
Year Model		Paint Finish	TWO COAT METALLIC
Km Reading	376,610 KM	Fuel	PETROL
Cab / Body Type	STATION WAGON	Transmission	MANUAL

CONDITION REPORT

Report No: 2016213531

DATE
28/12/2023

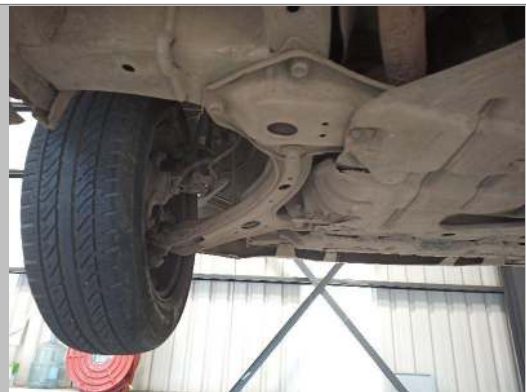
LF TYRE TREAD

Size	Load/Speed Index	Manufacture	Model	Type*	Production Date	Tread Depth (mm)
Front Left	185/65R14	86H	Dunlop	Sp	V	4816	2 mm
Front Right	185/70R14	88Q	Dunlop	Sp	V	4817	2 mm
Rear Left	185/60R14	82H	Dunlop	Sp	V	4620	2 mm
Rear Right	185/70R14	88T	Dunlop	Sp	V	1321	1 mm

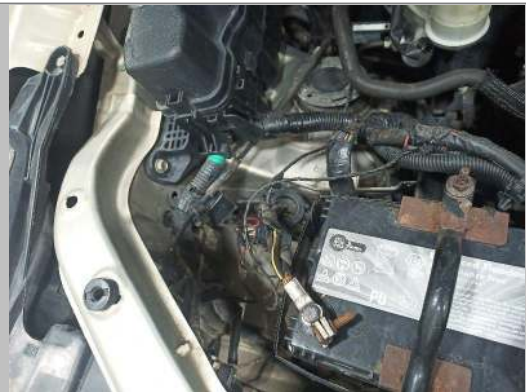
Damage	Repair Way
Engine Oil Leak	Repair
Engine Wiring Damaged	Replace
Fan Belt Worn	Replace
Central Air Vent Damaged	Repair
Electrical Window Winder front right Defective	Replace
Tail Light Left Damaged	Replace
Tail Light Right Damaged	Replace
Headlight Right Damaged	Replace
Seat Front Left Damaged	Repair
Seat Front Right Damaged	Repair
Seat Rear Damaged	Repair
Seat Rear (2. Row) Damaged	Repair
Sun Visor Right Damaged	Replace
Hood Lining Damaged	Repair
Door Panel Front Left Damaged	Replace
Door Panel Front Right Damaged	Replace
Carpet Rear Damaged	Replace
Steering Wheel Trim Worn	Repair
Side Mirror Right Damaged	Replace
Front Bumper Damaged	Repair
Grill Damaged	Replace
Bonnet Damaged	Repair
Front Fender Left Damaged	Replace
Front Fender Right Damaged	Repair
Rear Fender Left Damaged	Repair
Rear Fender Right Damaged	Repair
Door Front Left Damaged	Repair
Door Front Right Damaged	Repair
Door Rear Left Damaged	Repair

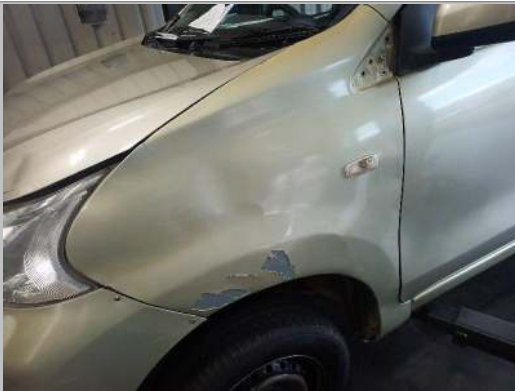
Front Fender Left

Body • Exterior: Minor dents and scratches and stone chips to some body panels. Signs of repair work done to some body panels. Poor alignment to some body panels. Vehicle body in poor condition. Repair work done to vehicle below-standard.

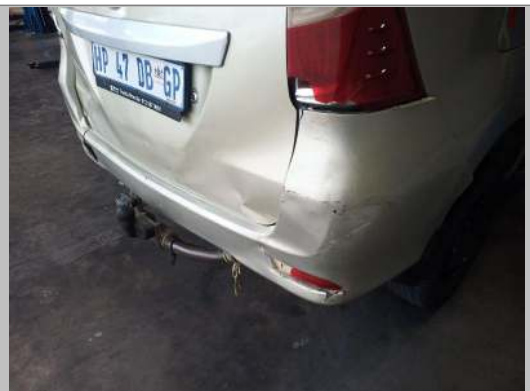
Damage	Repair Way
Door Rear Right Damaged	Repair
Boot Lid / Hatch door Damaged	Repair
Rear bumper Damaged	Repair
Sill Panel Left Damaged	Repair
Sill Panel Right Damaged	Repair
Windscreen Damaged	Replace
Service Brake Performance Rear Axle Left / Right	Repair
Difference out of legal range	
Parking Brake Performance Insufficient	Repair
Shock Absorber Rear Right Worn	Replace
Shock Absorber Mounting Front Right Damaged	Replace
Wheel bearing Rear Right Worn	Replace
Bolt(s) / Nut(s) Rear Wheel Right Damaged	Replace
Gearbox Oil Leak	Repair
