## CONDITION REPORT

Report No: 2016859990

MFC Auction House  
M57 Pretoria Rd, Glenmarais, KEMPTON PARK  
Gauteng

Vehicle Type	PASSENGER VEHICLE	Registered Owner	
Manufacturer	TOYOTA	Registration Number	KMJ344MP
Model	AVANZA 1.5 SX MPV [2019-2022]	Register Number	
VIN	MHKM5FA2N0K013298	Date Of First Licensing	
Engine Number		Last COR	
Doors	5	License Expiry Date	31/01/2026
Color	SILVER	Power / Displacement	
Year Model	2020	Paint Finish	TWO COAT METALLIC
Km Reading	338,572 KM	Fuel	PETROL
Cab / Body Type	HATCHBACK	Transmission	MANUAL

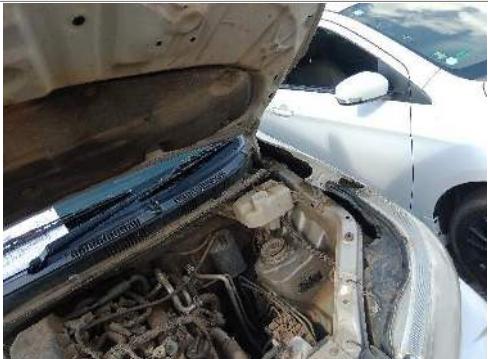
Damage	Repair Way
Bonnet stay and shocks Missing	Replace
Central Air Vent Damaged	Repair
Engine Management Lights Set	Repair
Headlight Left Damaged	Repair
Headlight Right Damaged	Replace
Seat Front Left Damaged	Repair
Seat Front Right Damaged	Repair
Sun Visor Left Damaged	Repair
Front Bumper Damaged	Repair
Bonnet Damaged	Repair
Front Fender Left Damaged	Repair
Front Fender Right Damaged	Repair
Rear Fender Left Damaged	Repair
Rear Fender Right Damaged	Repair
Door Front Left Damaged	Repair
Door Front Right Damaged	Repair
Door Rear Left Damaged	Repair
Door Rear Right Damaged	Repair
Boot Lid / Hatch door Damaged	Repair
Rear bumper Damaged	Repair

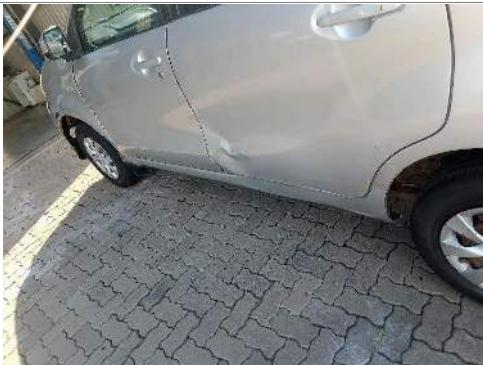
Damage	Repair Way
Sill Panel Left Damaged	Repair
Caliper 1. Axle left Leak	Replace
Caliper 1. Axle right Leak	Repair
Wheel Cylinder / Caliper 2. Axle left Leak	Replace
Service Brake Performance Rear Axle Left / Right	Repair
Difference out of legal range	
Shock Absorber Front Left Worn	Replace
Shock Absorber Front Right Worn	Replace
Control Arm Bush(es) Front Axle Left Worn	Replace
Control Arm Bush(es) Front Axle Right Worn	Replace
Tyre Front Left Damaged	Replace
Differential Oil Leak	Replace

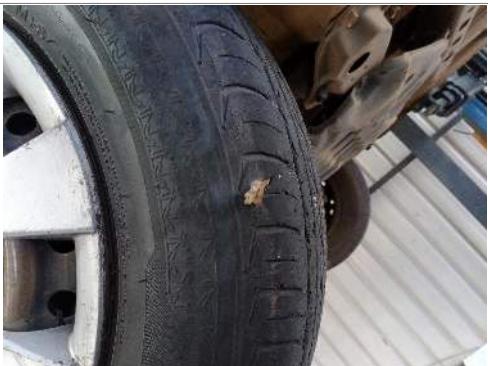
Tyre Front Left

Size	Load/Speed Index	Manufacture	Model	Type*	Production Date	Tread Depth (mm)
Front Left	185/70R14	88H	Autogrip	Radial	V	2424	2 mm
Front Right	185/70R14	88H	Autogrip	Radial	V	2424	2 mm
Rear Left	185/70R14	88H	Voyager	Radial	V	4222	3 mm
Rear Right	185/70R14	88H	Voyager	Radial	V	4422	3 mm
