CONDITION REPORT

Report No: 2016218793

MFC Auction House
M57 Pretoria Rd, Glenmarais, KEMPTON PARK
Gauteng

Vehicle Type	PASSENGER VEHICLE	Registered Owner	MFC
Manufacturer	TOYOTA	Registration Number	FH975MGP
Model	AVANZA	Register Number	
VIN	MHKM5FB2N0K000317	Date Of First Licensing	
Engine Number		Last COR	
Doors	5	License Expiry Date	30/09/2020
Color	WHITE	Power / Displacement	
Year Model		Paint Finish	TWO COAT UNI
Km Reading	133,950 KM	Fuel	PETROL
Cab / Body Type	STATION WAGON	Transmission	AUTOMATIC

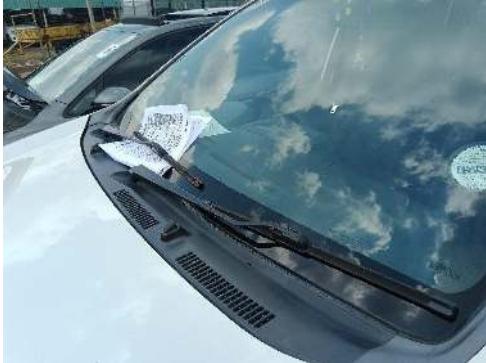
Damage	Repair Way
Engine Wiring Defective	Repair
Windscreen Wiper Damaged	Replace
Headlight Left Defective	Repair
Headlight Right Defective	Repair
Seat Front Left Dirty	Repair
Seat Front Right Damaged	Repair
Seat Rear Damaged	Repair
Seat Rear (2. Row) Damaged	Repair
Hood Lining Damaged	Repair
Door Panel Rear Right Defective	Repair
Boot Panel Left Defective	Repair
Boot Panel Right Defective	Repair
Steering Wheel Trim Defective	Repair
Front Bumper Paintwork • Scratched	Repair
Grill Paintwork • Scratched	Repair
Bonnet Paintwork • Scratched	Repair
B • Pillar Right Dented	Repair
C • Pillar Right Dented	Repair
Front Fender Left Paintwork • Scratched	Repair
Front Fender Right Paintwork • Scratched	Repair
Rear Fender Left Dented	Repair
Rear Fender Right Dented	Repair
Rear Fender Left / Inner Tray Dented	Repair
Rear Fender Right / Inner Tray Dented	Repair
Door Front Left Paintwork • Scratched	Repair
Door Front Right Dented	Repair

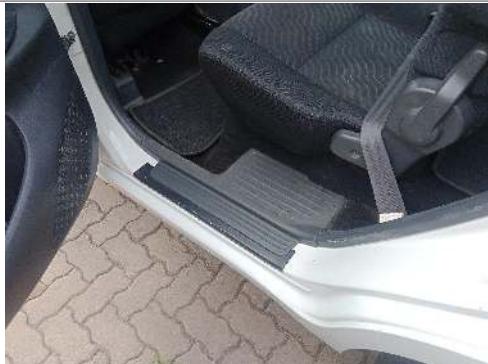
Damage	Repair Way
Boot Lid / Hatch door Damaged	Repair
Rear bumper Damaged	Repair
Sill Panel Left Paintwork • Scratched	Repair
Rocker Panel Left Paintwork • Scratched	Repair
Rocker Panel Right Dented	Repair
Roof Dented	Repair
Windscreen Cracked	Replace
Brake disc 1. Axle left Defective	Replace
Brake disc 1. Axle right Defective	Replace
Shock Absorber Rear Left Damaged	Replace
Control Arm Bush(es) Front Axle Left Cracked	Replace
Control Arm Bush(es) Front Axle Right Cracked	Replace
Chassis Dented	Repair
Belly plates Damaged	Repair
Gearbox Oil Sweat	Repair
Jack Missing	Replace
Wheel Spanner Missing	Replace
Triangle Missing	Replace

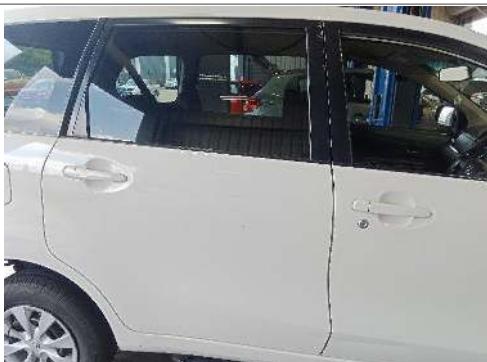
Door Rear Left Paintwork • Scratched	Repair
Door Rear Right Dented	Repair
Doorstopper Front Right Damaged	Replace
