MFC Auction House
M57 Pretoria Rd, Glenmarais, KEMPTON PARK
Gauteng

DEKRA MFC
M57 Pretoria Rd - 1619
KEMPTON PARK - GT
08610 33572

VEHICLE INSPECTION

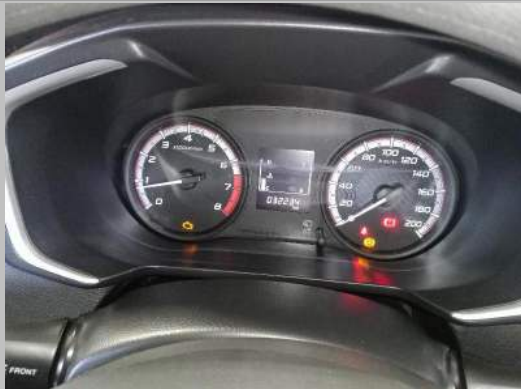
DASHBOARD (W/ ENGINE RUNNING)

Damage	Repair Way
Engine Wiring Defective	Repair
Number Plate Front Missing	Repair
Side Mirror Right Paintwork • Scratched	Repair
Front Bumper Paintwork • Scratched	Repair
Grill Damaged	Repair
Bonnet Cracked	Repair
Front Fender Right Paintwork • Scratched	Repair
Rear Fender Right Residual Traces of Repair	Repair
Door Front Left Paintwork • Scratched	Repair
Door Front Right Residual Traces of Repair	Repair
Door Rear Left Paintwork • Scratched	Repair
Door Rear Right Residual Traces of Repair	Repair
Rear bumper Paintwork • Scratched	Repair
Engine Performance Idling / Hunting	Repair
Engine management lights illuminated	Repair

No	System	Code	Description	Status
1	ACTIVE DTC	P0267	NO 3 INJECTOR CIRCUIT LOW
