**CONDITION REPORT**

Report No: 2016875409

**DATE**  
13/05/2025

Vehicle Type	PASSENGER VEHICLE	Registered Owner	
Manufacturer	MAZDA	Registration Number	KBS225EC
Model	MAZDA2 1.5 DYNAMIC 5-DR [2015-2017]	Register Number	
VIN	MM6DJ2HA6FW109337	Date Of First Licensing	
Engine Number		Last COR	
Doors	5	License Expiry Date	30/09/2023
Color	SILVER	Power / Displacement	
Year Model	2015	Paint Finish	M - METALLIC
Km Reading	150,541 KM	Fuel	PETROL
Cab / Body Type	HATCHBACK	Transmission	MANUAL

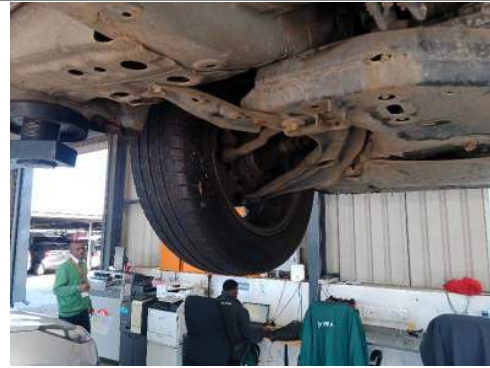
LF TYRE TREAD

Size	Load/Speed Index	Manufacture	Model	Type*	Production Date	Tread Depth (mm)
Front Left	185/65R15	88H	Voyager	Hp	V	2321	3 mm
Front Right	185/65R15	88H	Voyager	Hp	V	2321	3 mm
Rear Left	185/65R15	88T	Hankook	Kinergy	V	1218	1 mm
Rear Right	185/65R15	88T	Hankook	Kinergy	V	1218	3 mm
Spare	T125/70D15	95M	Falken	Temporary	V	0000	3 mm

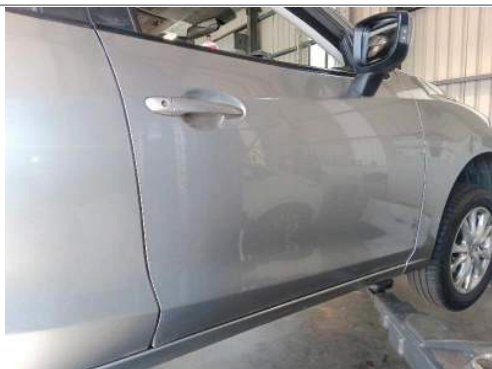
Damage	Repair Way
Side Mirror Left Paintwork • Scratched	Repair
Side Mirror Right Paintwork • Scratched	Repair
Front Bumper Damaged	Repair
Front Fender Left Dented	Repair
Front Fender Right Dented	Repair
Rear Fender Left Dented	Repair
Door Front Left Dented	Repair
Door Front Right Dented	Repair
Door Rear Left Dented	Repair
Door Rear Right Paintwork • Scratched	Repair
Boot Lid / Hatch door Dented	Repair
Rear bumper Paintwork • Scratched	Repair
Service Brake Performance Front Axle Left / Right	Repair
Difference out of legal range
