## CONDITION REPORT

2017304709

MFC Auction House  
M57 Pretoria Rd, Glenmarais, KEMPTON PARK  
Gauteng

| Model | MAZDA2 1.5 DYNAMIC 5-DR [2017-2020] | Register Number | |

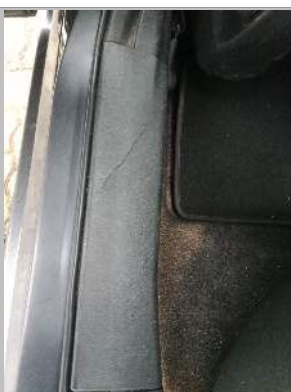
| Rear left interior sill panel plastic trim damaged | Replace |

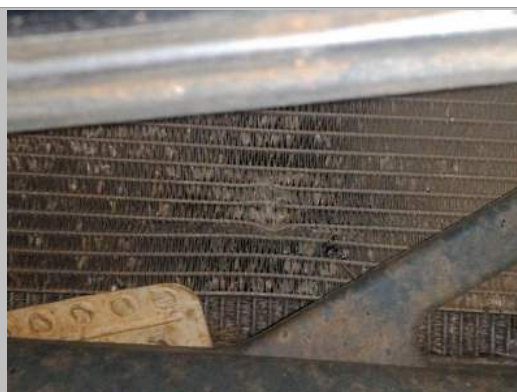
| Aircon condenser dented | Repair |
| Radiator and Aircon condenser misaligned | Repair |

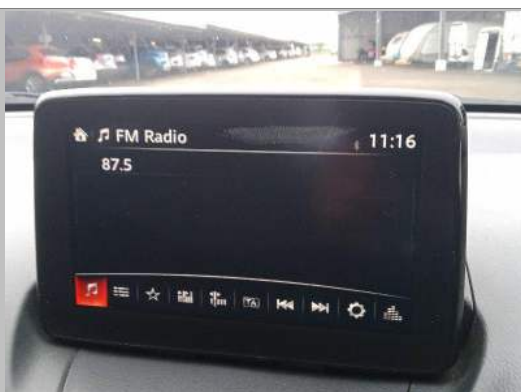
| Radio/CD/USB Damaged | Replace |

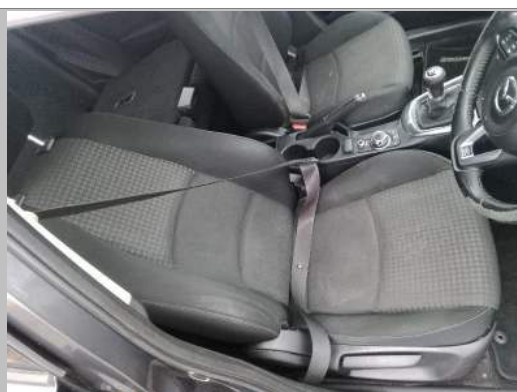
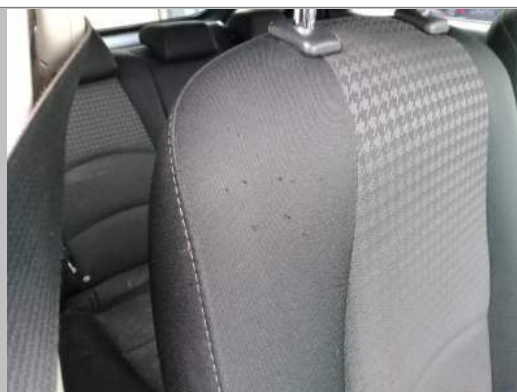
| Seat Front Right Damaged | Repair |

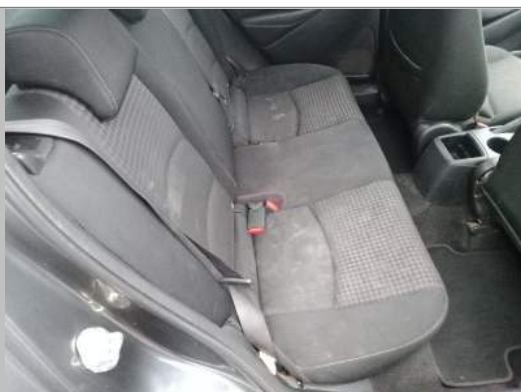
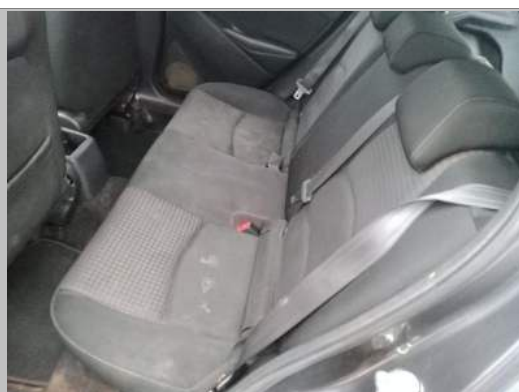
| Seat Rear Dirty | Repair |

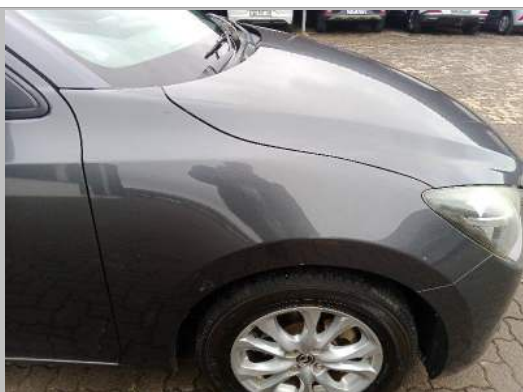
| Front Fender Right Damaged | Repair |

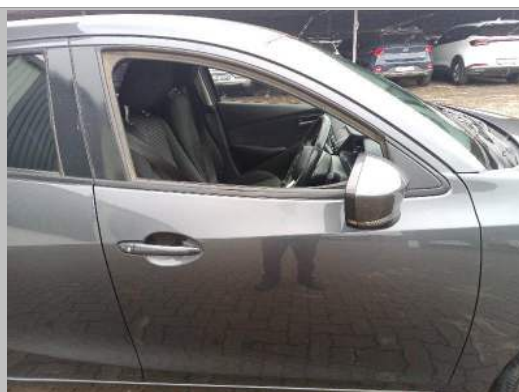
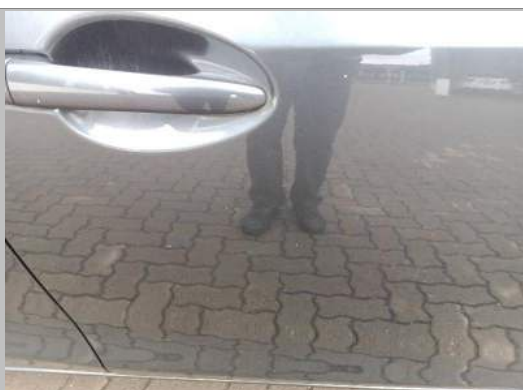
| Door Front Right Paintwork • Chipmarks | Repair |

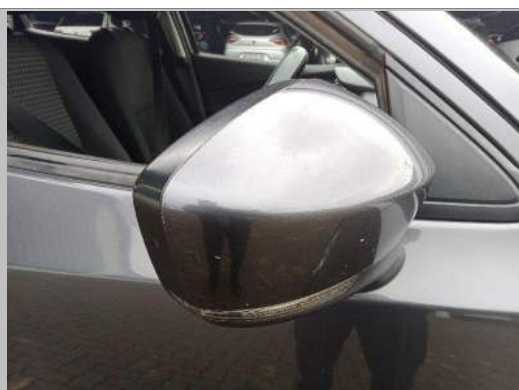
| Side Mirror Right Paintwork • Scratched | Repair |

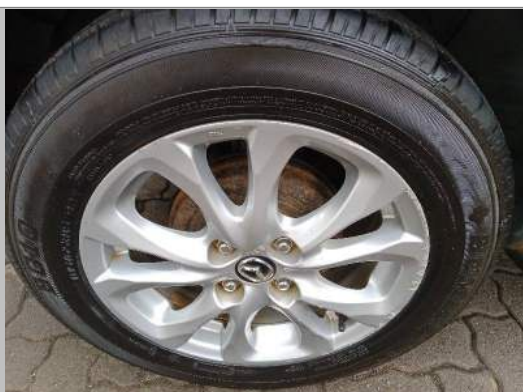
| Rim Rear Right Scratched | Repair |

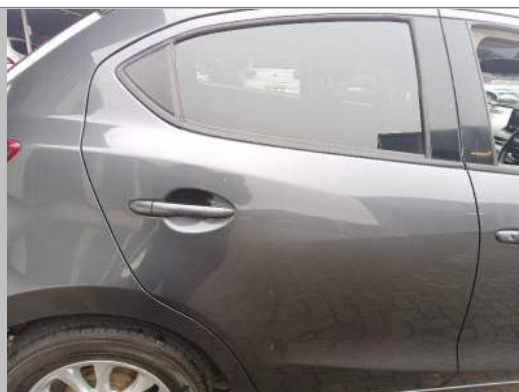
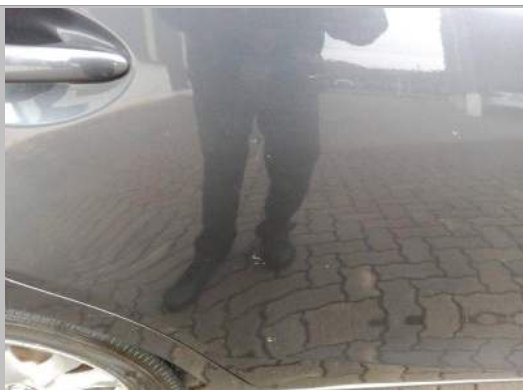
| Door Rear Right Paintwork • Scratched | Repair |

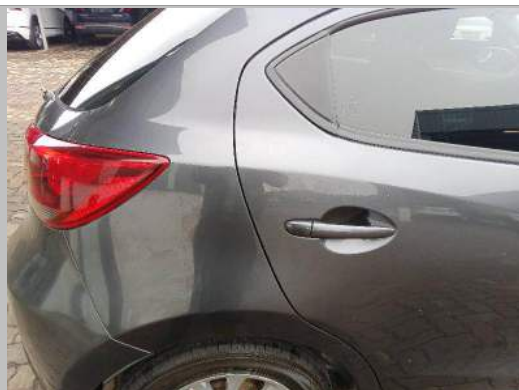
| Rear Fender Right Defective | Repair |

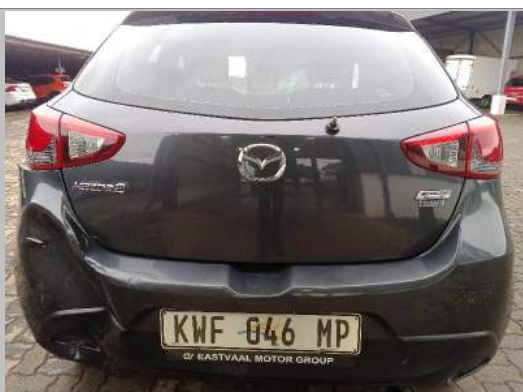
| Rear bumper Damaged | Repair |

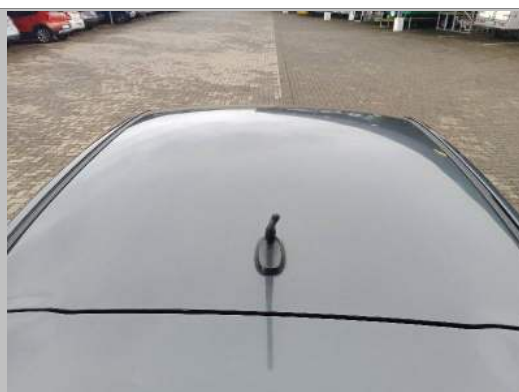
| Roof Dented | Repair |

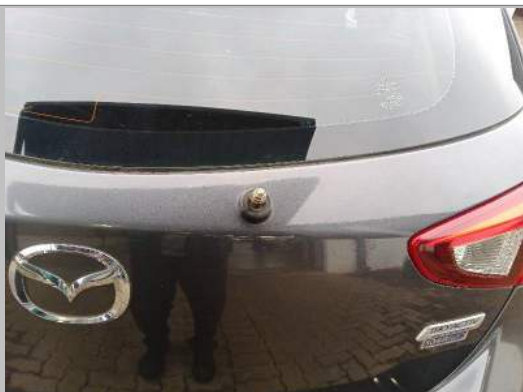
| Windscreen Wiper Missing | Replace |

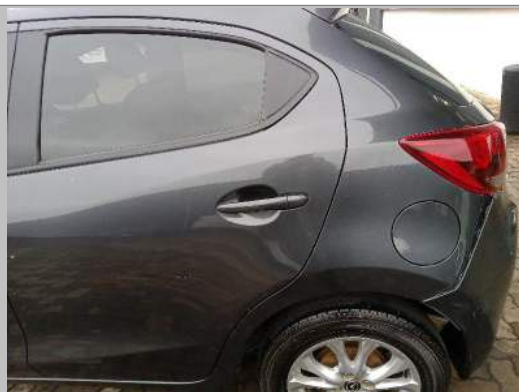
| Rear Fender Left Damaged | Repair |

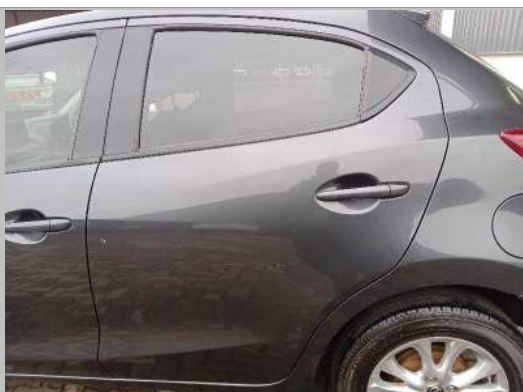
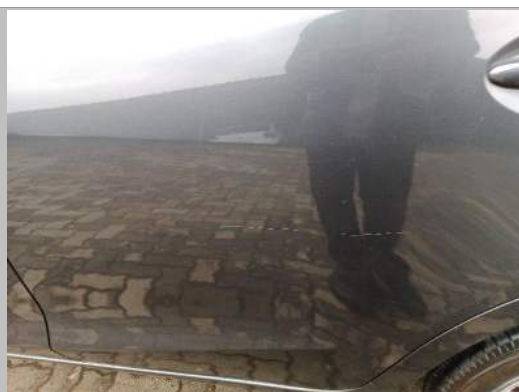
| Door Rear Left Paintwork • Scratched | Repair |

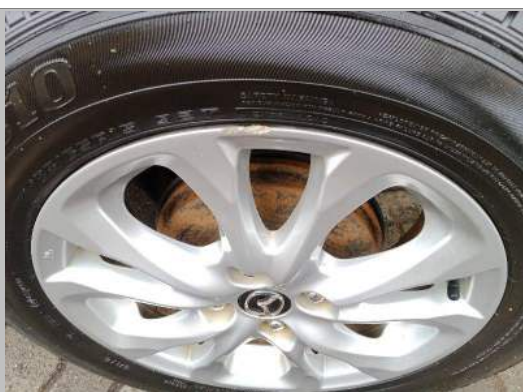
| Rim Rear Left Scratched | Repair |

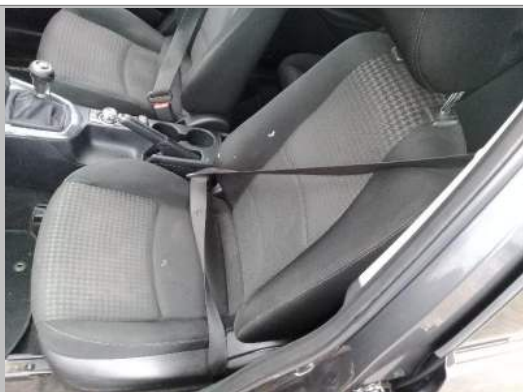
| Seat Front Left Dirty | Repair |

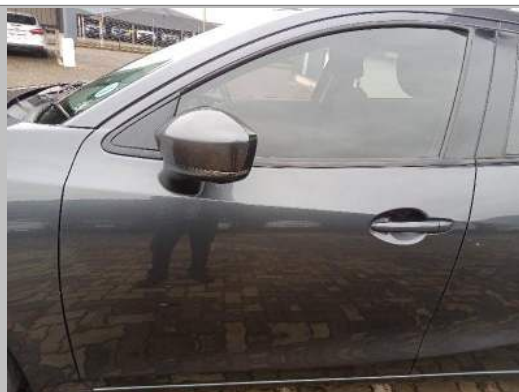
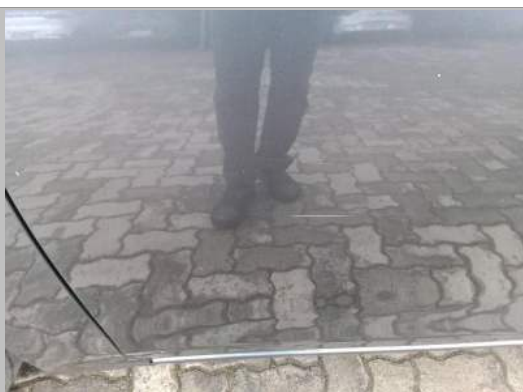
| Door Front Left Paintwork • Scratched | Repair |

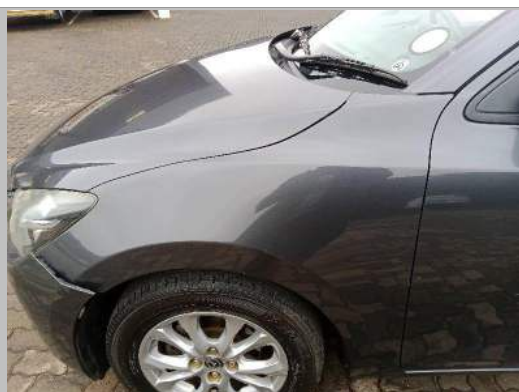
| Front Fender Left Damaged | Repair |

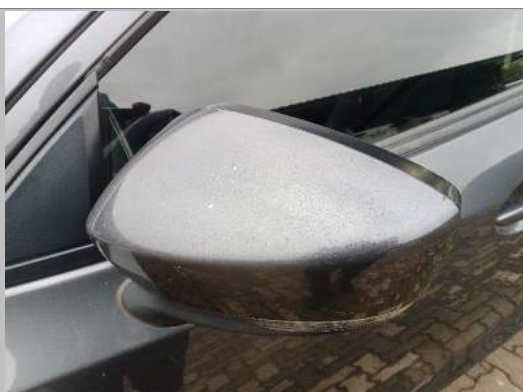
| Side Mirror Left Paintwork • Chipmarks | Repair |

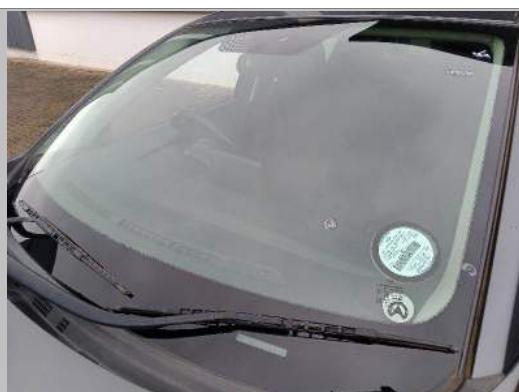
| Windscreen Damaged | Replace |

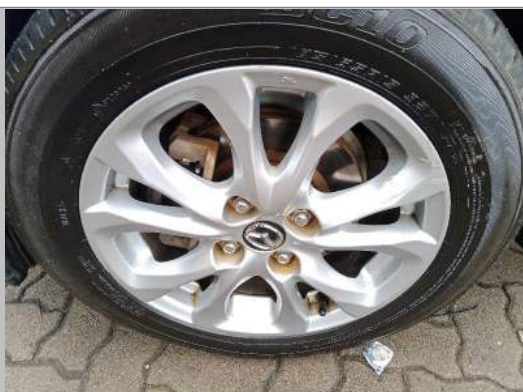
| Rim Front Left Scratched | Repair |

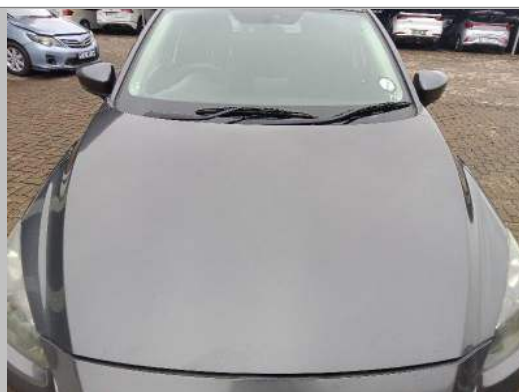
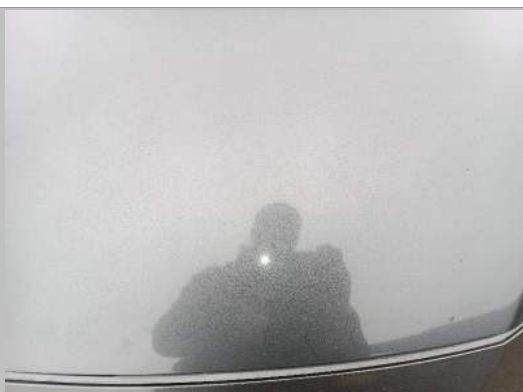
| Bonnet Paintwork • Chipmarks | Repair |

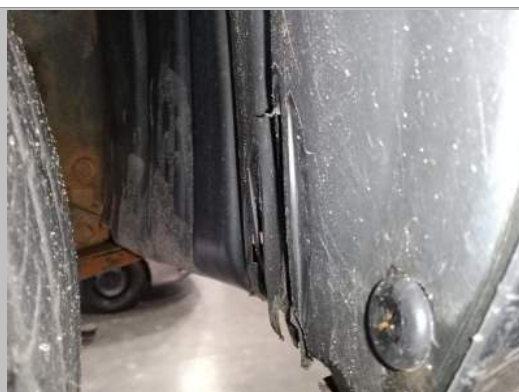
| Front Fender Right / Inner Tray Damaged | Replace |

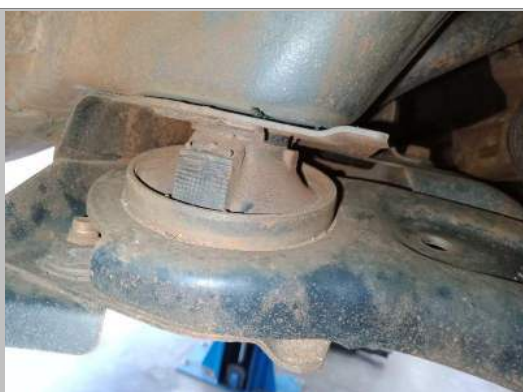
| Control Arm Bush(es) Front Axle Right Cracked | Replace |

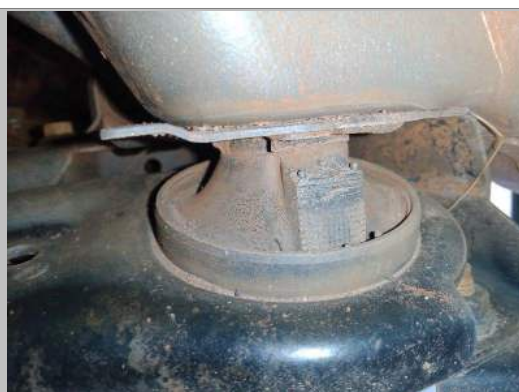
| Control Arm Bush(es) Front Axle Left Cracked | Replace |

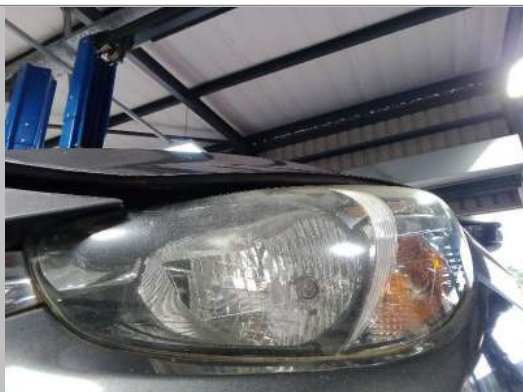
| Headlight Left Defective | Repair |
| Front left and right headlight lenses faded | Repair |

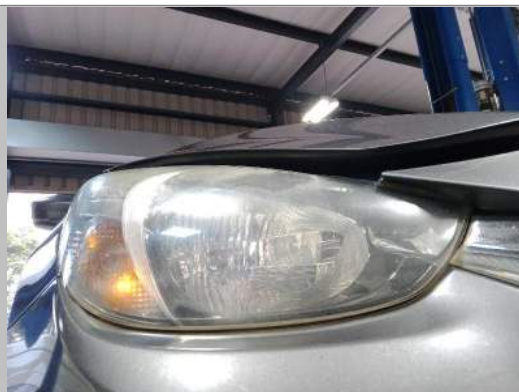
| Headlight Right Defective | Repair |

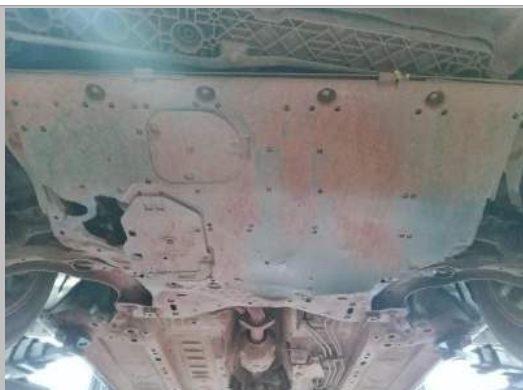
| Belly plates Damaged | Replace |

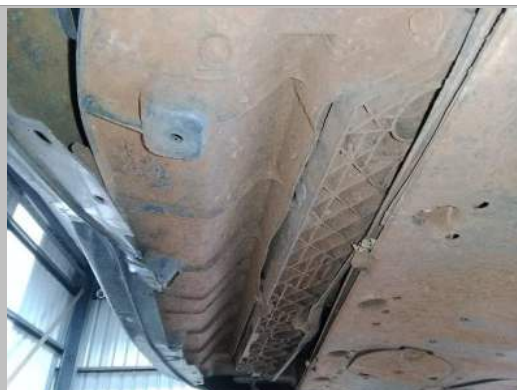
| Radiator Cradle Damaged | Replace |

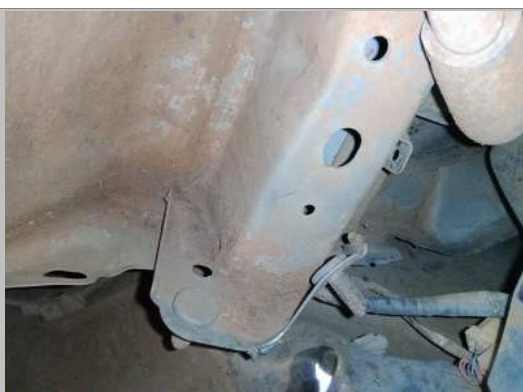
| Main Beam Left Damaged | Repair |

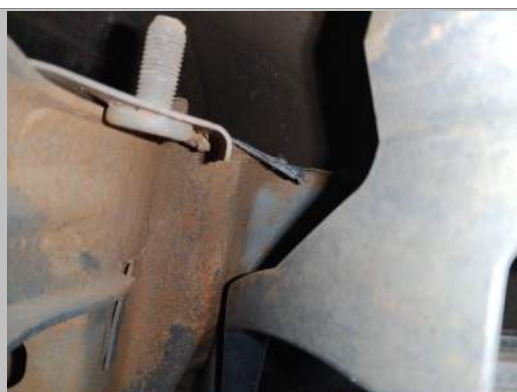
| Rear Fender Right / Inner Tray Dented | Repair |

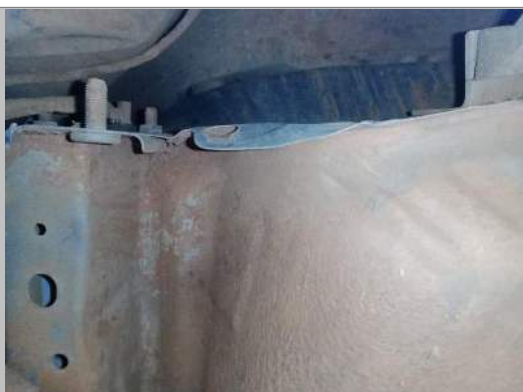
| Inner Boot Floor Pan and Spare Wheel Well Damaged | Repair |

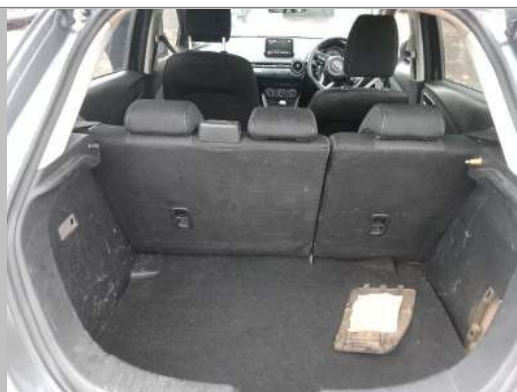
| Parcel Tray Missing | Replace |

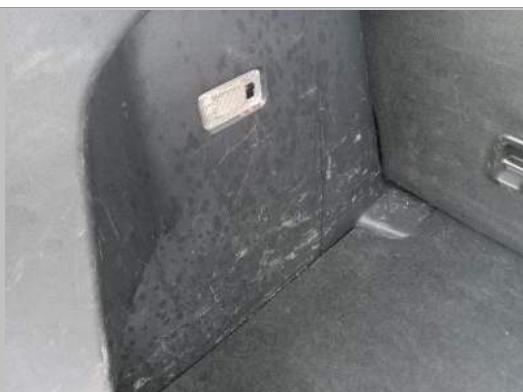
| Boot Panel Left Damaged | Repair |

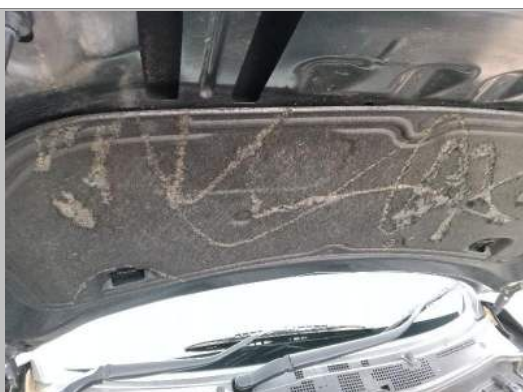
| Under bonnet insulation cover Damaged | Repair |

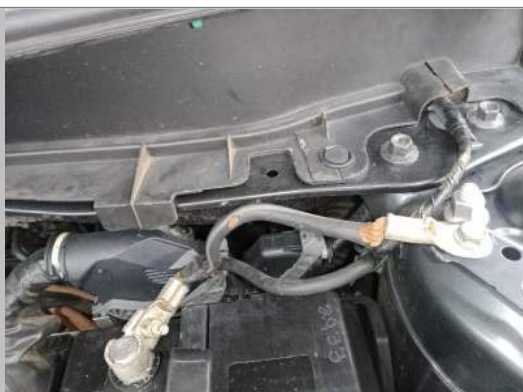
| Engine Wiring Damaged | Repair |

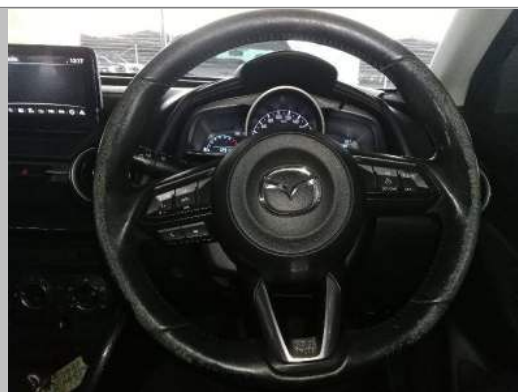
| Steering Wheel Trim Excessive Wear & Tear | Repair |
