## CONDITION REPORT

Report No: 2016210047

MFC Auction House  
M57 Pretoria Rd, Glenmarais, KEMPTON PARK  
Gauteng

Vehicle Type	PASSENGER VEHICLE	Registered Owner	MFC
Manufacturer	FORD	Registration Number	BS10CPGP
Model	FIESTA	Register Number	
VIN	MNBJXXARJJBT62953	Date Of First Licensing	
Engine Number		Last COR	
Doors	5	License Expiry Date	31/03/2023
Color	WHITE	Power / Displacement	
Year Model		Paint Finish	TWO COAT UNI
Km Reading	174,248 KM	Fuel	PETROL
Cab / Body Type	HATCHBACK	Transmission	MANUAL

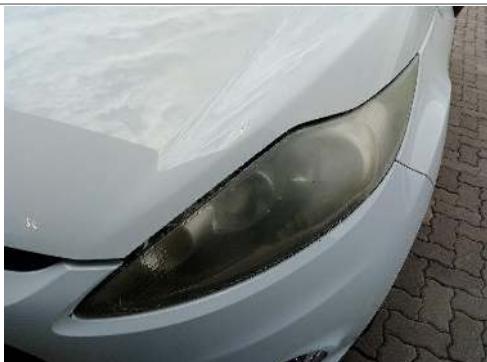
Damage	Repair Way
Engine Oil Sweat	Repair
Engine Wiring Defective	Repair
Expansion Bottle Defective	Replace
Windscreen Wiper Defective	Replace
Tail Light Left Cracked	Replace
Tail Light Right Defective	Repair
Headlight Left Damaged	Replace
Headlight Right Damaged	Replace
Seat Front Left Dirty	Repair
Seat Front Right Damaged	Repair
Seat Rear Dirty	Repair
Hood Lining Defective	Repair
Door Handle Rear Right Defective	Repair
Parcel Tray Damaged	Repair
Steering Wheel Trim Defective	Repair
Front Bumper Paintwork • Scratched	Repair
Rear Fender Right Paintwork • Scratched	Repair
Door Front Left Paintwork • Scratched	Repair
Door Front Right Dented	Repair
Door Rear Left Paintwork • Scratched	Repair
Door Rear Right Dented	Repair
Rear bumper Paintwork • Scratched	Repair
Inner Boot Floor Pan and Spare Wheel Well Paintwork • Scratched	Repair
Windscreen Chipped	Repair
Shock Absorber Rear Left Leak	Replace
Shock Absorber Rear Right Leak	Replace

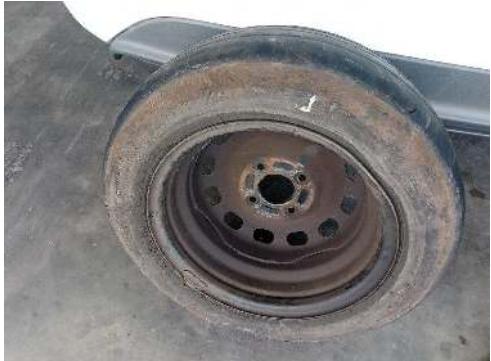
Damage	Repair Way
Tyre Front Right Worn	Replace
Spare Tyre Damaged	Replace
Rim Front Right Dented	Repair
Rim Spare Wheel Dented	Repair
Main Beam Right Defective	Repair
Chassis Scratched	Repair
Cross Member Front Right Damaged	Repair
Gearbox Mountings Cracked	Replace
Gearbox Oil Sweat	Repair
Engine Noise Excessive	Repair
Wheel Spanner Missing	Replace

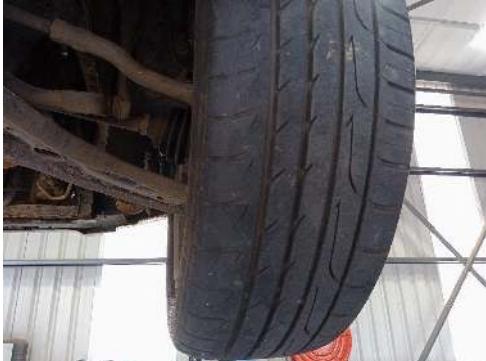
Tyre Front Right

Tyres and Rims: Alloy rims scratched. Front right tyre has flat spots.

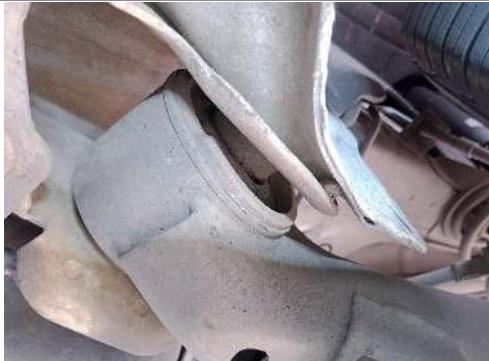
Mounting Rubber(s) Rear Axle Left Cracked	Replace
Mounting Rubber(s) Rear Axle Right Cracked	Replace
