## CONDITION REPORT

Report No:  
2017294297  
DATE  
04/09/2026

| Manufacturer | NISSAN | Registration Number | JZP592EC |
| Model | NAVARA 2.3 LE D-CAB DSL 4X4 PU [2017-2019] | Register Number | |

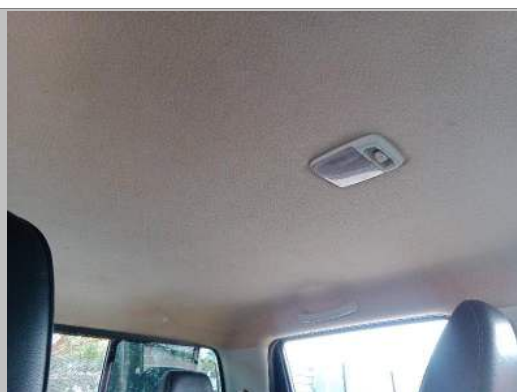
| Damage | Repair Way |
|---|---|
| Hood Lining Dirty | Repair |

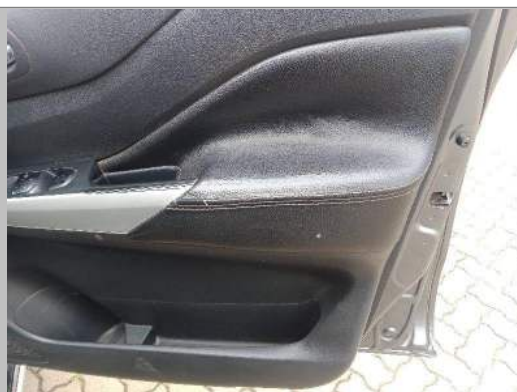
| Damage | Repair Way |
|---|---|
| Door Panel Front Right Damaged | Repair |

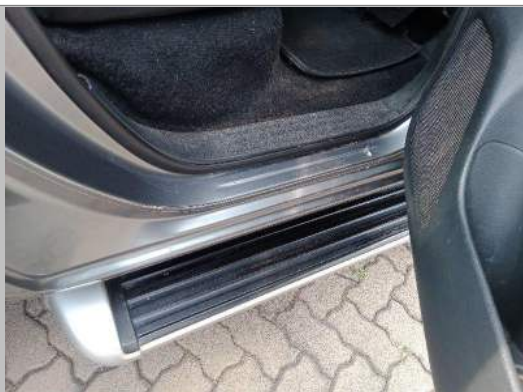
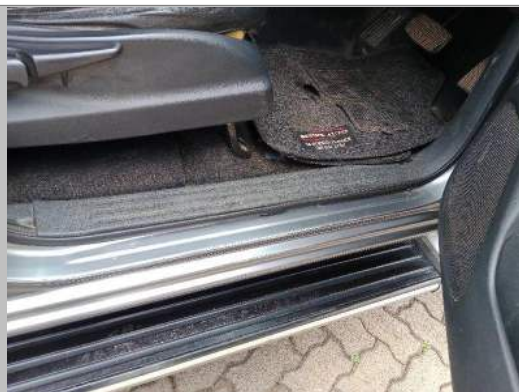
| Damage | Repair Way |
|---|---|
| Sill Panel Right Paintwork • Scratched | Repair |

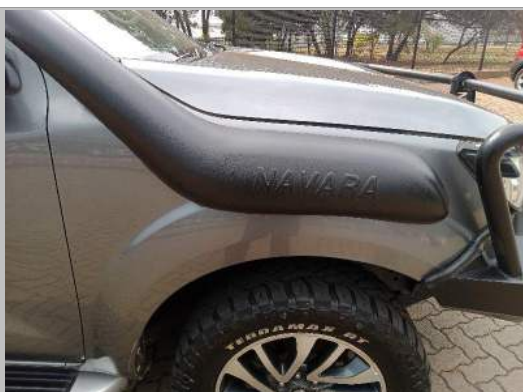
| Damage | Repair Way |
|---|---|
| Front Fender Right Damaged | Repair |

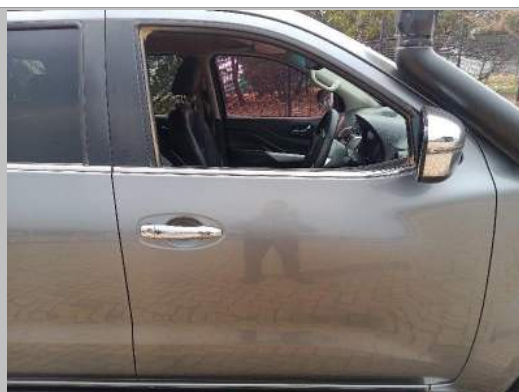
| Damage | Repair Way |
|---|---|
| Door Front Right Paintwork • Scratched | Repair |

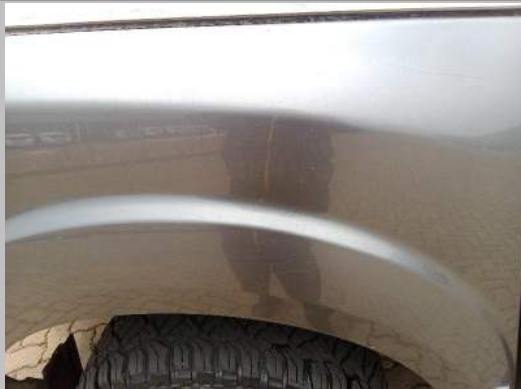
| Damage | Repair Way |
|---|---|
| Rear Fender Right Damaged | Repair |

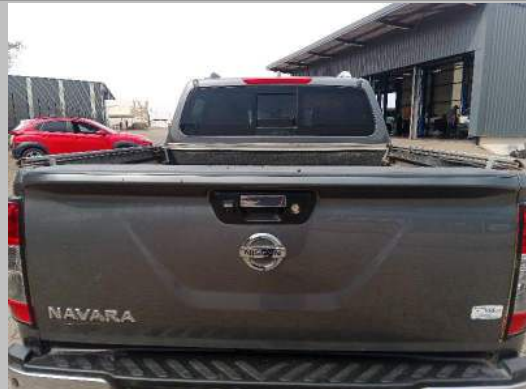
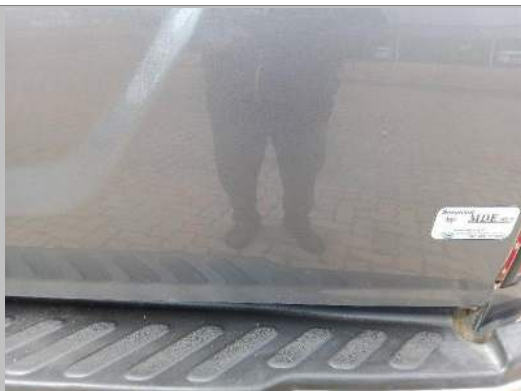
| Damage | Repair Way |
|---|---|
| Tailgate Damaged | Repair |

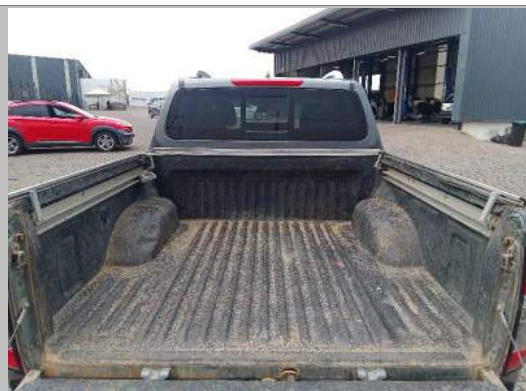
| Damage | Repair Way |
|---|---|
| Load Body Damaged | Repair |

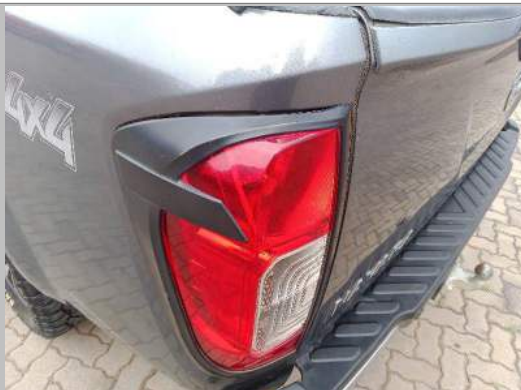
| Damage | Repair Way |
|---|---|
| Tail Light Left Defective | Repair |

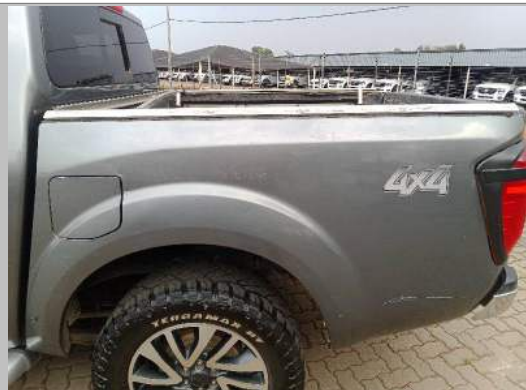
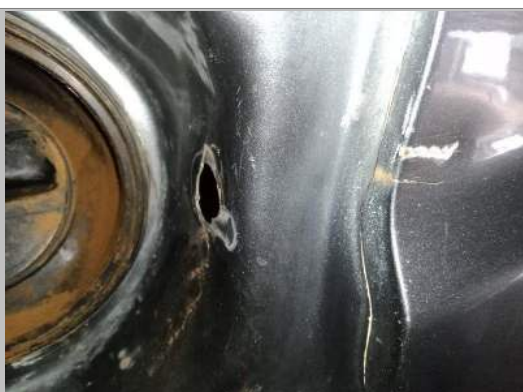
| Damage | Repair Way |
|---|---|
| Rear Fender Left Damaged | Repair |

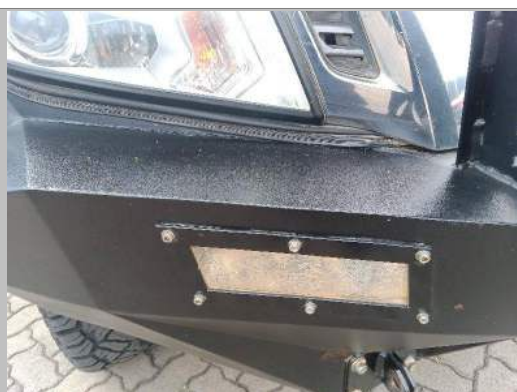
| Damage | Repair Way |
|---|---|
| Fog Light Front Right Damaged | Replace |

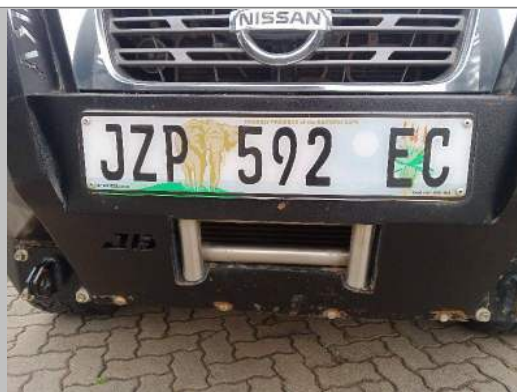
| Damage | Repair Way |
|---|---|
| Front Bumper Paintwork • Scratched | Repair |

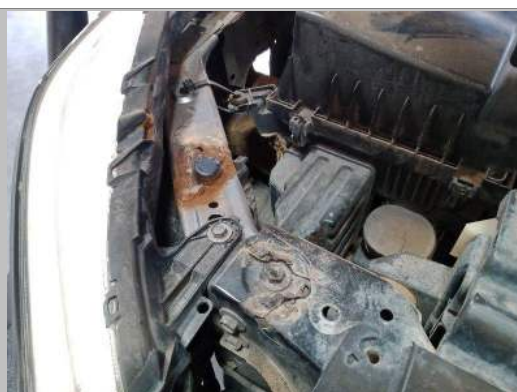
| Damage | Repair Way |
|---|---|
| Bonnet slam plate (Shock tower/ Inner tray) Welded | Replace |

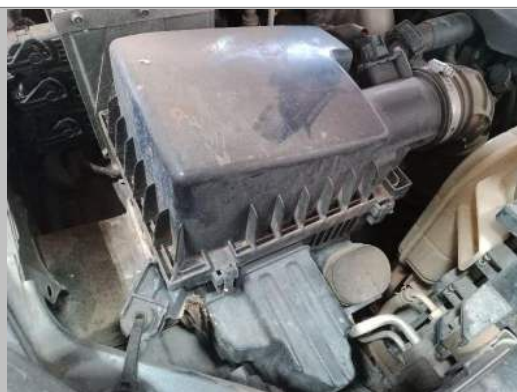
| Damage | Repair Way |
|---|---|
| Air cleaner Damaged | Replace |

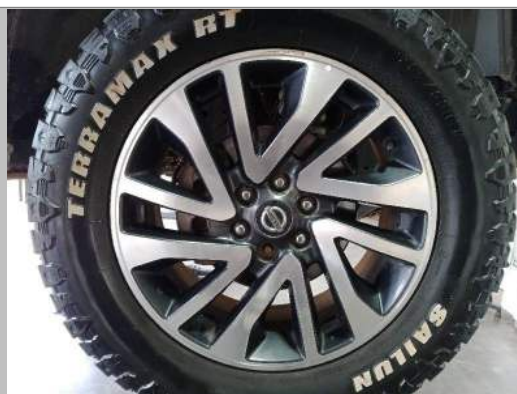
| Damage | Repair Way |
|---|---|
| Rim Front Right Scratched | Repair |

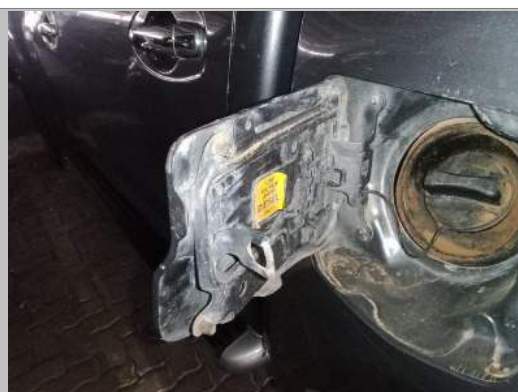
| Damage | Repair Way |
|---|---|
| Fuel Flap Damaged | Repair |
