MFC Auction House  
M57 Pretoria Rd, Glenmarais, KEMPTON PARK  
Gauteng

| Manufacturer | TOYOTA | Registration Number | FYK681L |

## CONDITION REPORT

Report No: 2016348420

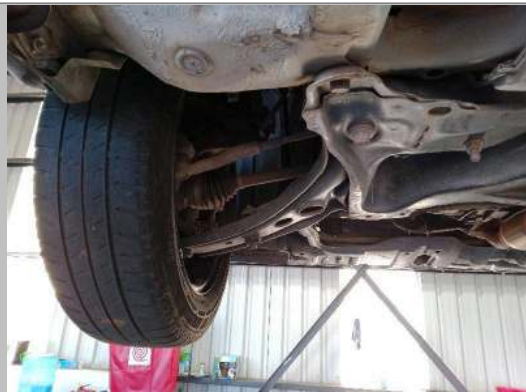
LF TYRE TREAD

| | Size | Load/Speed Index | Manufacture | Model | Type* | Production Date | Tread Depth (mm) |
|---|---|---|---|---|---|---|---|
| Front Left | 185/60R15 | 84H | Bridgestone | Radial | V | 1217 | 1 mm |

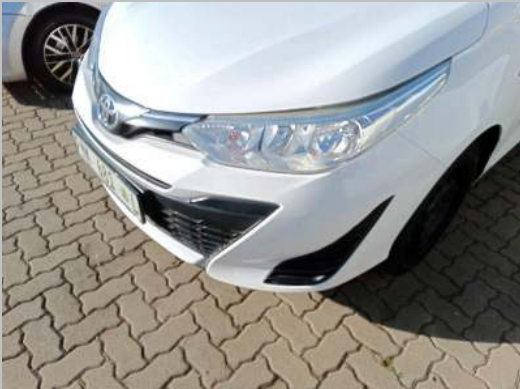
| Damage | Repair Way |
|---|---|
| Front Bumper Damaged | Repair |

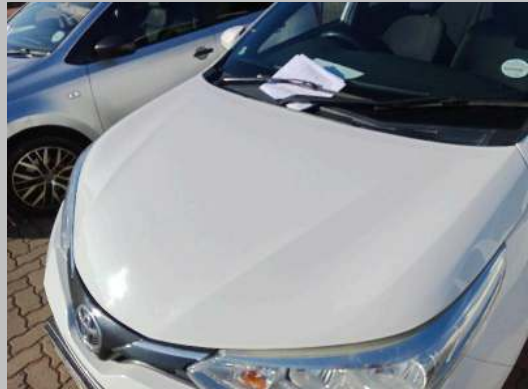
| Damage | Repair Way |
|---|---|
| Bonnet Damaged | Repair |

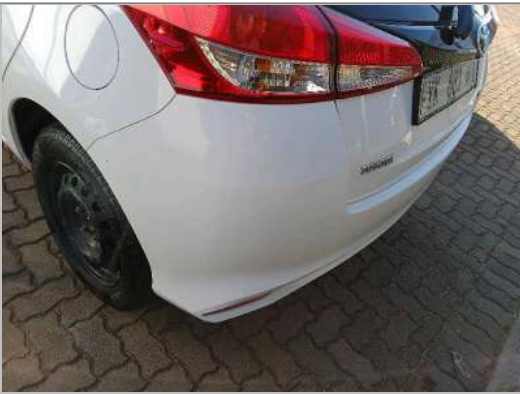
| Damage | Repair Way |
|---|---|
| Rear bumper Damaged | Repair |

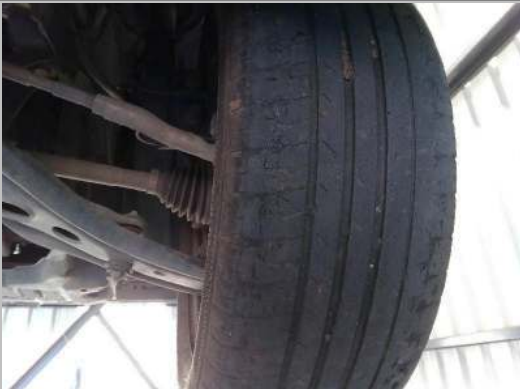
| Damage | Repair Way |
|---|---|
| Tyre Front Right Worn | Replace |

| | Size | Load/Speed Index | Manufacture | Model | Type* | Production Date | Tread Depth (mm) |
|---|---|---|---|---|---|---|---|
| Front Right | 185/60R15 | 88H | Kapsen | Radial | V | 3719 | 0 mm |

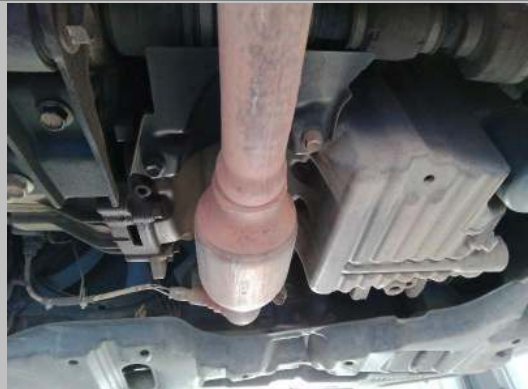
| Damage | Repair Way |
|---|---|
| Engine Oil Sweat | Repair |
