## CONDITION REPORT

Report No:  
2017304198  
DATE  
30/09/2026

| Manufacturer | HONDA | Registration Number | KW40TGGP |
| Model | BALLADE 1.5 COMFORT AT [2011-2014] | Register Number | |

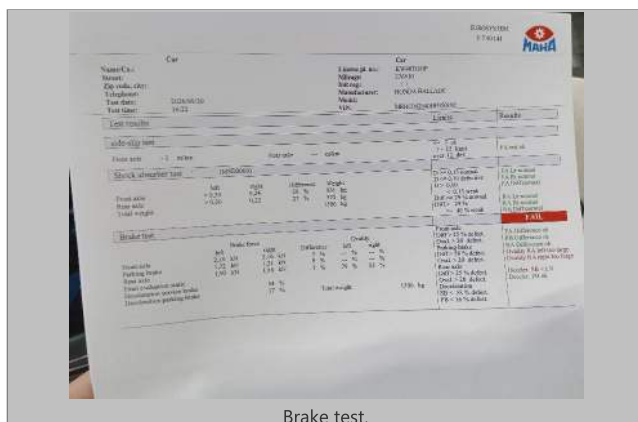
### Brake test.

## Brake Test Results

| | Left | Right | | |
|---|---|---|---|---|
| Front | 2.1 | 2.16 | - | |
| Rear | 1.9 | 1.88 | - | |
| Emergency / Parking | 1.32 | 1.21 | - | |

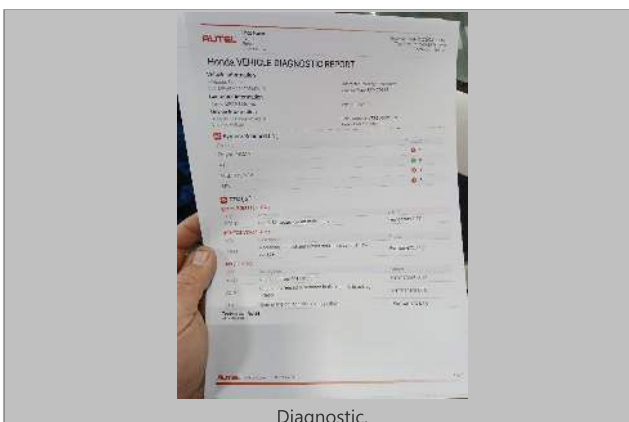
Diagnostic.

| No | System | Code | Description | Status |
|---|---|---|---|---|
| 1 | SRS | 85-61 | NO SIGNAL FROM THE ODS UNIT | PERMANENT DTC |

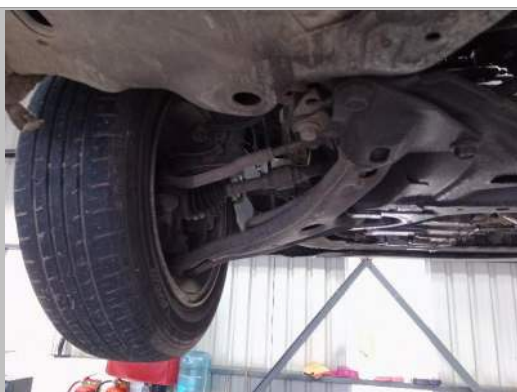
LF TYRE TREAD

| | Size | Load/Speed Index | Manufacture | Model | Type* | Production Date | Tread Depth (mm) |
|---|---|---|---|---|---|---|---|
| Front Left | 175/65R15 | 84H | Durun | Radial | V | 4523 | 0 mm |

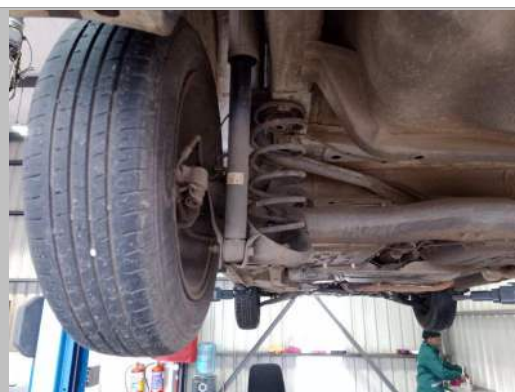
LR TYRE TREAD

| | Size | Load/Speed Index | Manufacture | Model | Type* | Production Date | Tread Depth (mm) |
|---|---|---|---|---|---|---|---|
| Rear Left | 175/65R15 | 84H | Durun | Radial | V | 4523 | 1 mm |

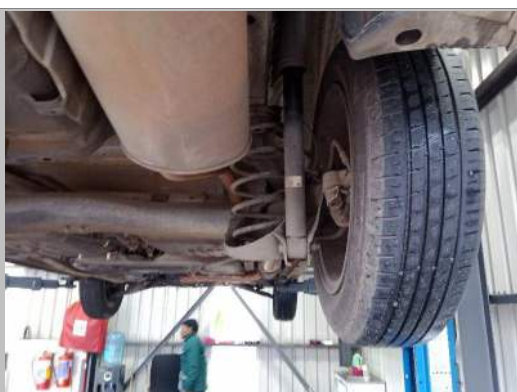
RR TYRE TREAD

| | Size | Load/Speed Index | Manufacture | Model | Type* | Production Date | Tread Depth (mm) |
|---|---|---|---|---|---|---|---|
| Rear Right | 175/65R15 | 84H | Durun | Radial | V | 4523 | 2 mm |

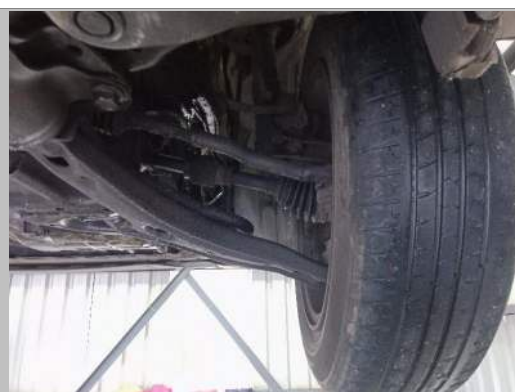
RF TYRE TREAD

| | Size | Load/Speed Index | Manufacture | Model | Type* | Production Date | Tread Depth (mm) |
|---|---|---|---|---|---|---|---|
| Front Right | 175/65R15 | 84H | Durun | Radial | V | 4523 | 0 mm |

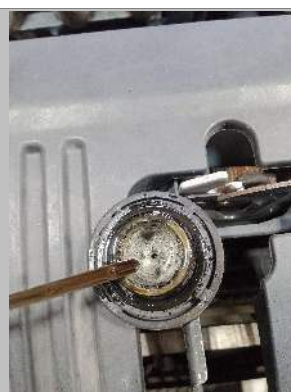
General Comments: ACCORDING TO THE AGE AND MILEAGE OF THE VEHICLE, NORMAL WEAR AND TEAR MARKS ARE VISIBLE ON THE INTERIOR, EXTERIOR, ELECTRICAL AND MECHANICAL PARTS. Engine Compartment: Foreign substance on oil filler cap. vehicle has a excessive oil leak. Battery loose. Electrical Components and Instruments: vehicle struggles to start. vehicle electronics malfunctioning.

Oil cap and dipstick.

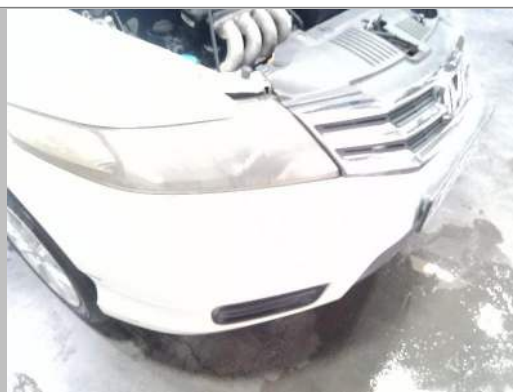
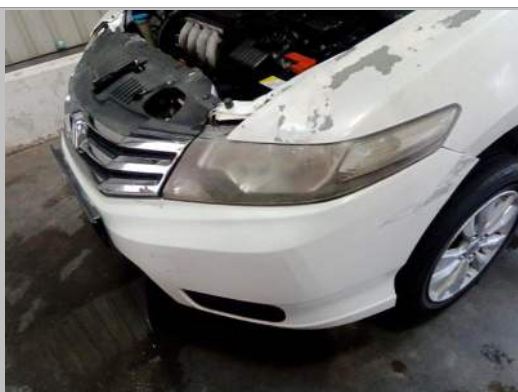
| Front Bumper Damaged | Repair |

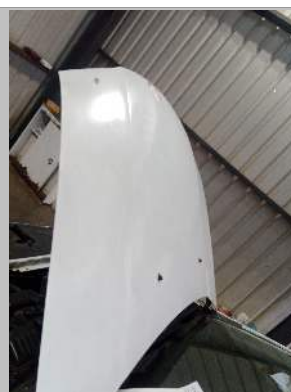
| Bonnet Damaged | Repair |

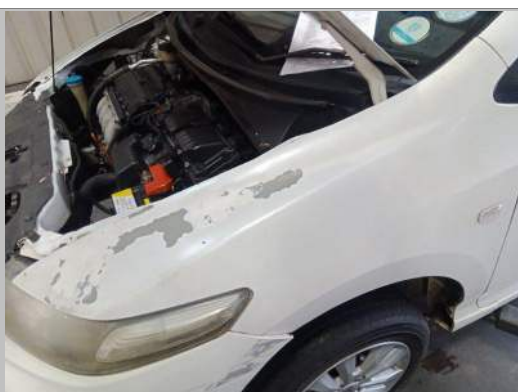
| Front Fender Left Damaged | Repair |

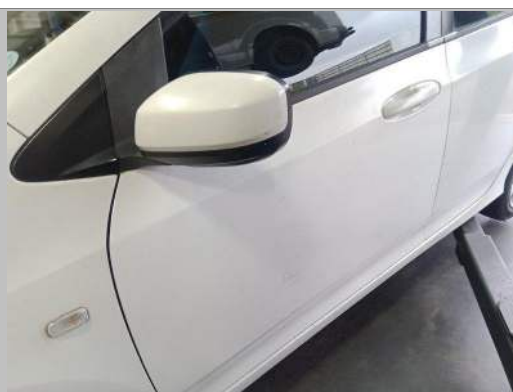
| Door Front Left Damaged | Repair |

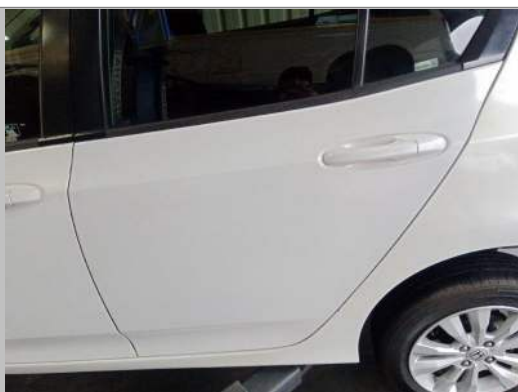
| Door Rear Left Damaged | Repair |

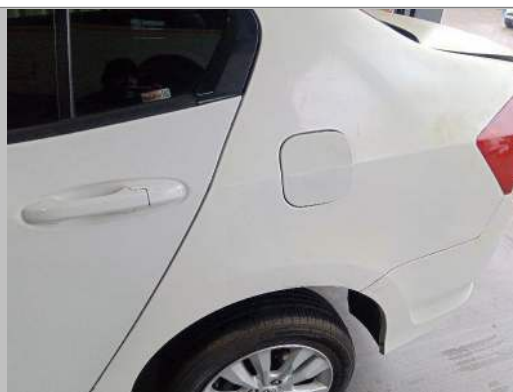
| Rear Fender Left Damaged | Repair |

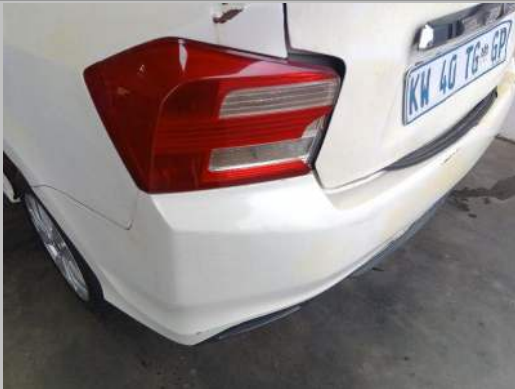
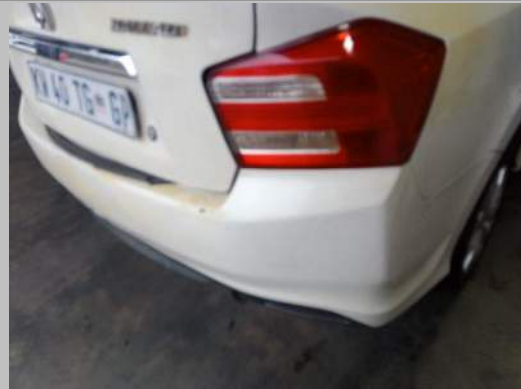
| Rear bumper Damaged | Repair |

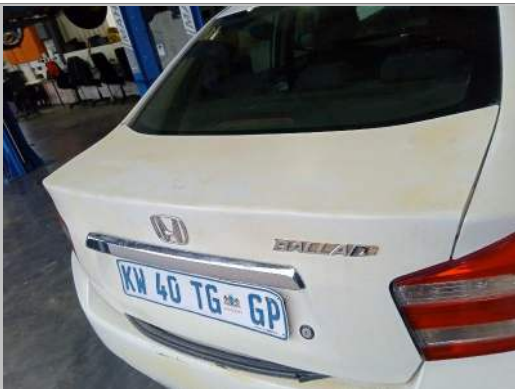
| Boot Lid / Hatch door Damaged | Repair |

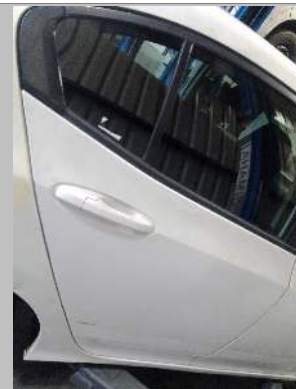
| Door Rear Right Damaged | Repair |

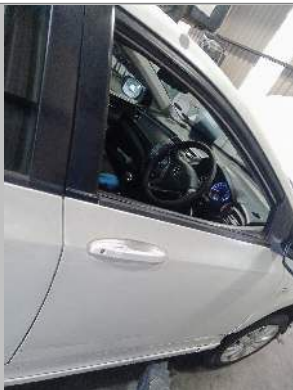
| Door Front Right Damaged | Repair |

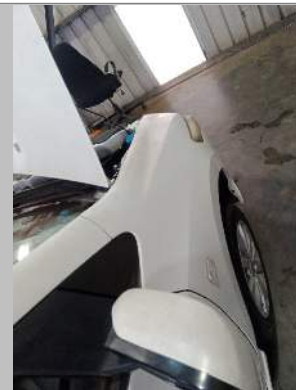
| Front Fender Right Damaged | Repair |

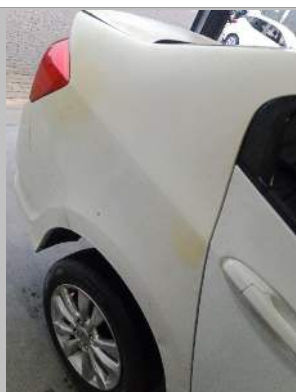
| Rear Fender Right Damaged | Repair |

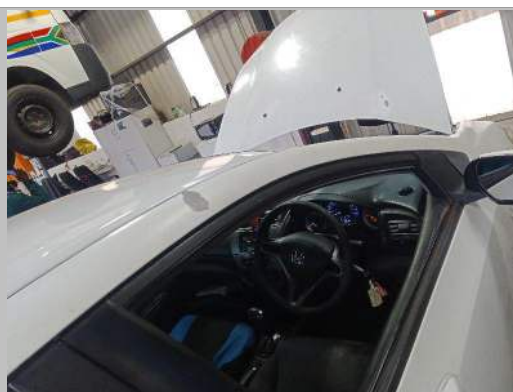
| A • Pillar Right Damaged | Repair |

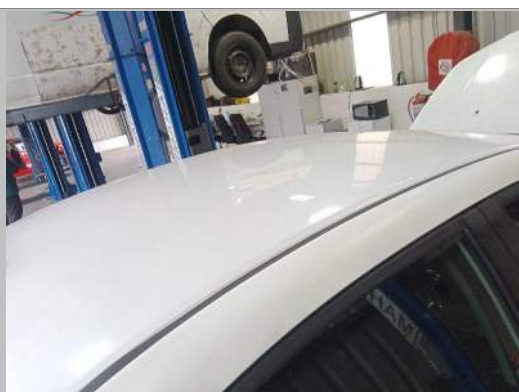
| Roof Damaged | Repair |

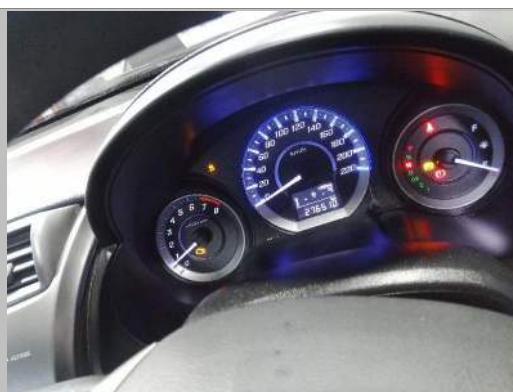
| Engine Management Lights Set | Repair |

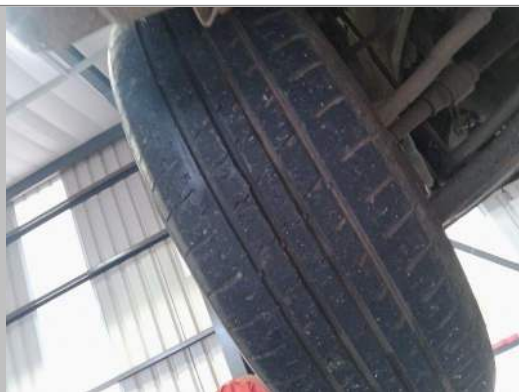
| Tyre Front Left Worn | Replace |

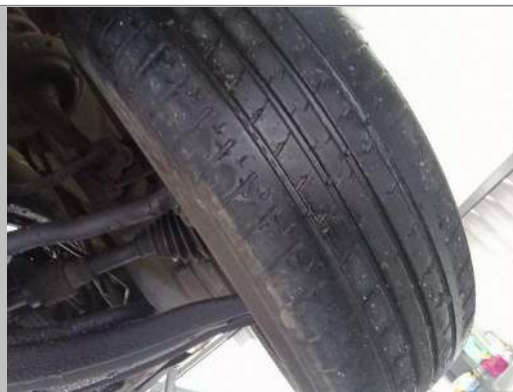
| Tyre Front Right Worn | Replace |

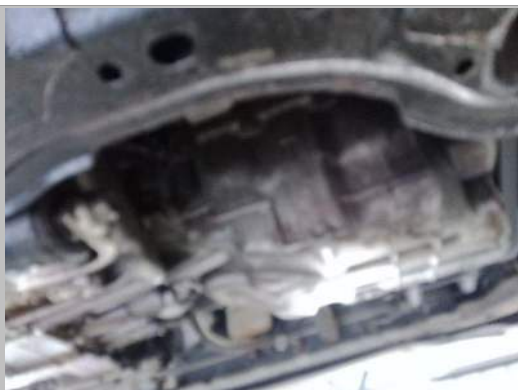
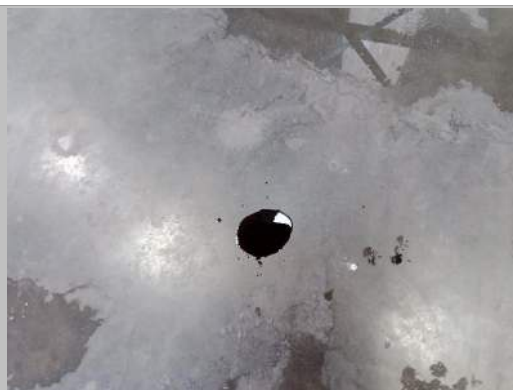
| Engine Oil Leak | Repair |
| Engine Performance Insufficient | Repair |
| Engine Noise Idling / Hunting | Repair |

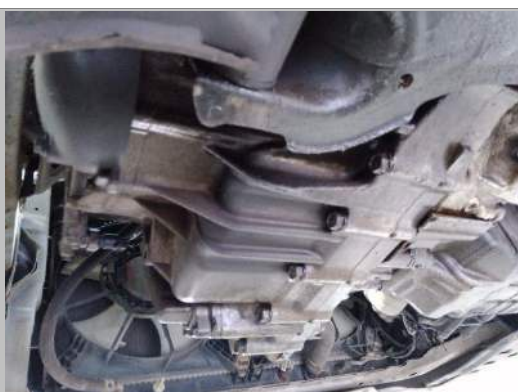
| Gearbox Oil Leak | Repair |

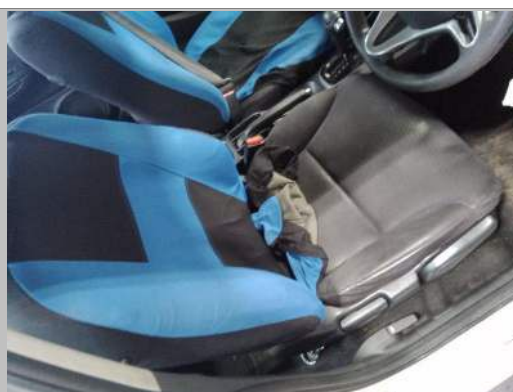
| Seat Front Right Damaged | Repair |

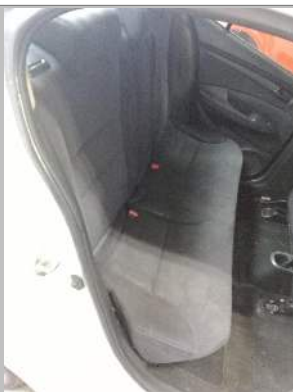
| Seat Rear Damaged | Replace |

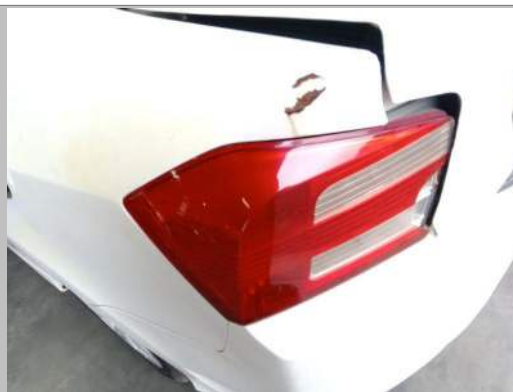
| Tail Light Left Damaged | Replace |

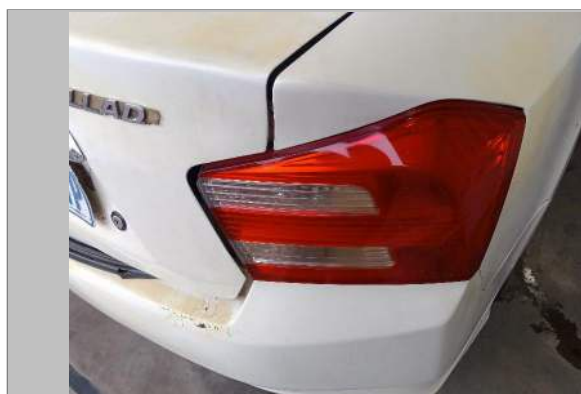
| Tail Light Right Damaged | Replace |
