CONDITION REPORT

Report No: 2016276249

MFC Auction House
M57 Pretoria Rd, Glenmarais, KEMPTON PARK
Gauteng

Vehicle Type	LIGHT LOAD VEHICLE	Registered Owner	MFC AUCTION HOUSE
Manufacturer	HONDA	Registration Number	HDH719MP
Model	CR-V	Register Number	
VIN	MRHRM1750EP000027	Date Of First Licensing	
Engine Number		Last COR	
Doors	5	License Expiry Date	31/08/2021
Color	BROWN	Power / Displacement	
Year Model		Paint Finish	TWO COAT METALLIC
Km Reading	43,303 KM	Fuel	PETROL
Cab / Body Type	STATION WAGON	Transmission	MANUAL

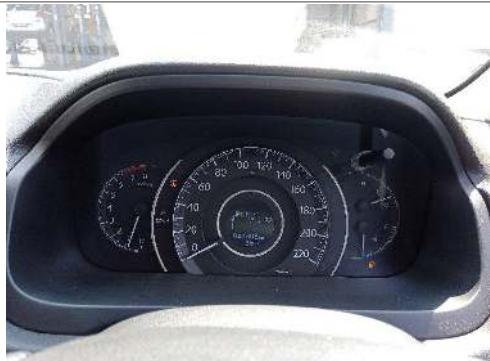
DASHBOARD (W/ ENGINE RUNNING)

Warning light illuminated on dashboard	Repair
Interior	Vehicle interior dirty.

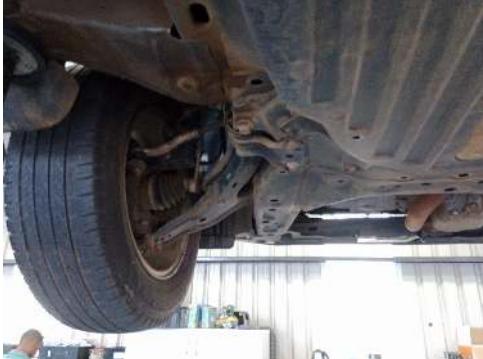
LF TYRE TREAD

Size	Load/Speed Index	Manufacture	Model	Type*	Production Date	Tread Depth (mm)
Front Left	225/65 R17	102T	Michelin	Latitude	V	0813	4 mm
Front Right	225/65 R17	102T	Michelin	Latitude	V	0813	4 mm
Rear Left	225/65 R17	102T	Michelin	Latitude	V	0813	5 mm
Rear Right	225/65 R17	102T	Michelin	Latitude	V	0813	5 mm
Spare	225/65 R17	102T	Michelin	Latitude	V	0000	6 mm

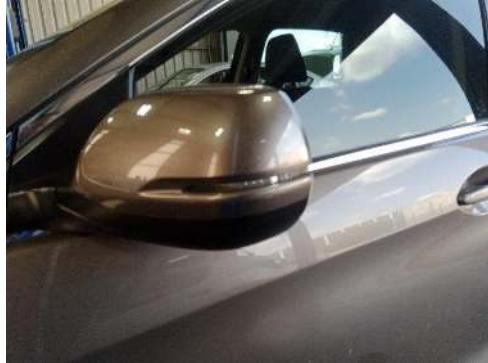
Damage	Repair Way
Headlight Left Scratched	Repair
Side Mirror Left Paintwork • Scratched	Repair
Front Bumper Paintwork • Scratched	Repair
Grill Paintwork • Scratched	Repair
Bonnet Paintwork • Scratched	Repair
Front Fender Left Paintwork • Scratched	Repair
Rear Fender Right Paintwork • Scratched	Repair
Door Front Left Paintwork • Scratched	Repair
Door Front Right Paintwork • Scratched	Repair
Door Rear Left Paintwork • Scratched	Repair
Door Rear Right Paintwork • Scratched	Repair
Rear bumper Paintwork • Scratched	Repair
Engine to silencer pipe Welded	Replace
Steering Malfunction	Repair
Body and Exterior	Dents and scratches on some body panels.
Body and Exterior	Some body panels misaligned
Body and Exterior	Spray work and stone chips on some body panels.
Undercarriage	Vehicle undercarriage dirty
Tyres and Rims	Alloy rims scratched.
Engine	Engine bay dirty. Brake fluid level ok.
Electrical components and Instruments	Vehicle electronics malfunctioning
