MFC Auction House
M57 Pretoria Rd, Glenmarais, KEMPTON PARK
Gauteng

Vehicle Type	PASSENGER VEHICLE	Registered Owner	MFC AUCTION HOUSE
Manufacturer	KIA	Registration Number	JV51KSGP
Model	SELTOS	Register Number	
VIN	MZBER814MMN160539	Date Of First Licensing	
Engine Number		Last COR	
Doors	5	License Expiry Date	
Color	BLUE	Power / Displacement	
Year Model		Paint Finish	M - METALLIC
Km Reading	114,863 KM	Fuel	PETROL
Cab / Body Type	HATCHBACK	Transmission	AUTOMATIC

VEHICLE INSPECTION

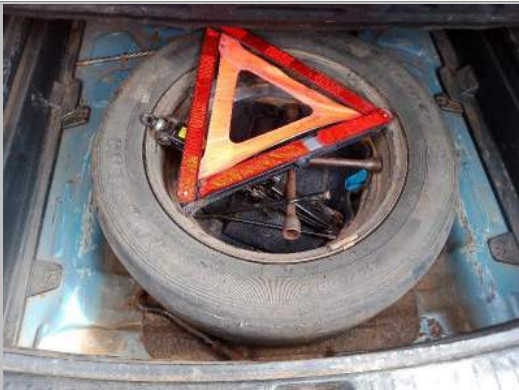
Spare wheel

Size	Load/Speed Index	Manufacture	Model	Type*	Production Date	Tread Depth (mm)
Front Left	215/60R17	96H	Goodyear	Assurance	V	3721	3 mm
Front Right	215/60R17	96H	Goodyear	Assurance	V	3720	3 mm
Rear Left	215/60R17	96H	Dunlop	Sp sport	V	1221	2 mm
Rear Right	215/60R17	96H	Bridgestone	Turanza	V	4215	3 mm
Spare	215/60R17	96H	Goodyear	Assurance	V	3620	0 mm

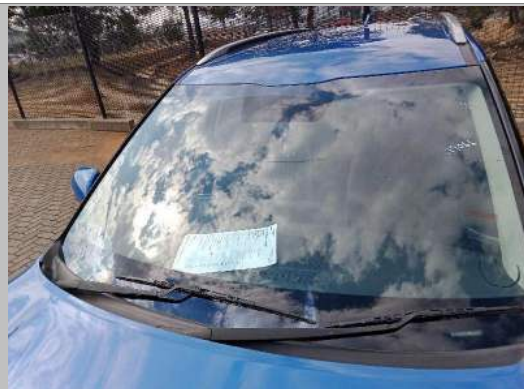
LICENSE DISC MISSING

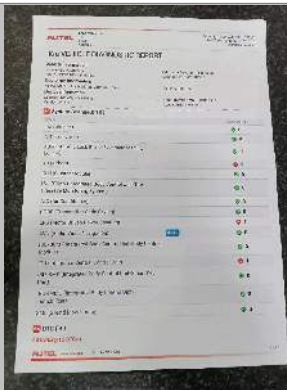
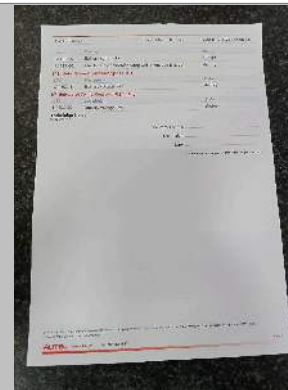
No	System	Code	Description	Status
1	HISTORY	B2617:00	CLUSTER AIRBAG WARNING LAMP CAN MESSAGE TIME OUT

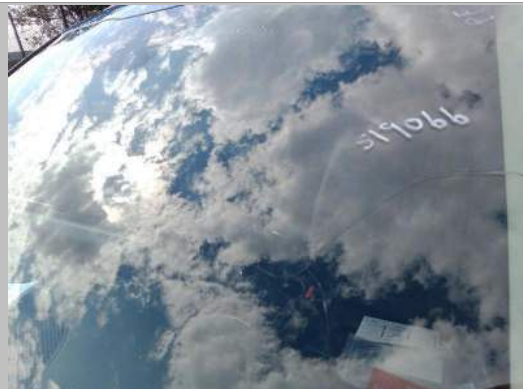
Damage	Repair Way
Parcel Tray Missing	Repair
Front Bumper Paintwork • Scratched	Repair
Front Fender Left Paintwork • Scratched	Repair
Front Fender Right Paintwork • Scratched	Repair
Rear Fender Left Dented	Repair
Rear Fender Right Dented	Repair
Door Front Left Paintwork • Chipmarks	Repair
Door Rear Left Paintwork • Scratched	Repair
Door Rear Right Paintwork • Scratched	Repair
Boot Lid / Hatch door Dented	Repair
Rear bumper Paintwork • Scratched	Repair
Windscreen Cracked	Replace
Spare Tyre Excessive Wear & Tear	Replace
License disc missing	Replace
