## CONDITION REPORT

Report No:  
2017297100  
DATE  
10/09/2026

MFC Auction House  
M57 Pretoria Rd, Glenmarais, KEMPTON PARK  
Gauteng

| Manufacturer | KIA | Registration Number | LC02TZGP |

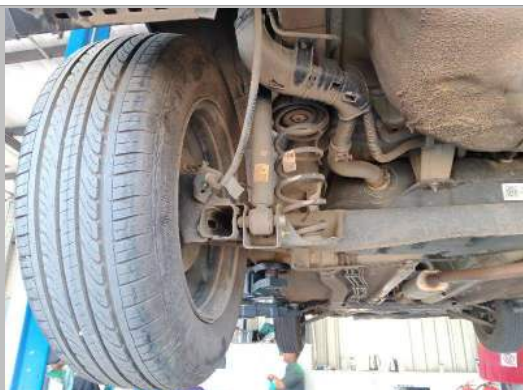
LR TYRE TREAD

| | Size | Load/Speed Index | Manufacture | Model | Type* | Production Date | Tread Depth (mm) |
|---|---|---|---|---|---|---|---|
| Rear Left | 195/65R15 | 91H | Goodyear | Assurance | V | 3722 | 3 mm |

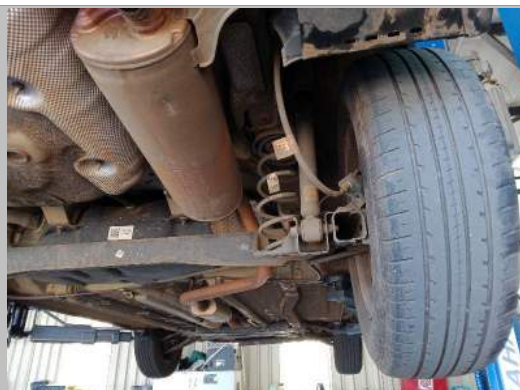
RR TYRE TREAD

| | Size | Load/Speed Index | Manufacture | Model | Type* | Production Date | Tread Depth (mm) |
|---|---|---|---|---|---|---|---|
| Rear Right | 195/65R15 | 91H | Goodyear | Assurance | V | 2322 | 1 mm |

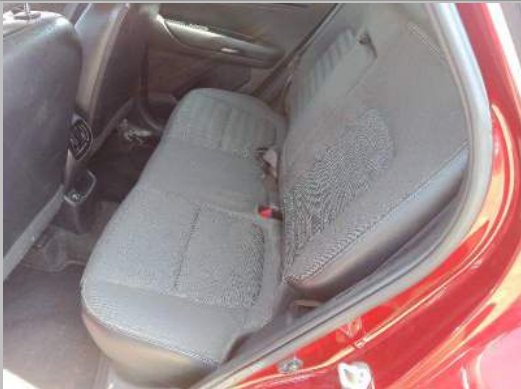
| Damage | Repair Way |
|---|---|
| Seat Rear Dirty | Repair |

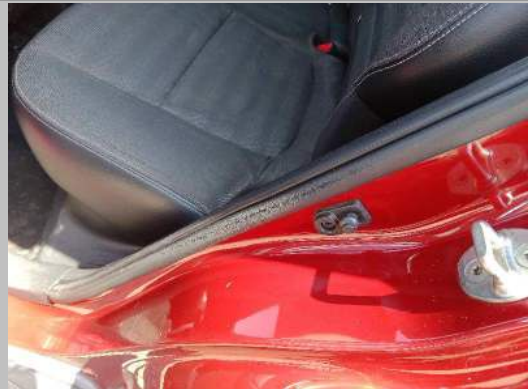
| Damage | Repair Way |
|---|---|
| Door Sealing Rubber Rear Left Damaged | Replace |

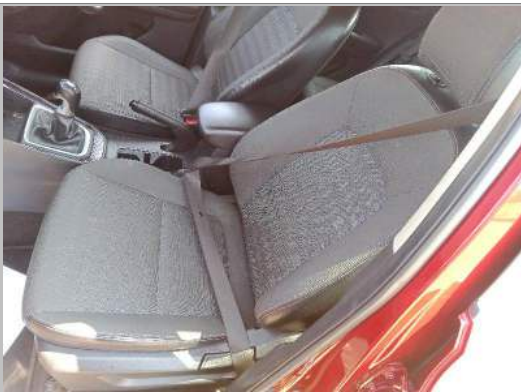
| Damage | Repair Way |
|---|---|
| Seat Front Left Dirty | Repair |

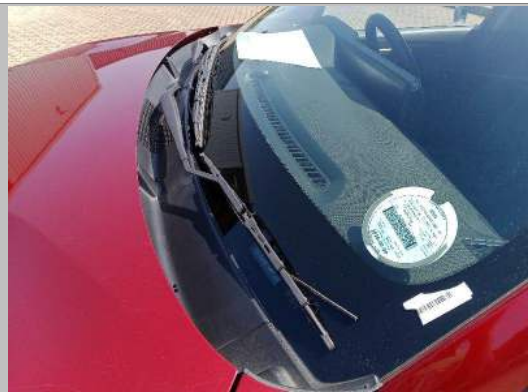
| Damage | Repair Way |
|---|---|
| Windscreen Wiper Damaged | Replace |

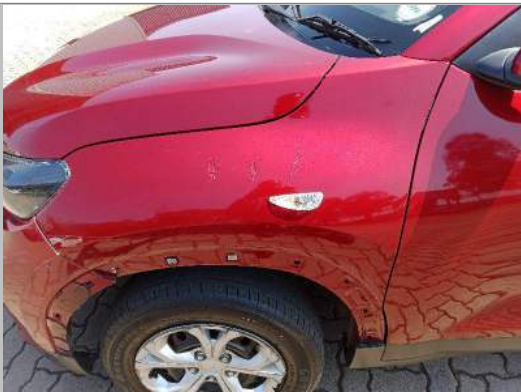
| Damage | Repair Way |
|---|---|
| Front Fender Left Damaged | Repair |

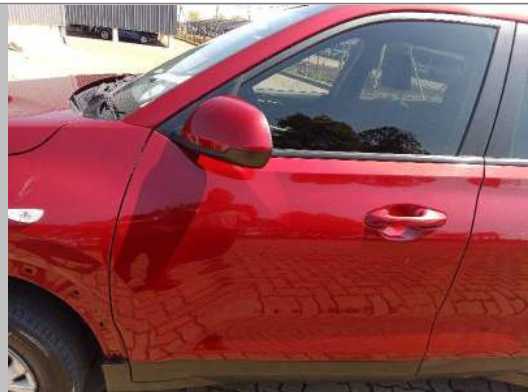
| Damage | Repair Way |
|---|---|
| Door Front Left Paintwork • Scratched | Repair |

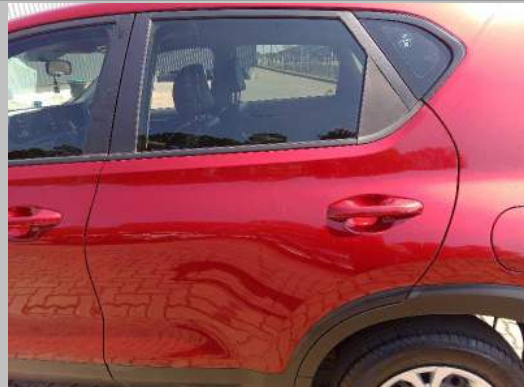
| Damage | Repair Way |
|---|---|
| Door Rear Left Paintwork • Scratched | Repair |

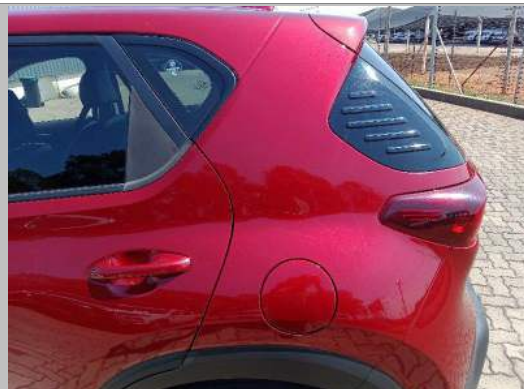
| Damage | Repair Way |
|---|---|
| Rear Fender Left Paintwork • Scratched | Repair |

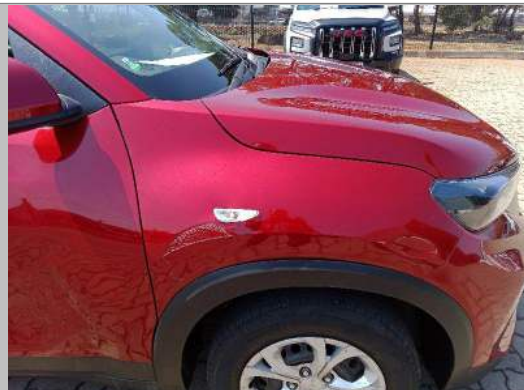
| Damage | Repair Way |
|---|---|
| Front Fender Right Damaged | Repair |

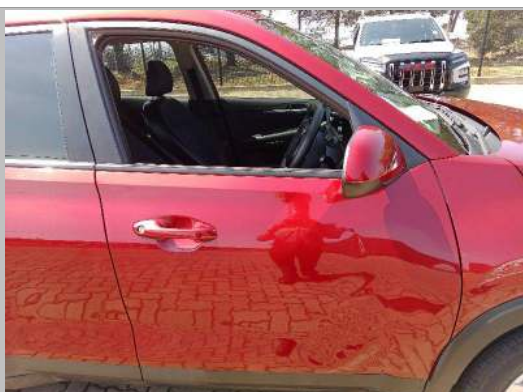
| Damage | Repair Way |
|---|---|
| Door Front Right Damaged | Repair |

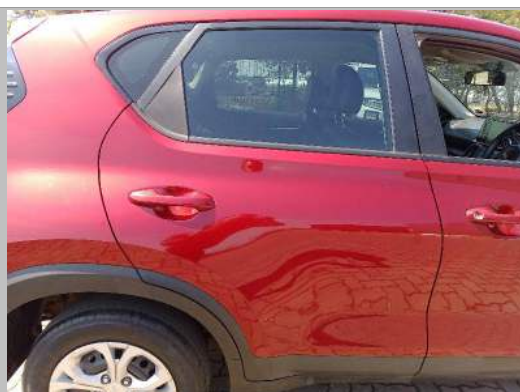
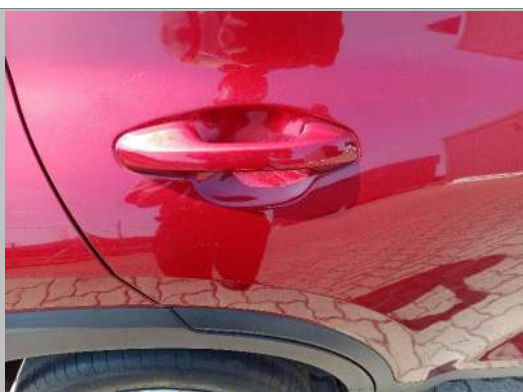
| Damage | Repair Way |
|---|---|
| Door Rear Right Paintwork • Scratched | Repair |

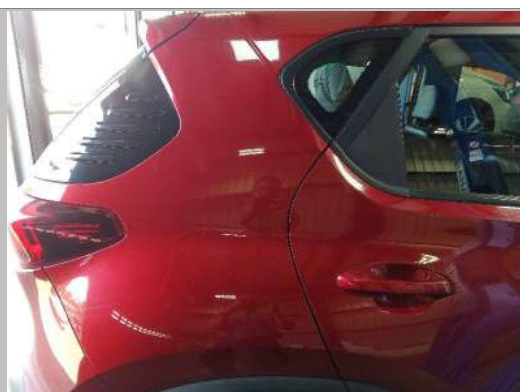
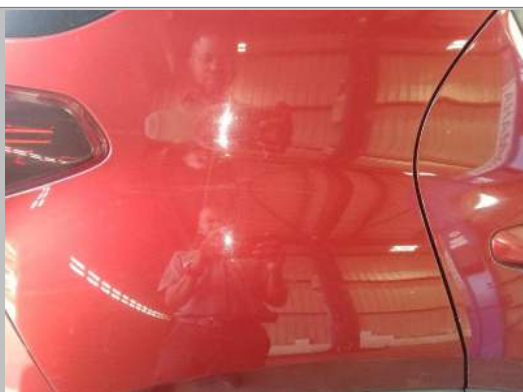
| Damage | Repair Way |
|---|---|
| Rear Fender Right Paintwork • Scratched | Repair |

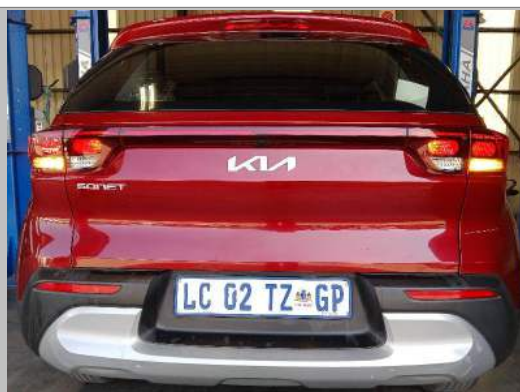
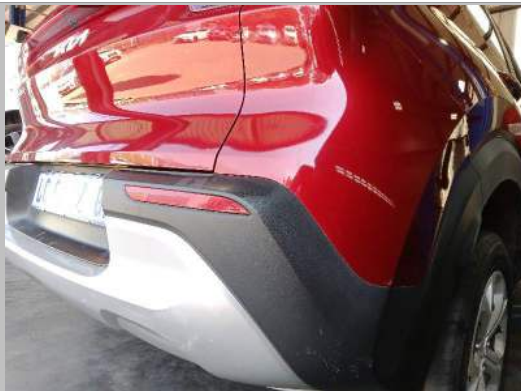
| Damage | Repair Way |
|---|---|
| Rear bumper Damaged | Repair |

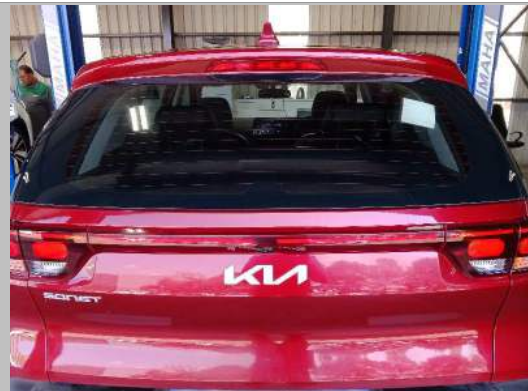
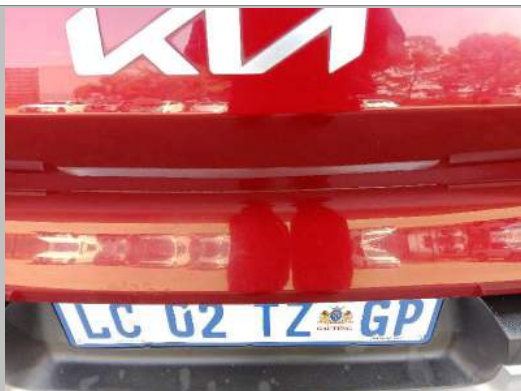
| Damage | Repair Way |
|---|---|
| Boot Lid / Hatch door Paintwork • Scratched | Repair |

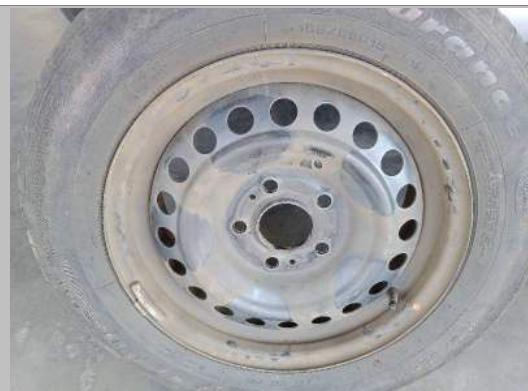
| Damage | Repair Way |
|---|---|
| Rim Spare Wheel Dented | Repair |

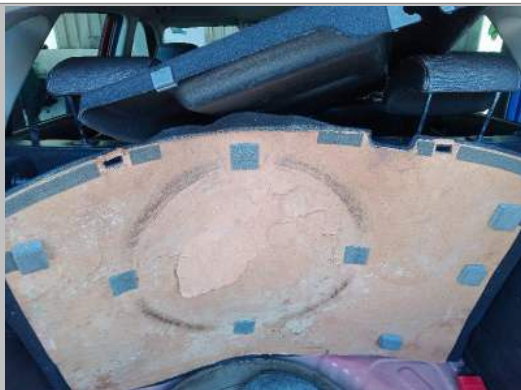
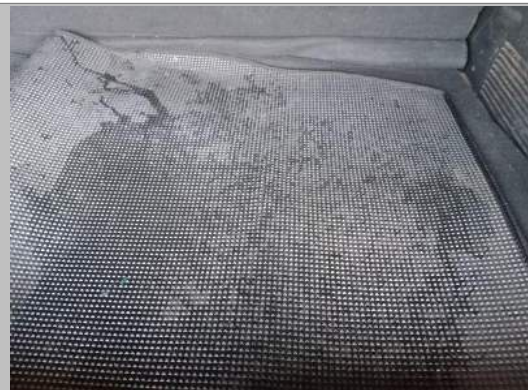
| Damage | Repair Way |
|---|---|
| Boot Carpet Damaged | Repair |

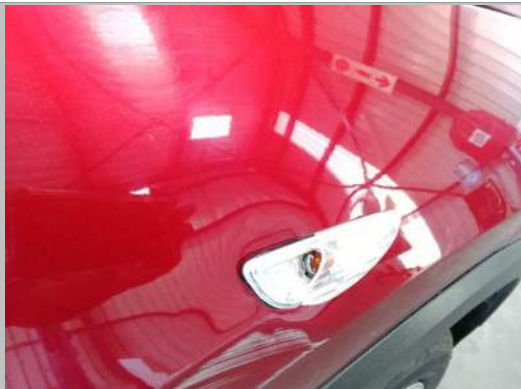
| Damage | Repair Way |
|---|---|
| Indicator Light Front Right Damaged | Replace |

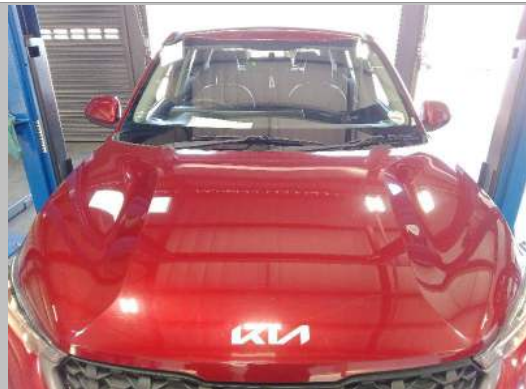
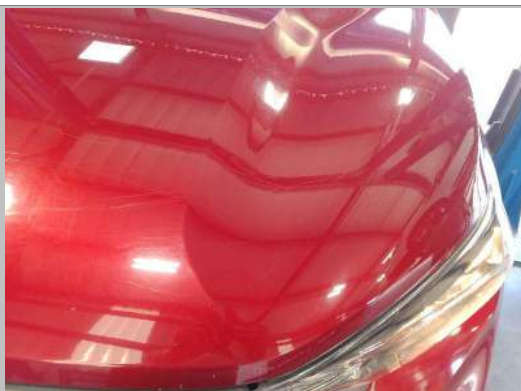
| Damage | Repair Way |
|---|---|
| Bonnet Paintwork • Scratched | Repair |

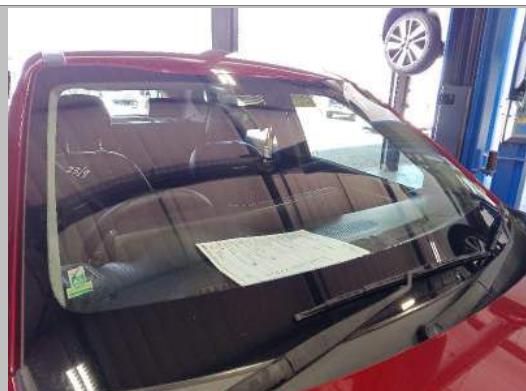
| Damage | Repair Way |
|---|---|
| Windscreen Chipped | Repair |

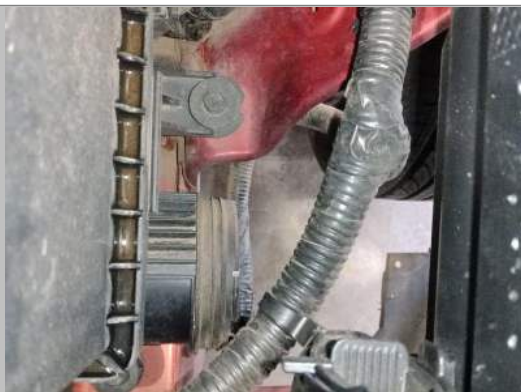
| Damage | Repair Way |
|---|---|
| Air cleaner Defective | Replace |

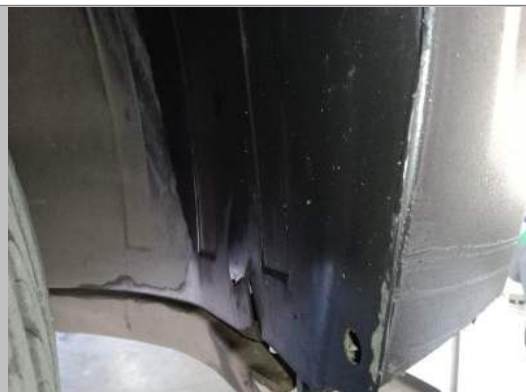
| Damage | Repair Way |
|---|---|
| Front Fender Right / Inner Tray Damaged | Repair |

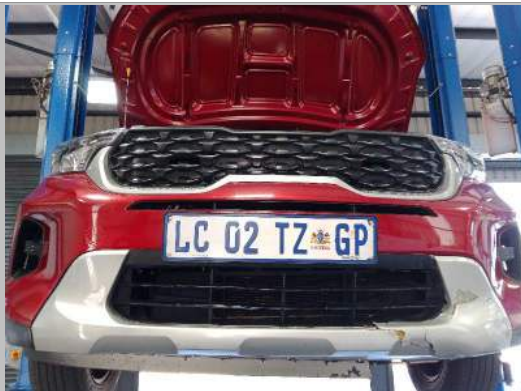
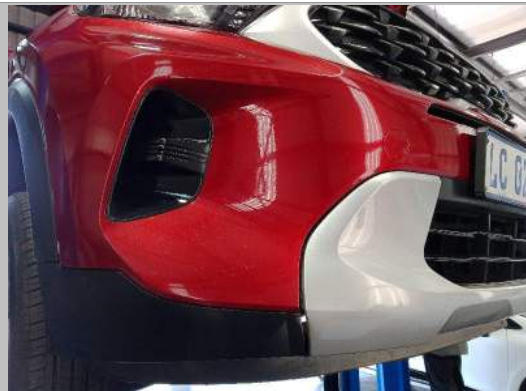
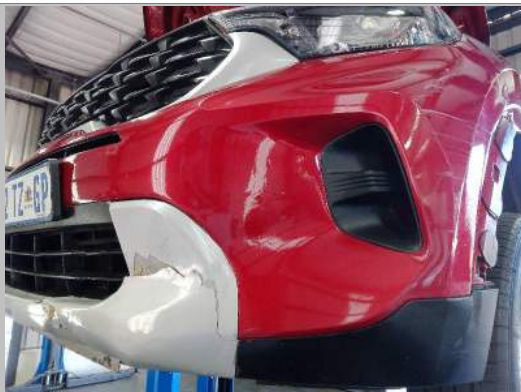
| Damage | Repair Way |
|---|---|
| Front Bumper Damaged | Replace |

Body • Exterior: Dents and scratches on body panels. Signs of impact damage to the front of the vehicle. Body panels misaligned.

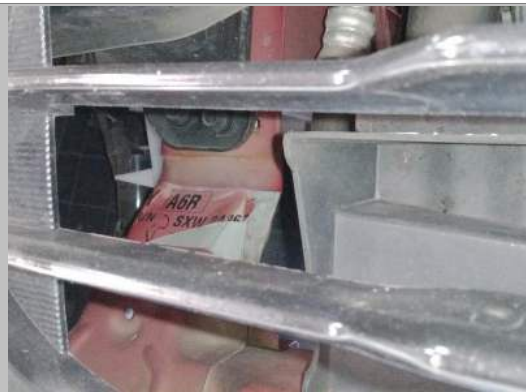
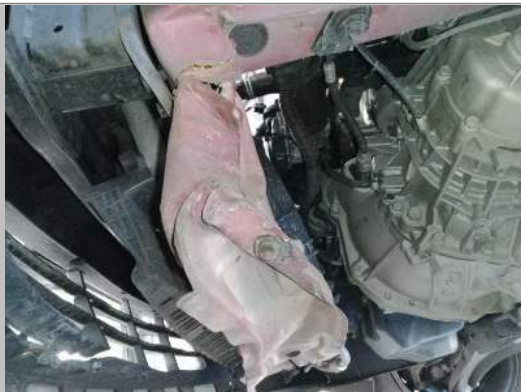
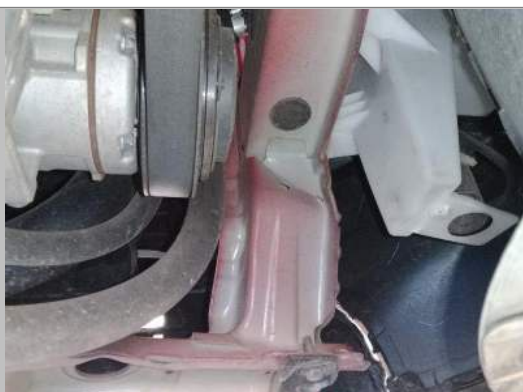
| Damage | Repair Way |
|---|---|
| Radiator Cradle Damaged | Replace |

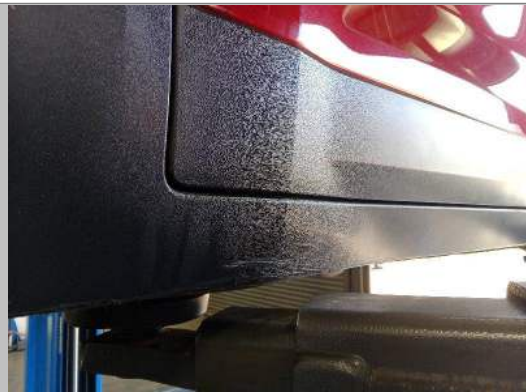
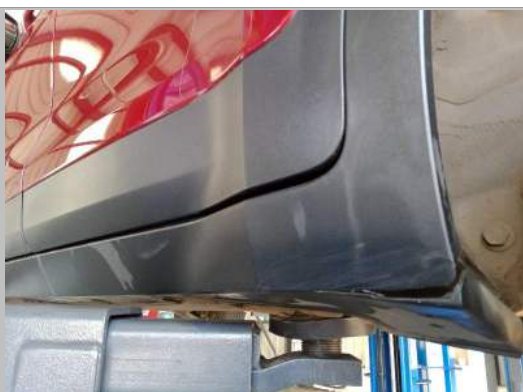
| Damage | Repair Way |
|---|---|
| Rocker Panel Left Damaged | Repair |

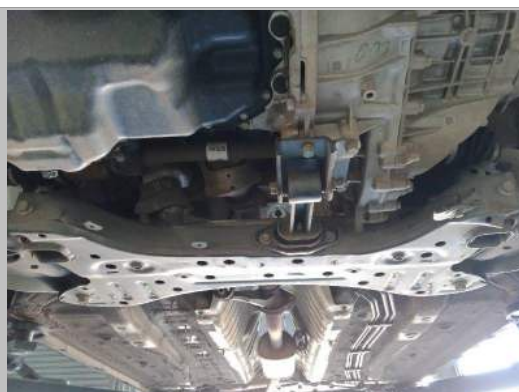
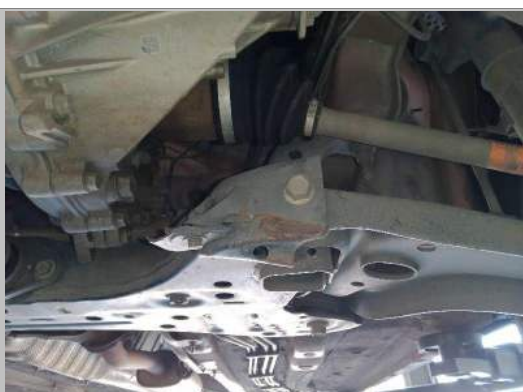
| Damage | Repair Way |
|---|---|
| Sub Frame Damaged | Replace |

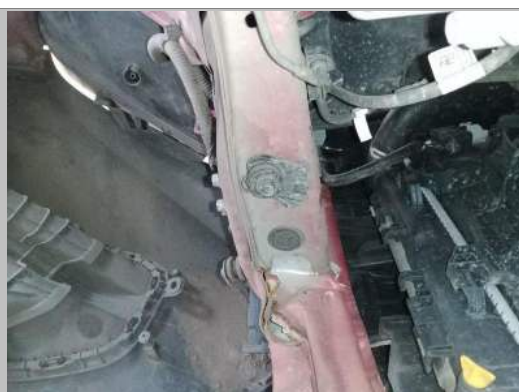
| Damage | Repair Way |
|---|---|
| Main Beam Left Damaged | Repair |

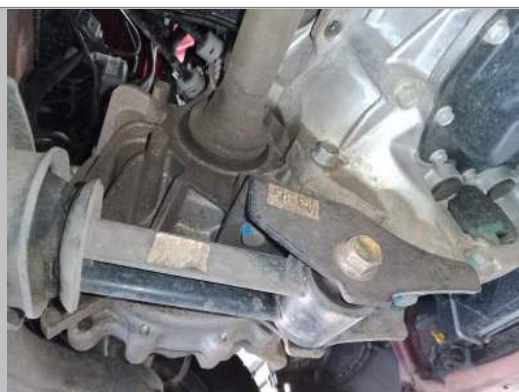
| Damage | Repair Way |
|---|---|
| Gearbox Oil Sweat | Repair |

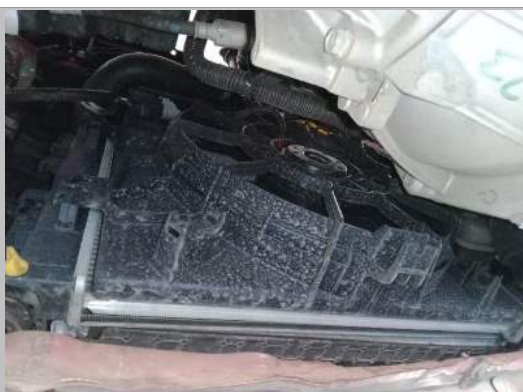
| Damage | Repair Way |
|---|---|
| Radiator Defective | Repair |

General Comments: Engine Compartment: Radiator and Aircon condenser misaligned. Foreign substance inside radiator and expansion bottle.

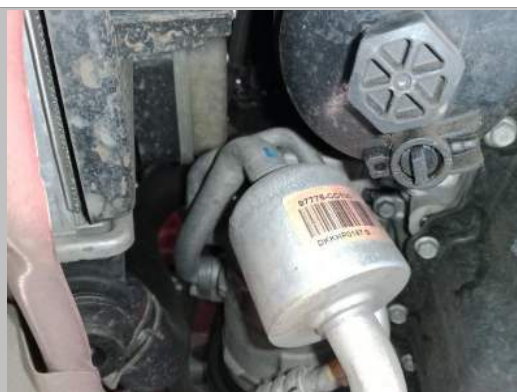
| Damage | Repair Way |
|---|---|
| Air conditioner pipes Damaged | Replace |

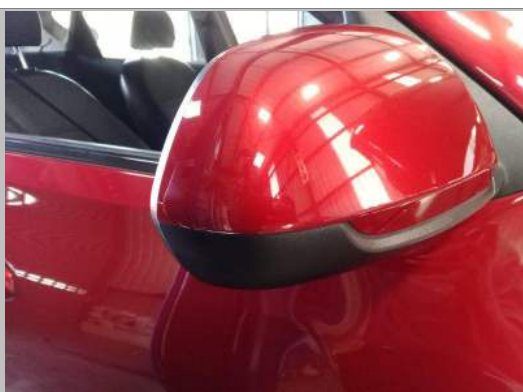
| Damage | Repair Way |
|---|---|
| Side Mirror Right Paintwork • Scratched | Repair |

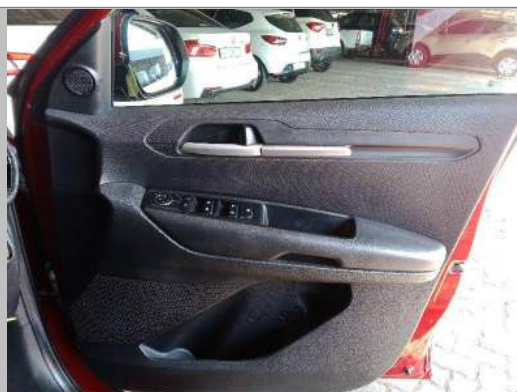
| Damage | Repair Way |
|---|---|
| Door Panel Front Right Defective | Repair |

Interior: The vehicle interior is dirty, and the panels are scratched. Front right door panel loose.
