## CONDITION REPORT

Report No:  
2017305015  
DATE  
29/09/2026

| Manufacturer | KIA | Registration Number | LR05JJGP |
| Model | SONET/HATCH BACK | Register Number | |

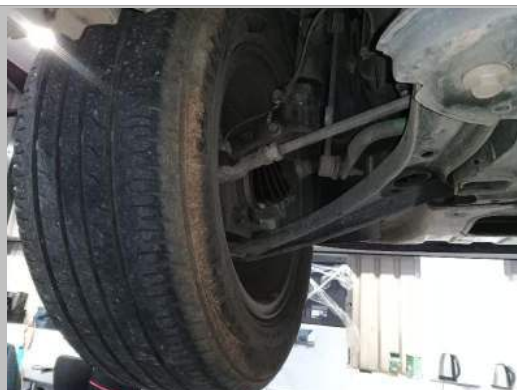
LF TYRE TREAD

| | Size | Load/Speed Index | Manufacture | Model | Type* | Production Date | Tread Depth (mm) |
|---|---|---|---|---|---|---|---|
| Front Left | 215/60 R16 | 95H | MRF | Wanderer | V | 0623 | 3 mm |

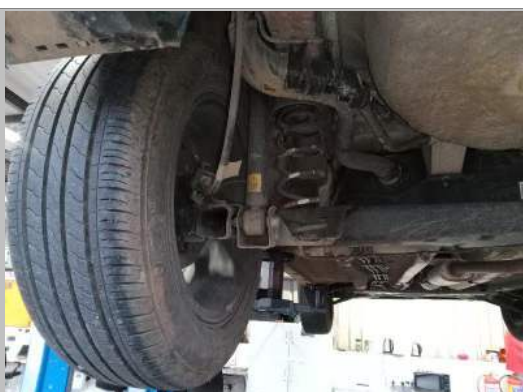
LR TYRE TREAD

| | Size | Load/Speed Index | Manufacture | Model | Type* | Production Date | Tread Depth (mm) |
|---|---|---|---|---|---|---|---|
| Rear Left | 215/60 R16 | 95H | MRF | Wanderer | V | 0623 | 5 mm |

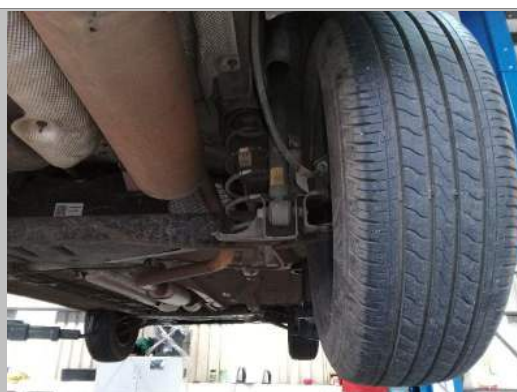
RR TYRE TREAD

| | Size | Load/Speed Index | Manufacture | Model | Type* | Production Date | Tread Depth (mm) |
|---|---|---|---|---|---|---|---|
| Rear Right | 215/60 R16 | 95H | MRF | Wanderer | V | 0623 | 5 mm |

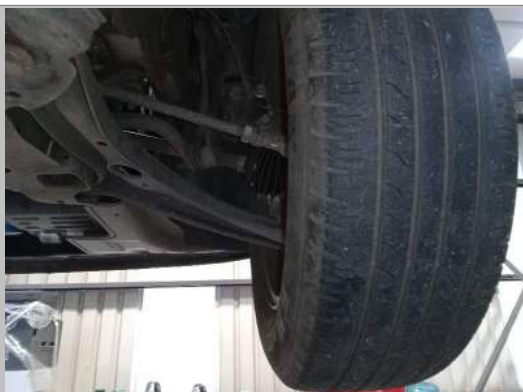
RF TYRE TREAD

| | Size | Load/Speed Index | Manufacture | Model | Type* | Production Date | Tread Depth (mm) |
|---|---|---|---|---|---|---|---|
| Front Right | 215/60 R16 | 95H | MRF | Wanderer | V | 0623 | 3 mm |

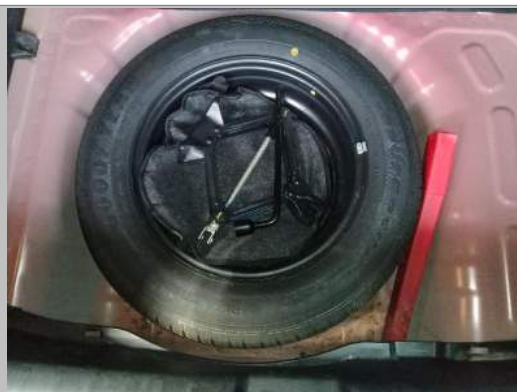
Spare Wheel and Accessories

| | Size | Load/Speed Index | Manufacture | Model | Type* | Production Date | Tread Depth (mm) |
|---|---|---|---|---|---|---|---|
| Spare | 195/65 R15 | 91H | Goodyear | Assurance | V | 0623 | 7 mm |

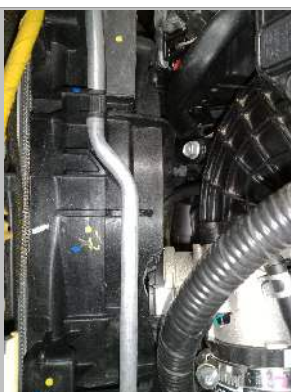
| Fan Cowley damaged | Replace |

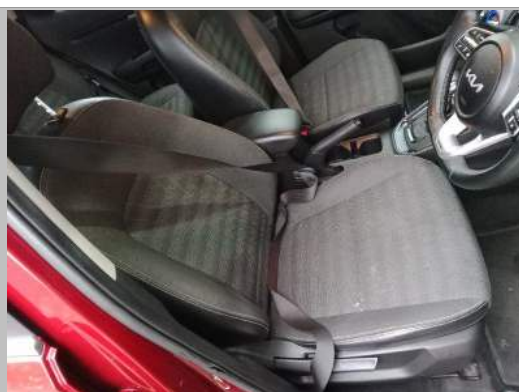
| Seat Front Right Dirty | Repair |

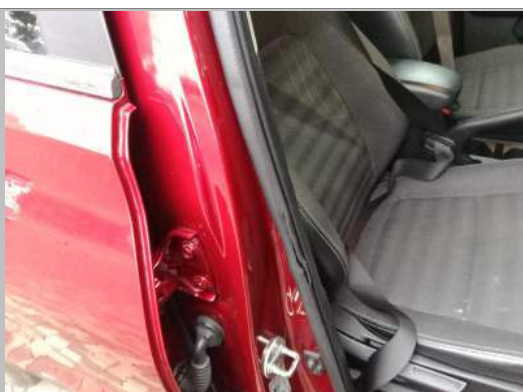
| Door Sealing Rubber Front Right Damaged | Replace |

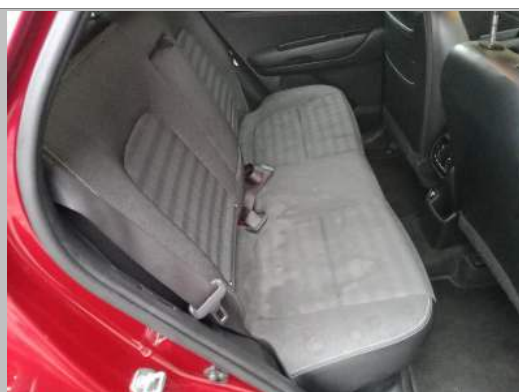
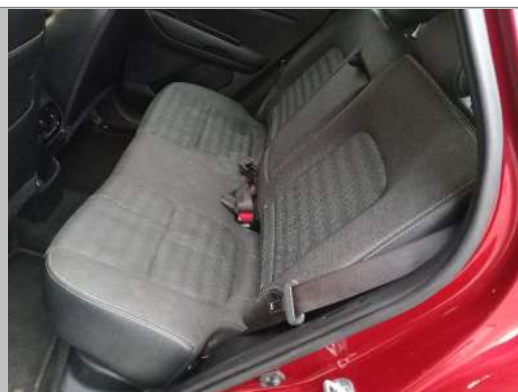
| Seat Rear Damaged | Repair |

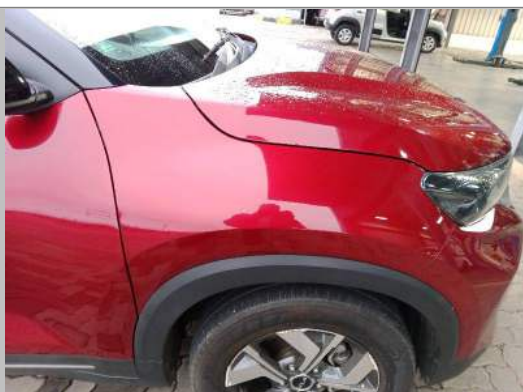
| Front Fender Right Dented | Repair |

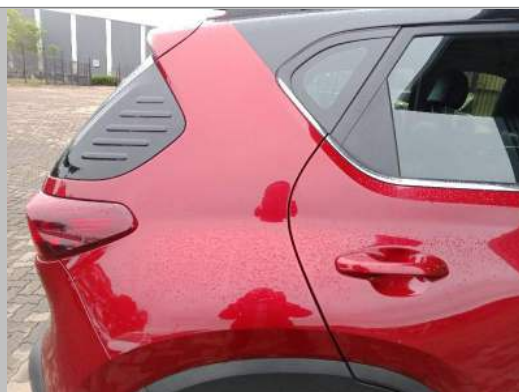
| Rear Fender Right Dented | Repair |

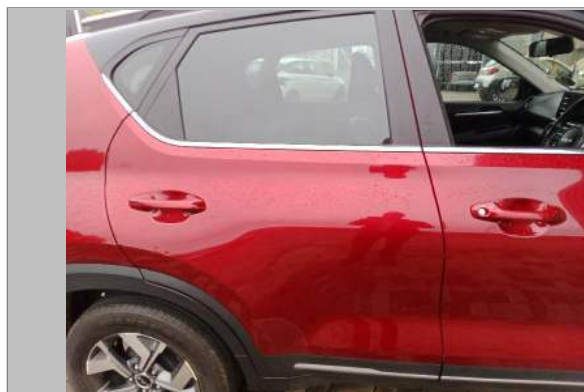
| Door Rear Right Dented | Repair |

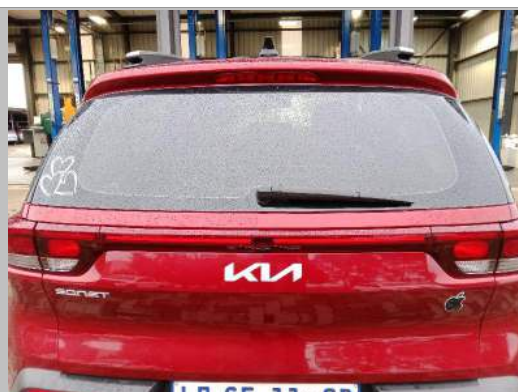
| Boot Lid / Hatch door Dented | Repair |

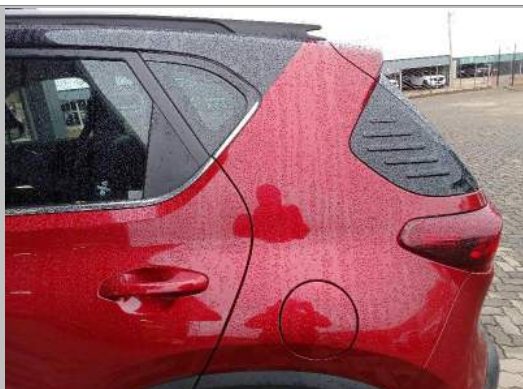
| Rear Fender Left Dented | Repair |

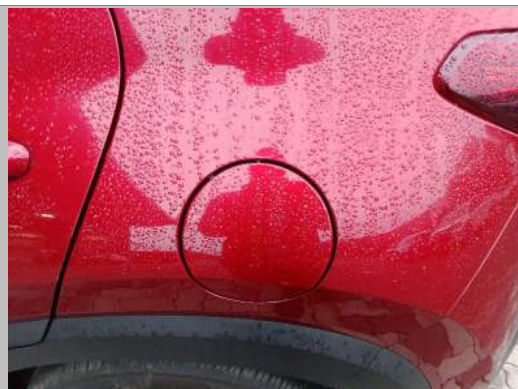
| Fuel Flap Dented | Repair |

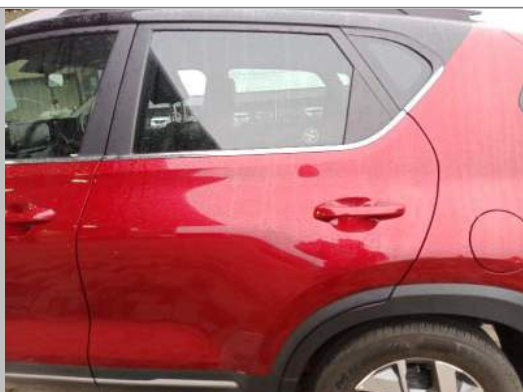
| Door Rear Left Damaged | Repair |

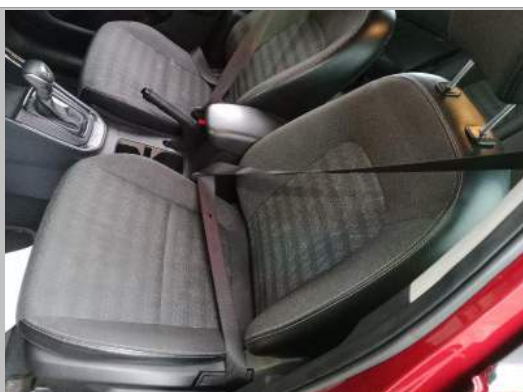
| Seat Front Left Dirty | Repair |

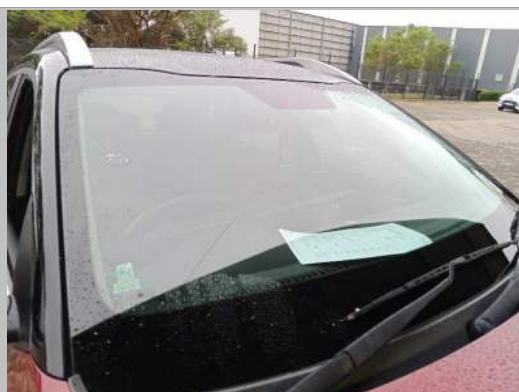
| Windscreen Cracked | |

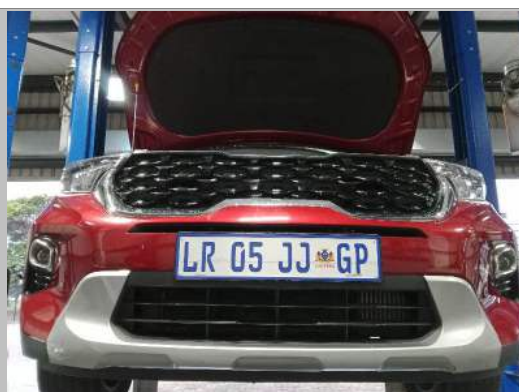
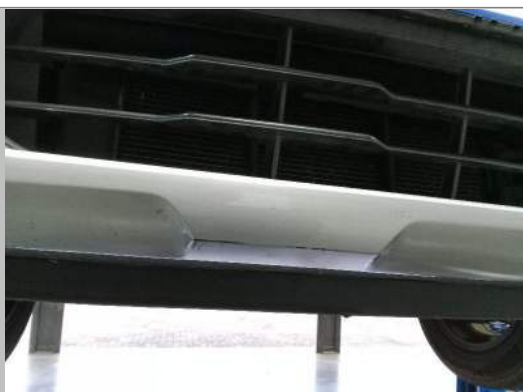
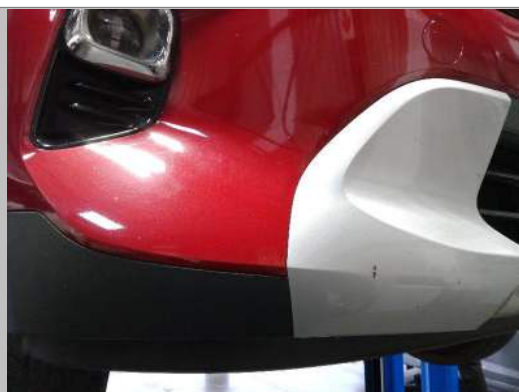
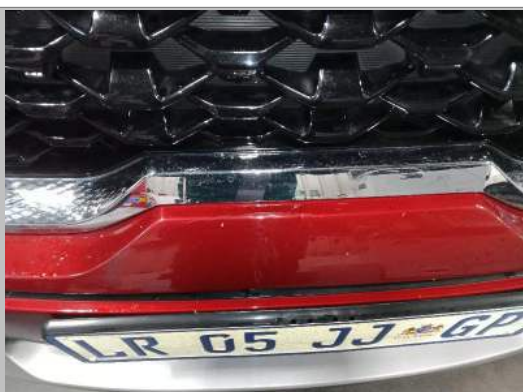
| Front Bumper Paintwork • Scratched | Repair |

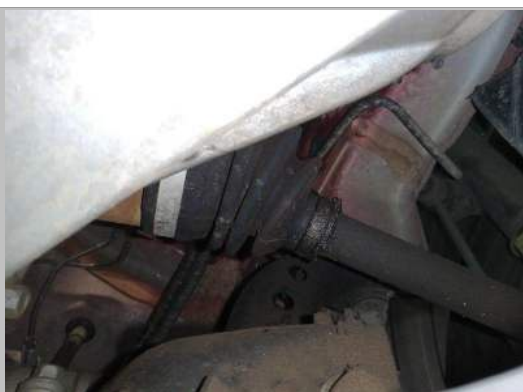
| CV Joint(s) Boot(s) Front Left (inner/outer) Damaged | Replace |

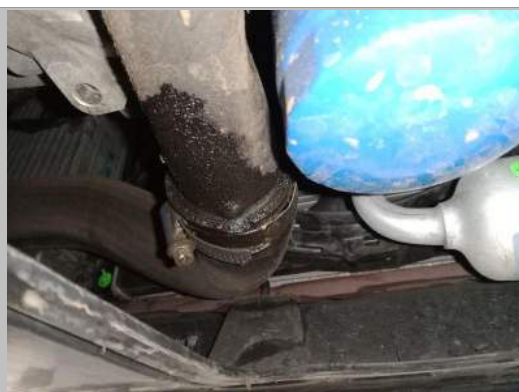
| Hoses Oil Leak | Replace |

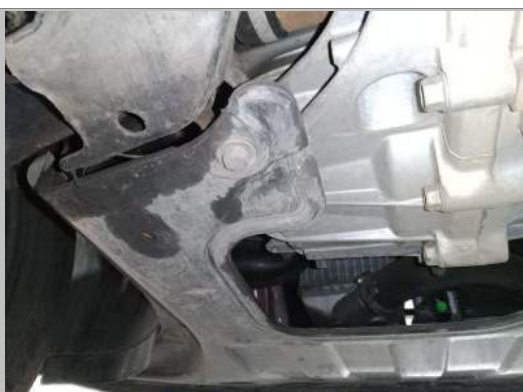
| Belly plates Damaged | Repair |
