## CONDITION REPORT

Report No:  
2017299879  
DATE  
16/09/2026

MFC Auction House  
M57 Pretoria Rd, Glenmarais, KEMPTON PARK  
Gauteng

| Manufacturer | KIA | Registration Number | LM80LLGP |

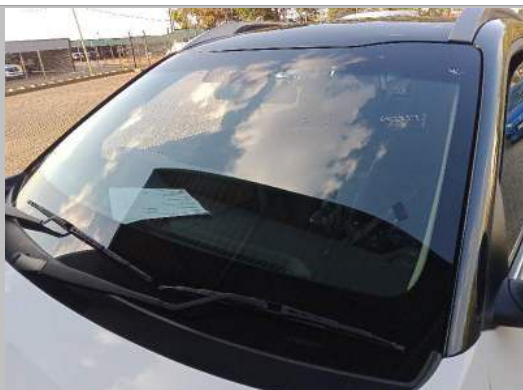
| Damage | Repair Way |
|---|---|
| Vehicle license disk missing | Replace |

No license disc

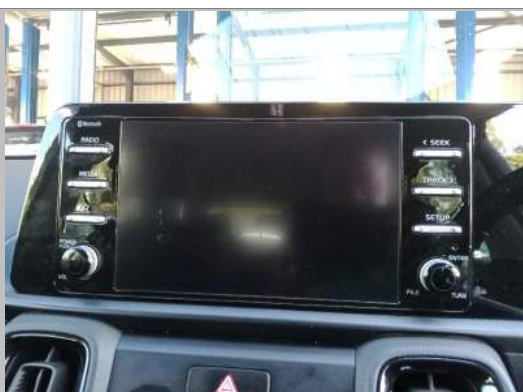
| Damage | Repair Way |
|---|---|
| Radio/CD/USB Defective | Repair |

General Comments: ACCORDING TO THE AGE AND MILEAGE OF THE VEHICLE, NORMAL WEAR AND TEAR MARKS ARE VISIBLE ON THE INTERIOR, EXTERIOR, ELECTRICAL AND MECHANICAL PARTS. Electrical Components and Instruments: Radio not working.

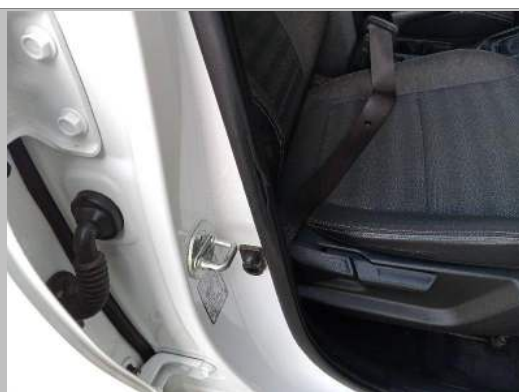
| Damage | Repair Way |
|---|---|
| Door Sealing Rubber Front Right Damaged | Replace |

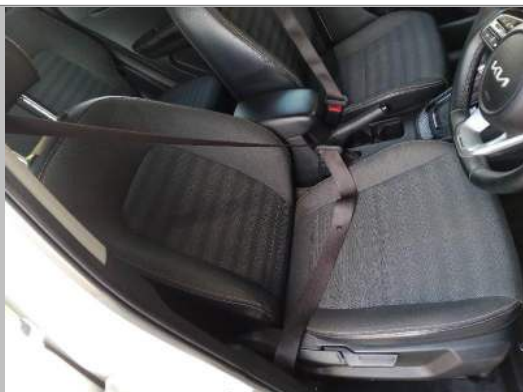
| Damage | Repair Way |
|---|---|
| Seat Front Right Dirty | Repair |

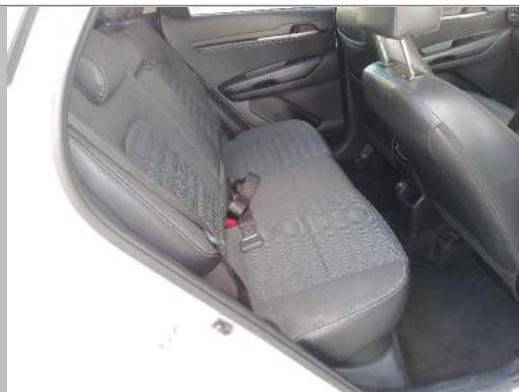
| Damage | Repair Way |
|---|---|
| Seat Rear Dirty | Repair |

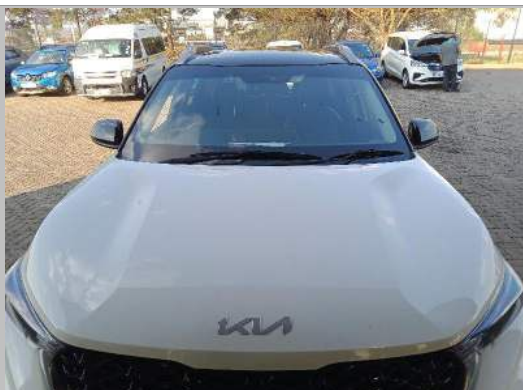
| Damage | Repair Way |
|---|---|
| Bonnet Paintwork • Chipmarks | Repair |

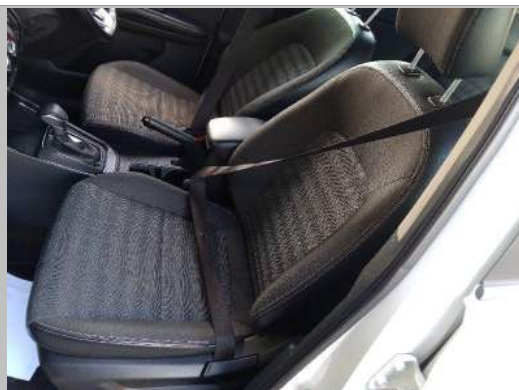
| Damage | Repair Way |
|---|---|
| Seat Front Left Dirty | Repair |

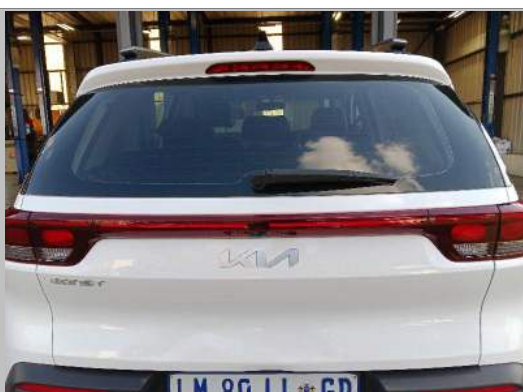
| Damage | Repair Way |
|---|---|
| Boot Lid / Hatch door Damaged | Repair |

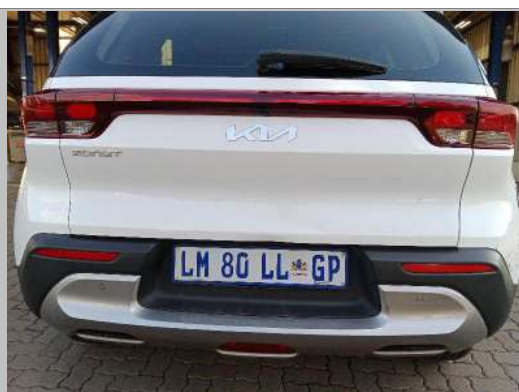
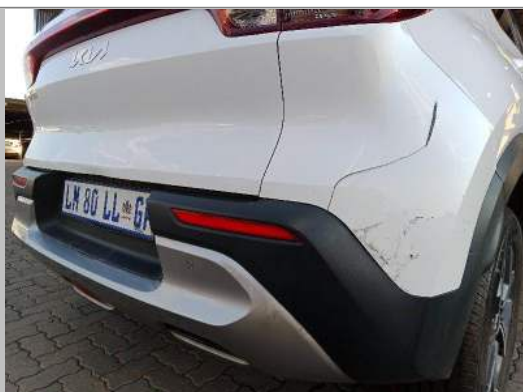
| Damage | Repair Way |
|---|---|
| Rear bumper Damaged | Repair |

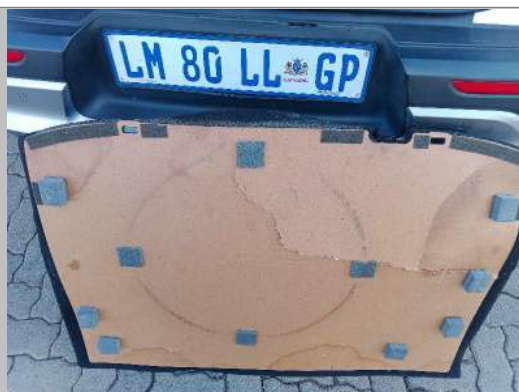
| Damage | Repair Way |
|---|---|
| Boot Carpet Damaged | Repair |

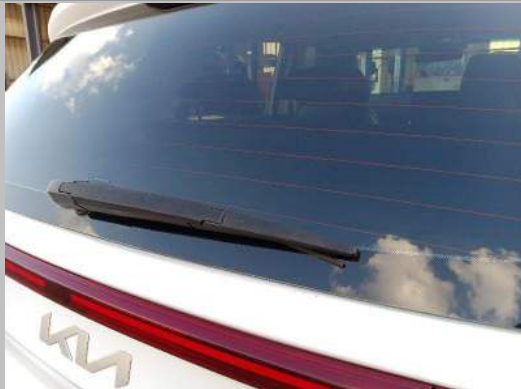
| Damage | Repair Way |
|---|---|
| Windscreen Wiper Damaged | Replace |

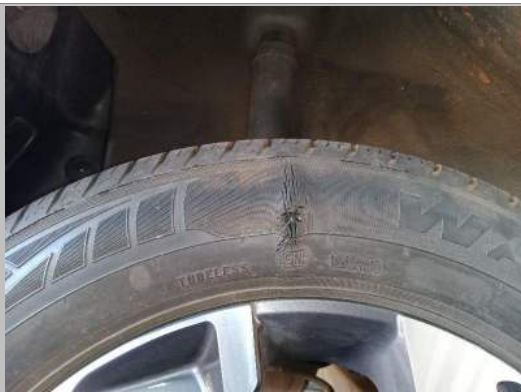
| Damage | Repair Way |
|---|---|
| Tyre Rear Right Damaged | Replace |

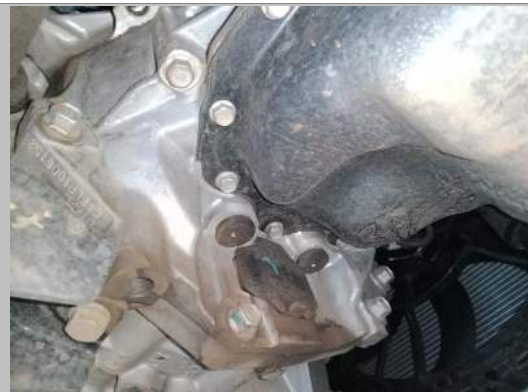
| Damage | Repair Way |
|---|---|
| Engine Oil Sweat | Repair |

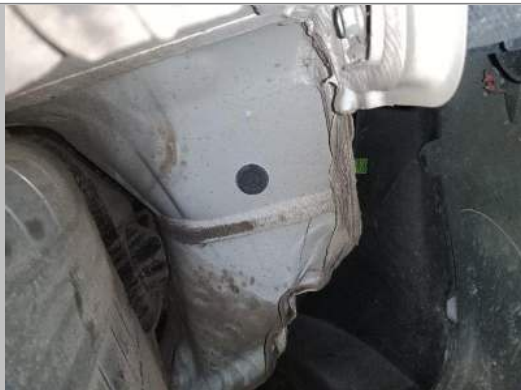
| Damage | Repair Way |
|---|---|
| Rear Fender Right / Inner Tray Damaged | Repair |

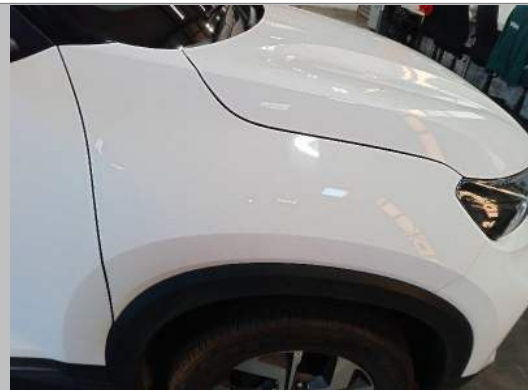
| Damage | Repair Way |
|---|---|
| Front Fender Right Residual Traces of Repair | Repair |

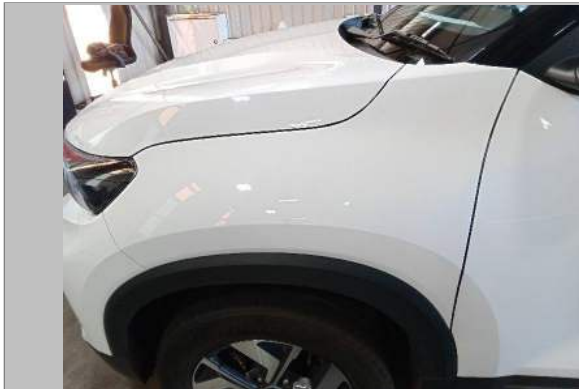
| Damage | Repair Way |
|---|---|
| Front Fender Left Residual Traces of Repair | Repair |
