## CONDITION REPORT

2017282653

| Manufacturer | LAND ROVER | Registration Number | HLT714FS |
| Model | DISCOVERY 4 3.0 TDV6 HSE 4X4 DSL AT [2011-2013] | Register Number | |

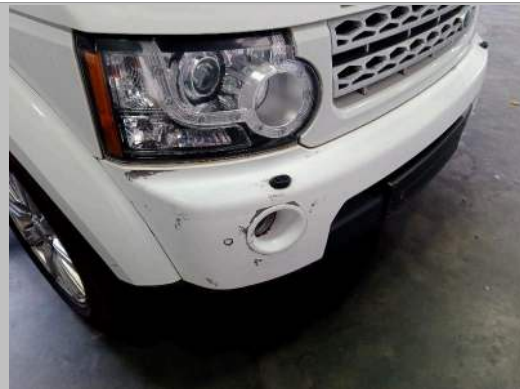
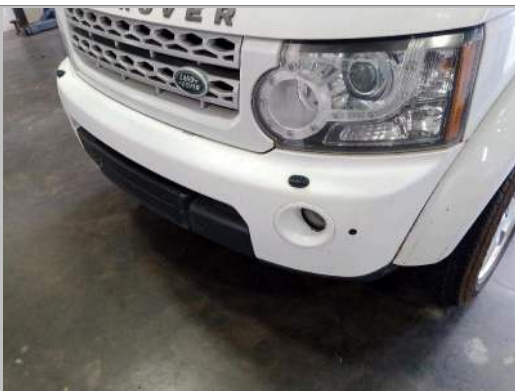
| Front Bumper Damaged | Repair |

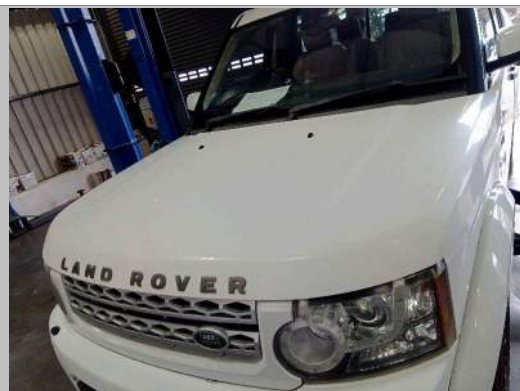
| Bonnet Damaged | Repair |

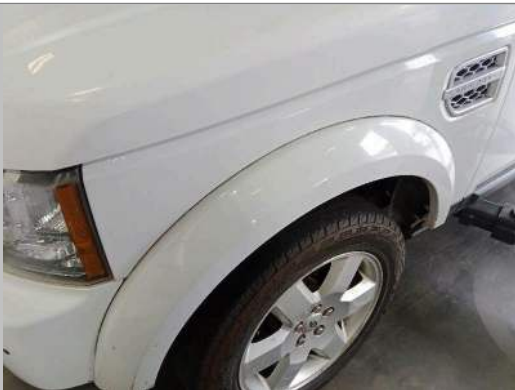
| Front Fender Left Damaged | Repair |

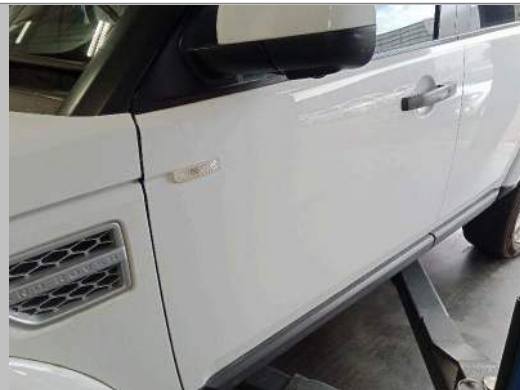
| Door Front Left Damaged | Repair |

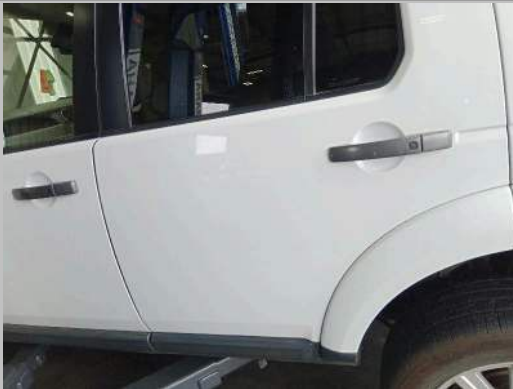
| Door Rear Left Damaged | Repair |

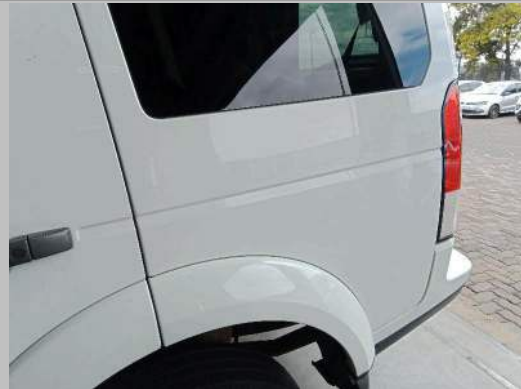
| Rear Fender Left Damaged | Repair |

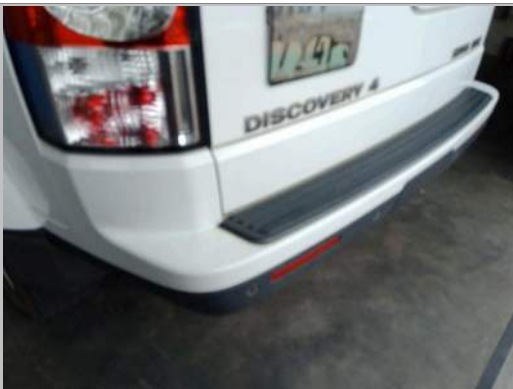
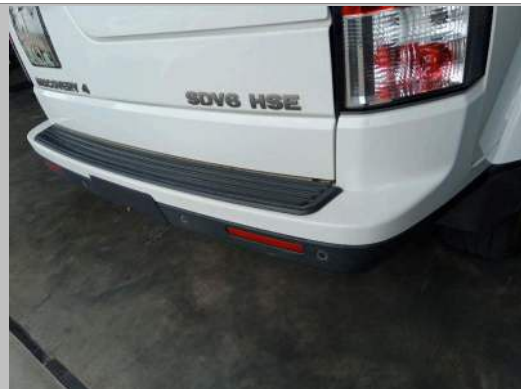
| Rear bumper Damaged | Repair |

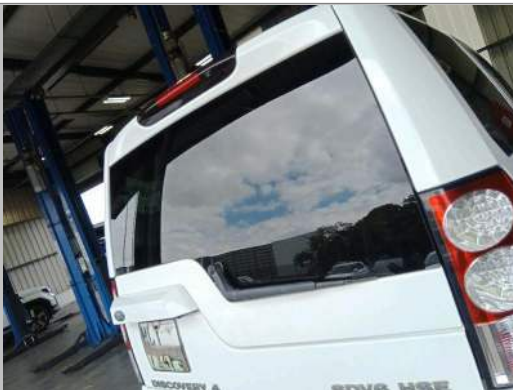
| Boot Lid / Hatch door Damaged | Repair |

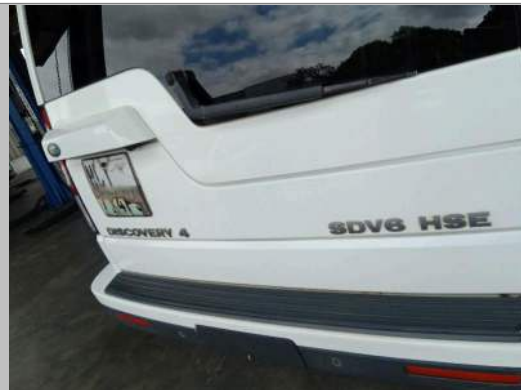
| Tailgate Damaged | Repair |

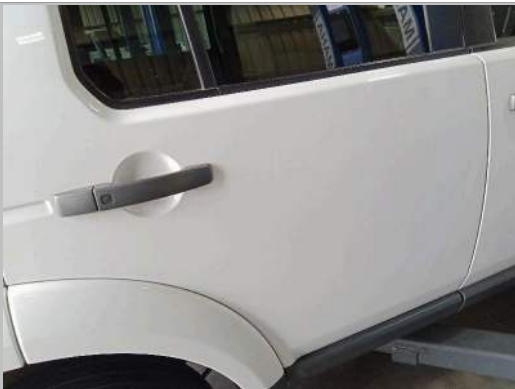
| Door Rear Right Damaged | Repair |

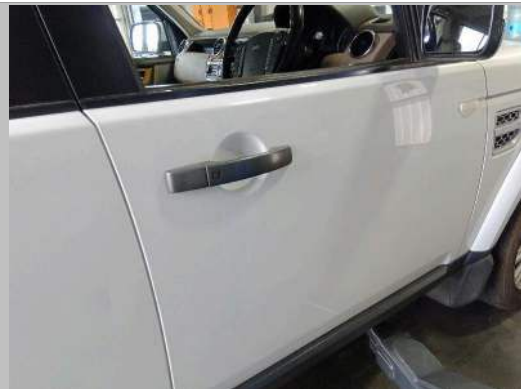
| Door Front Right Damaged | Repair |

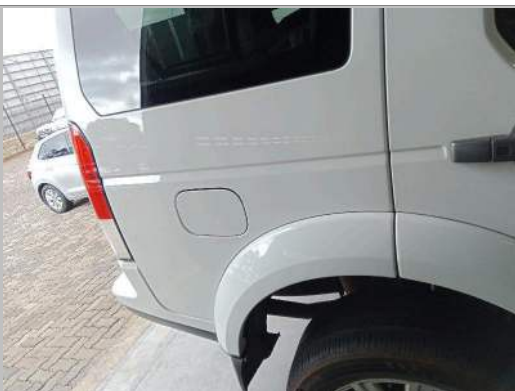
| Rear Fender Right Damaged | Repair |

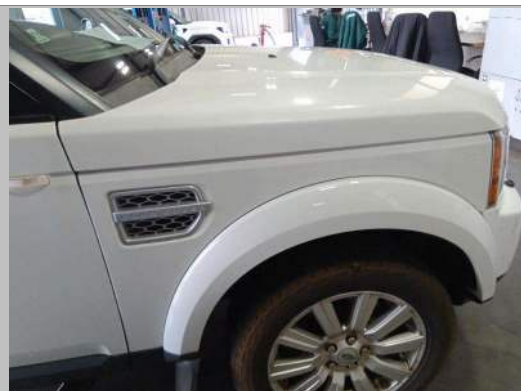
| Front Fender Right Damaged | Repair |

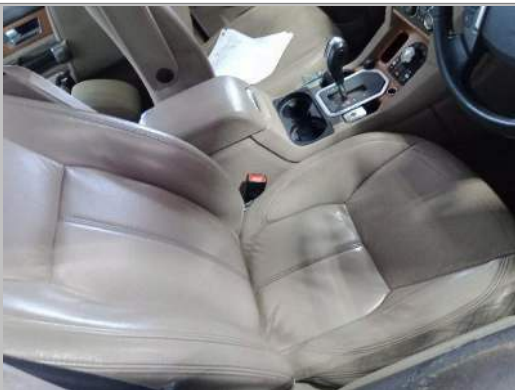
| Seat Front Right Worn | Replace |

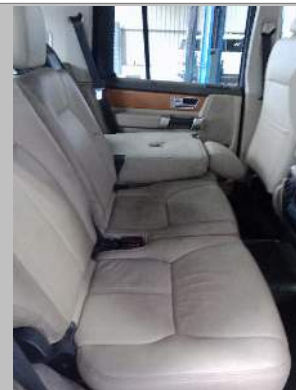
| Seat Rear Worn | Repair |

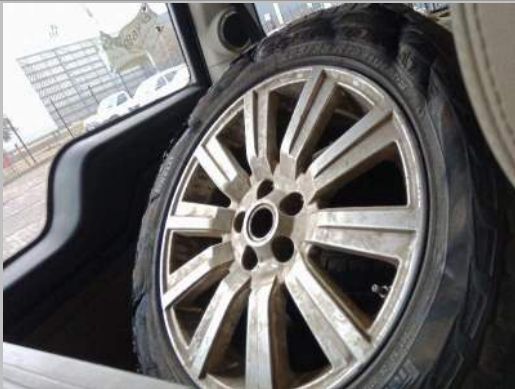
| Spare Tyre Damaged | Replace |

| | Size | Load/Speed Index | Manufacture | Model | Type* | Production Date | Tread Depth (mm) |
|---|---|---|---|---|---|---|---|
| Spare | 255/55R19 | 111H | Pirelli | Radial | V | 5117 | 0 mm |

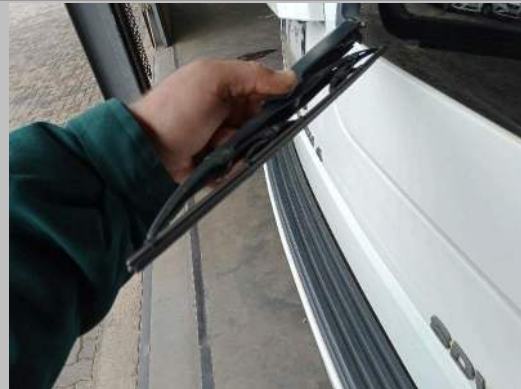
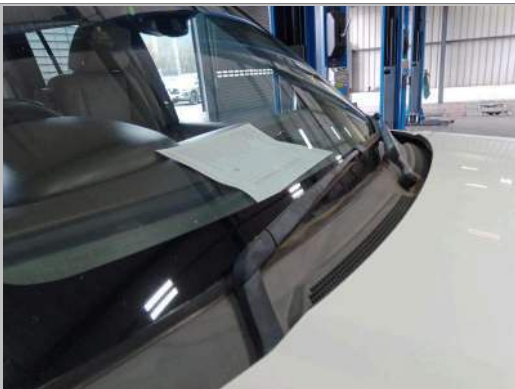
| Windscreen Wiper Damaged | Replace |

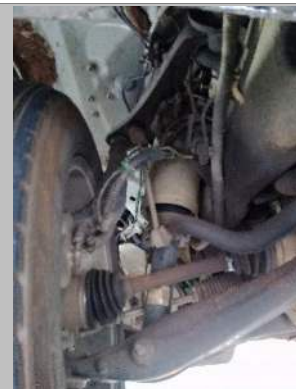
| Air Suspension Front Left Defective | Replace |

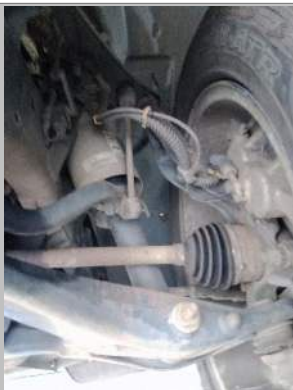
| Air Suspension Front Right Defective | Replace |

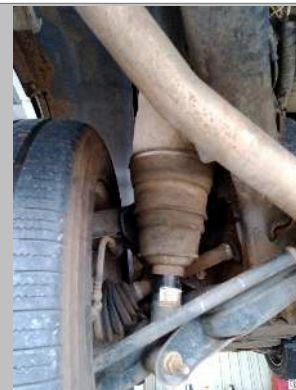
| Air Suspension Rear Left Defective | Replace |

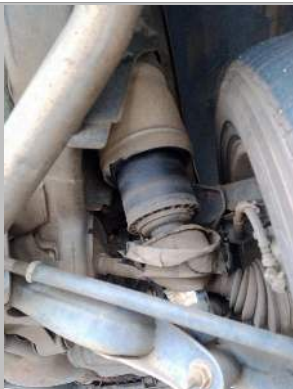
| Air Suspension Rear Right Defective | Replace |

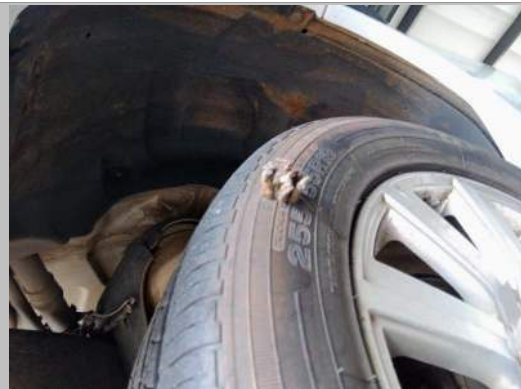
| Tyre Rear Right Damaged | Replace |

| | Size | Load/Speed Index | Manufacture | Model | Type* | Production Date | Tread Depth (mm) |
|---|---|---|---|---|---|---|---|
| Rear Right | 255/55R19 | 111V | Hilo | Radial | V | 0920 | 1 mm |

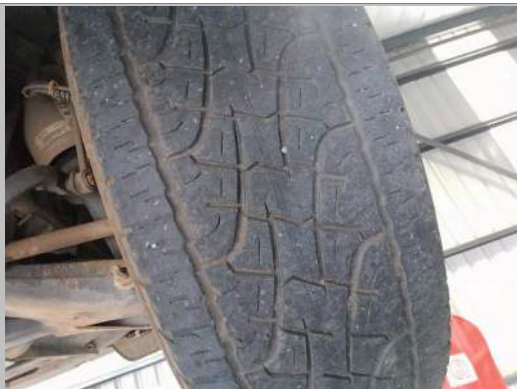
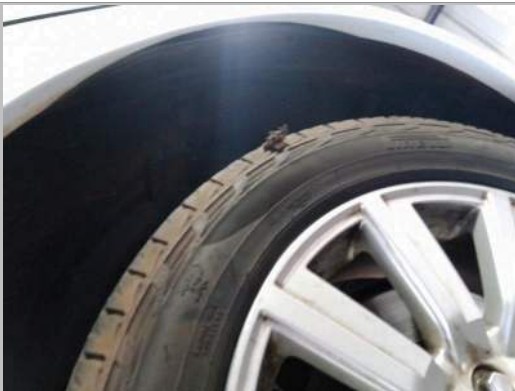
| Tyre Front Right Worn | Replace |

| | Size | Load/Speed Index | Manufacture | Model | Type* | Production Date | Tread Depth (mm) |
|---|---|---|---|---|---|---|---|
| Front Right | 255/55R19 | 111H | Pirelli | Radial | V | 0118 | 0 mm |

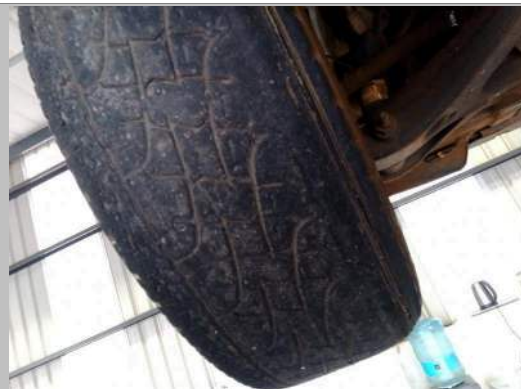
| Tyre Front Left Worn | Replace |

| | Size | Load/Speed Index | Manufacture | Model | Type* | Production Date | Tread Depth (mm) |
|---|---|---|---|---|---|---|---|
| Front Left | 255/55R19 | 111H | Pirelli | Radial | V | 0913 | 0 mm |

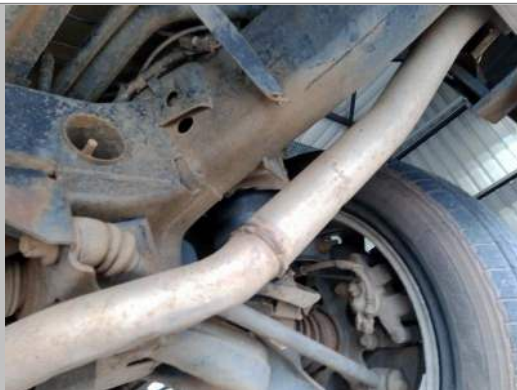
| Engine to silencer pipe Welded | Replace |

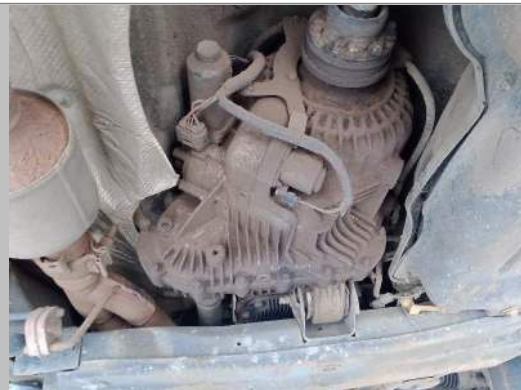
| Gearbox Oil Leak | Repair |

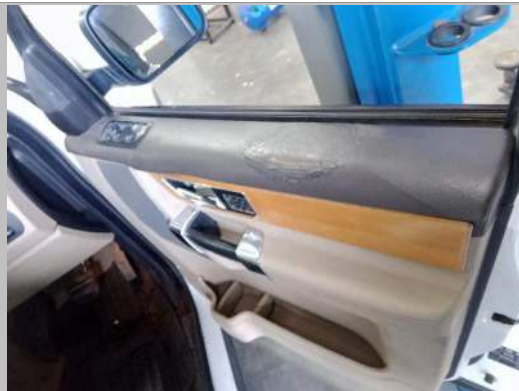
| Door Panel Front Right Damaged | Repair |

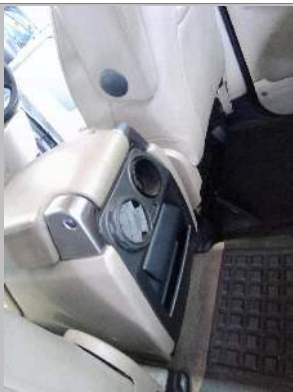
| Central Air Vent Damaged | Replace |

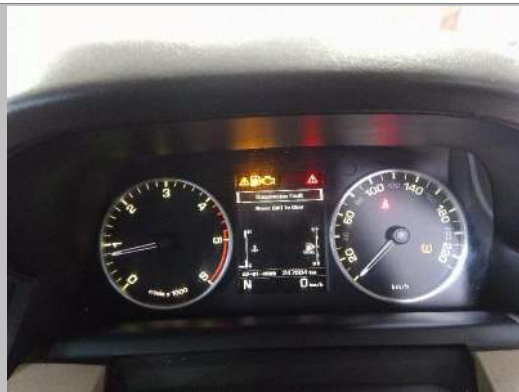
| Engine Management Lights Set | Repair |
