## CONDITION REPORT

Report No:  
2017302331  
DATE  
22/09/2026

| Manufacturer | LAND ROVER | Registration Number | KH07JCGP |
| Model | RANGE ROVER EVOQUE 2.2 SD4 DSL<br>DYNAMIC 4WD AT [2011-2013] | Register Number | |

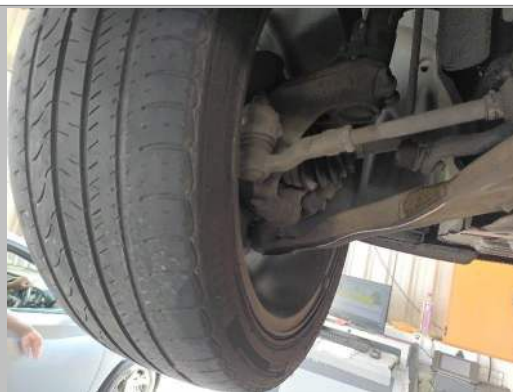
LF TYRE TREAD

| | Size | Load/Speed Index | Manufacture | Model | Type* | Production Date | Tread Depth (mm) |
|---|---|---|---|---|---|---|---|
| Front Left | 245/45R20 | 103Y | Anchee | AC | V | 4023 | 0 mm |

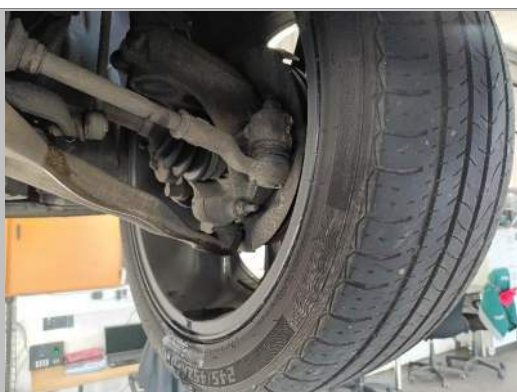
RF TYRE TREAD

| | Size | Load/Speed Index | Manufacture | Model | Type* | Production Date | Tread Depth (mm) |
|---|---|---|---|---|---|---|---|
| Front Right | 245/45R20 | 103Y | Anchee | AC | V | 4023 | 1 mm |

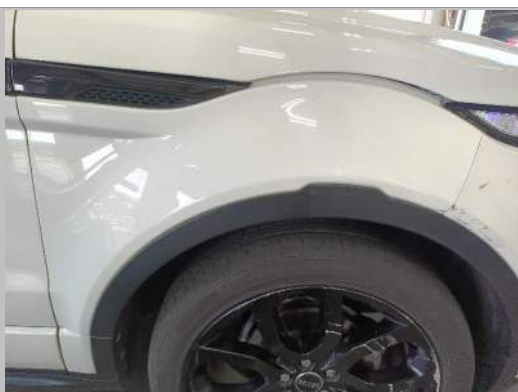
| Damage | Repair Way |
|---|---|
| Front Fender Right Paintwork • Scratched | Repair |

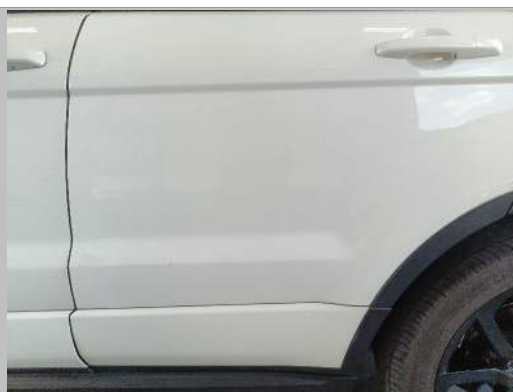
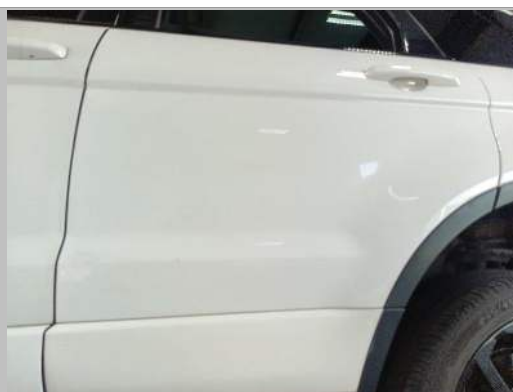
| Damage | Repair Way |
|---|---|
| Door Rear Left Residual Traces of Repair | Repair |

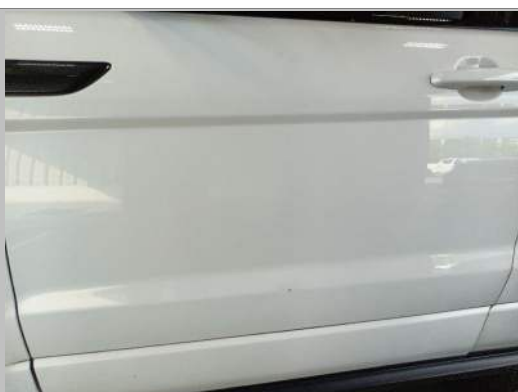
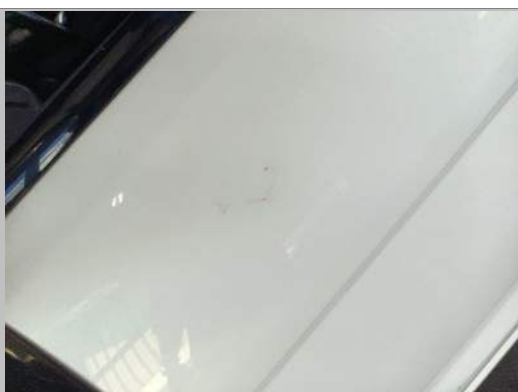
| Damage | Repair Way |
|---|---|
| Door Front Left Paintwork • Scratched | Repair |

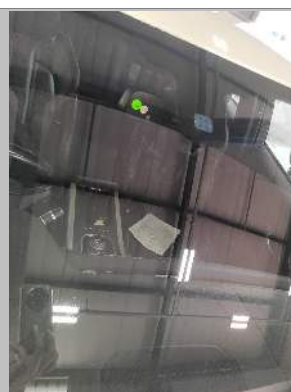
| Damage | Repair Way |
|---|---|
| Windscreen Chipped | Replace |

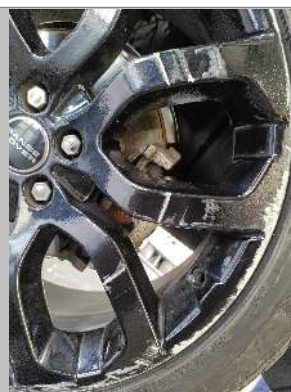
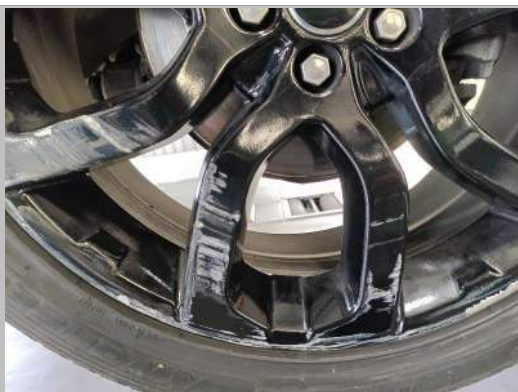
| Damage | Repair Way |
|---|---|
| Rim Front Right Scratched | Repair |

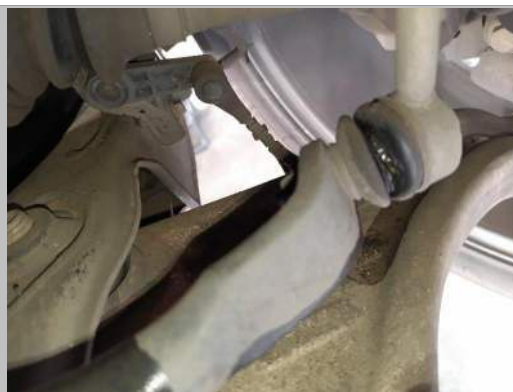
| Damage | Repair Way |
|---|---|
| Stabilizer Mounting Front Right Damaged | Replace |

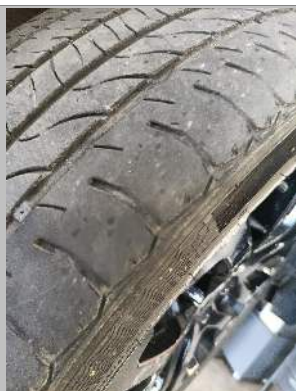
| Damage | Repair Way |
|---|---|
| Tyre Front Right Smooth | Replace |

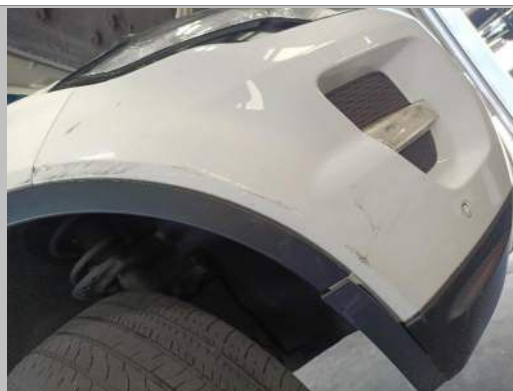
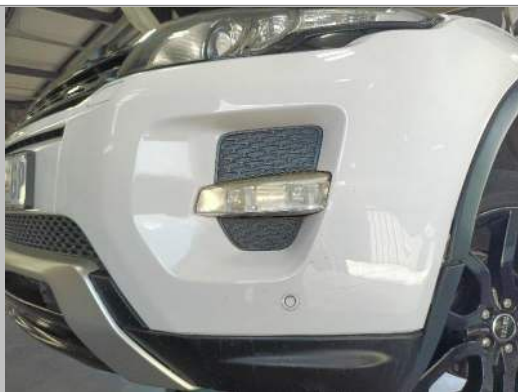
| Damage | Repair Way |
|---|---|
| Front Bumper Paintwork • Scratched | Repair |

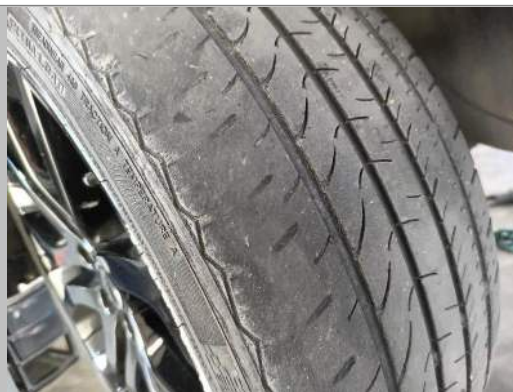
| Damage | Repair Way |
|---|---|
| Tyre Front Left Smooth | Replace |

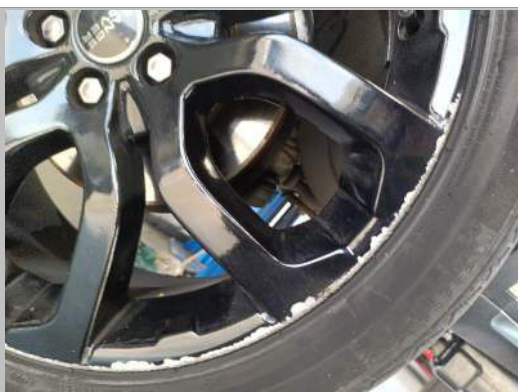
| Damage | Repair Way |
|---|---|
| Rim Front Left Scratched | Repair |

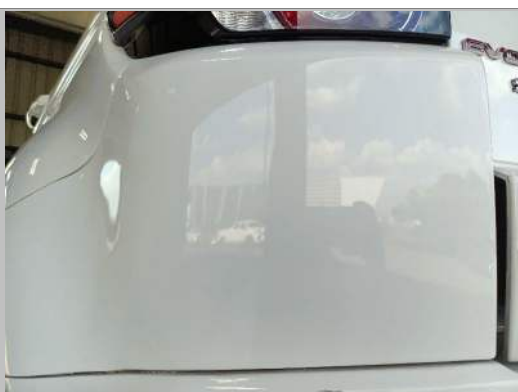
| Damage | Repair Way |
|---|---|
| Rear Fender Left Paintwork • Scratched | Repair |

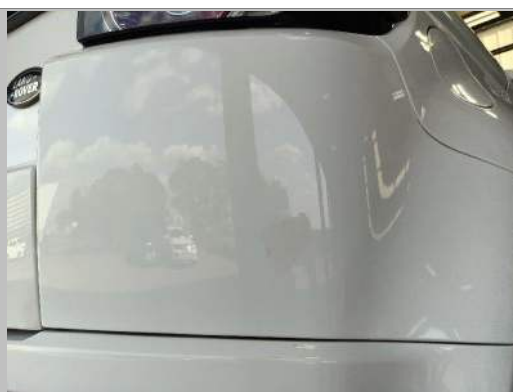
| Damage | Repair Way |
|---|---|
| Rear Fender Right Paintwork • Scratched | Repair |

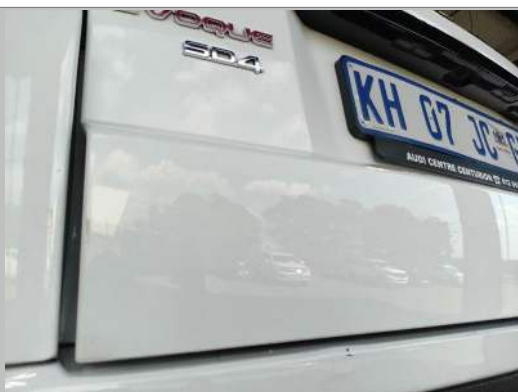
| Damage | Repair Way |
|---|---|
| Boot Lid / Hatch door Paintwork • Scratched | Repair |

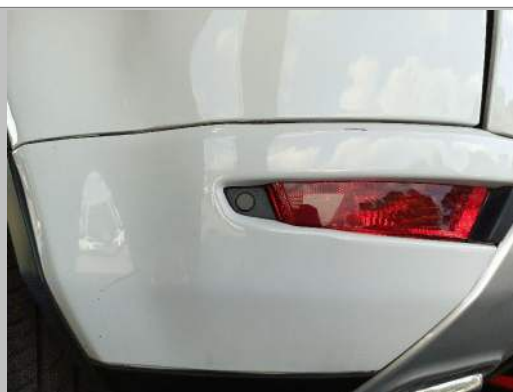
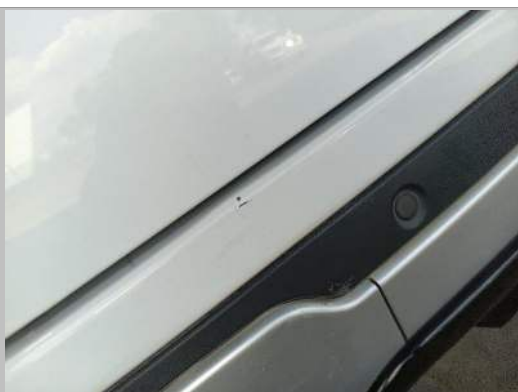
| Damage | Repair Way |
|---|---|
| Rear bumper Paintwork • Scratched | Repair |

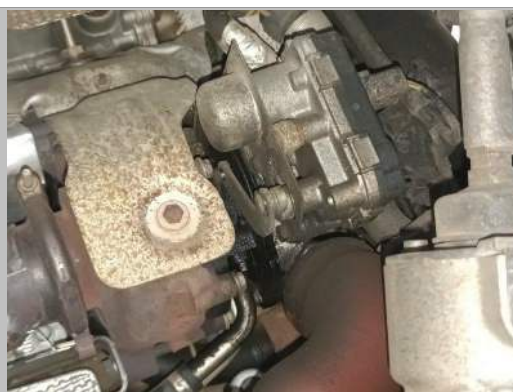
| Damage | Repair Way |
|---|---|
| Engine Oil Sweat | Repair |

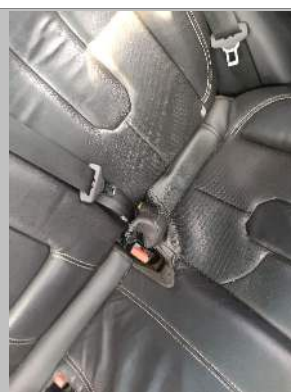
| Damage | Repair Way |
|---|---|
| Seat Rear Damaged | Repair |

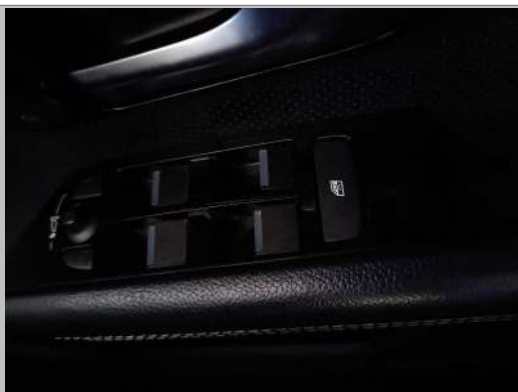
| Damage | Repair Way |
|---|---|
| Switch Electrical Window Winder rear right Damaged | Repair |
