## CONDITION REPORT

Report No:  
2017304612  
DATE  
29/09/2026

| Manufacturer | RANGE ROVER | Registration Number | DV71NWGP |
| Model | EVOQUE | Register Number | |

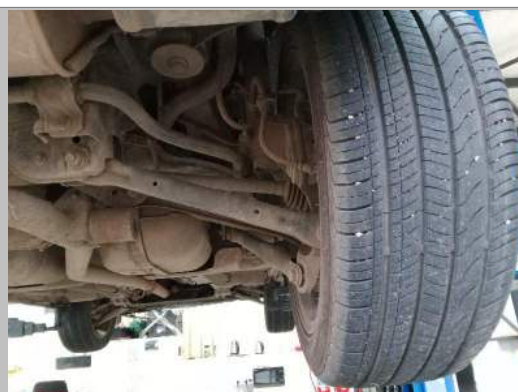
RR TYRE TREAD

| Rear tyres size differs | Replace |

| | Size | Load/Speed Index | Manufacture | Model | Type* | Production Date | Tread Depth (mm) |
|---|---|---|---|---|---|---|---|
| Rear Right | 245/45Z R20 | 103Y | Annaite | AN606 | V | 0725 | 5 mm |

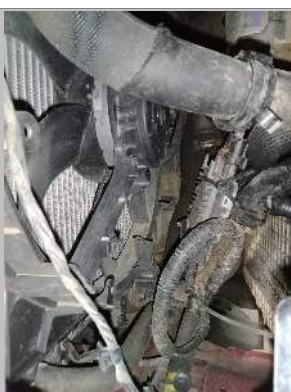
| Fan Cowley damaged | Replace |

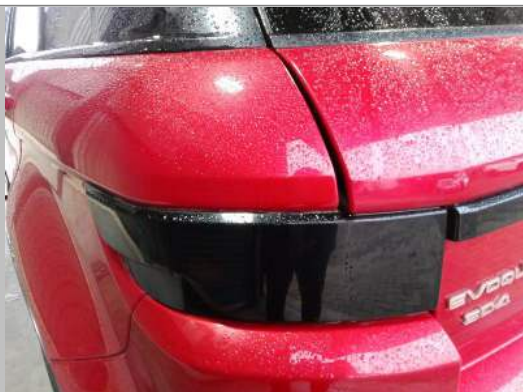
| Tail Light Left Defective | Repair |

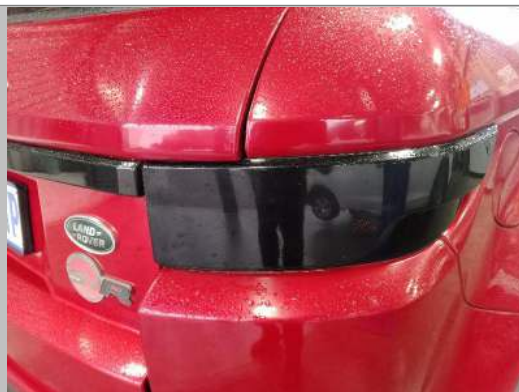
| Tail Light Right Defective | Repair |

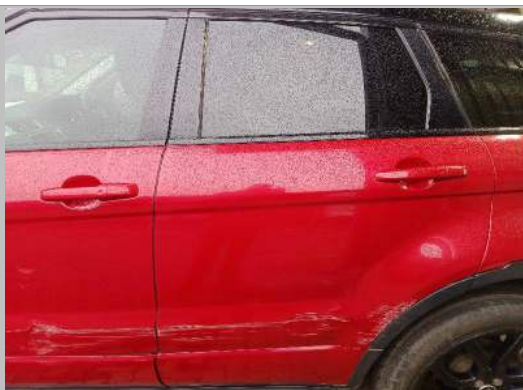
| Door Rear Left Damaged | Repair |

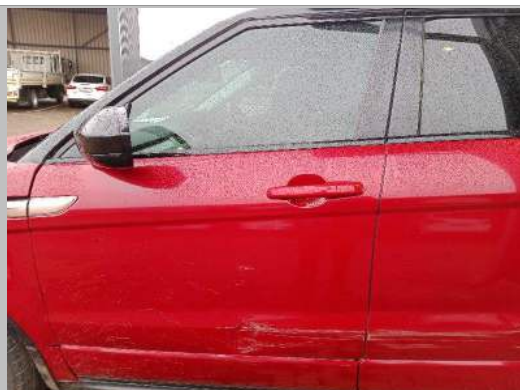
| Door Front Left Damaged | Repair |

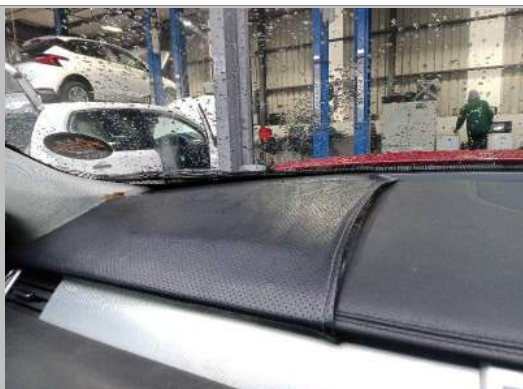
| Dash Padding Damaged | Repair |

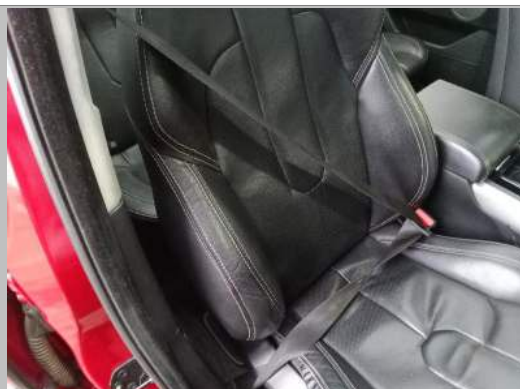
| Seat Belt Front Right Defective | Replace |

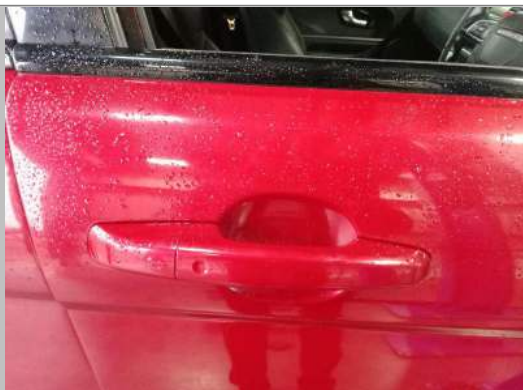
| Door Handle Front Right Damaged | Replace |

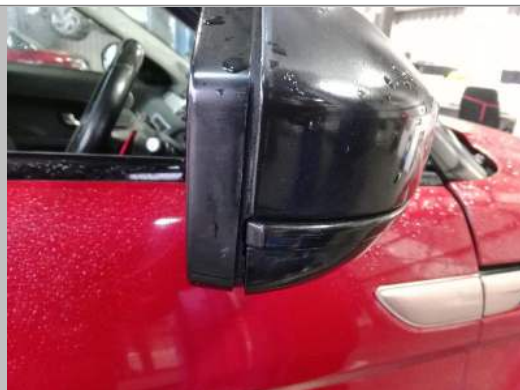
| Side Mirror Right Damaged | Replace |

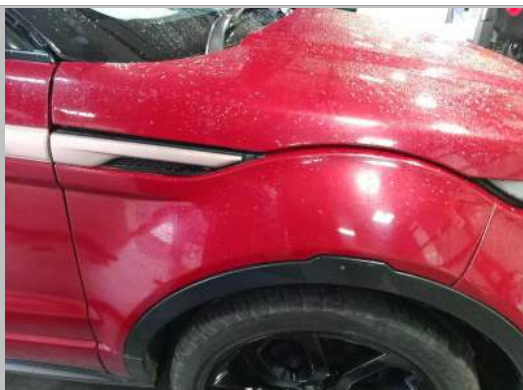
| Front Fender Right Residual Traces of Repair | Repair |

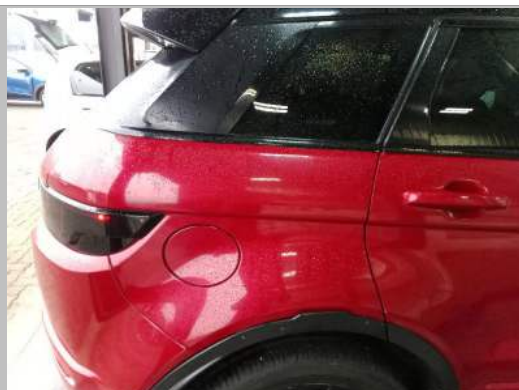
| Rear Fender Right Residual Traces of Repair | Repair |

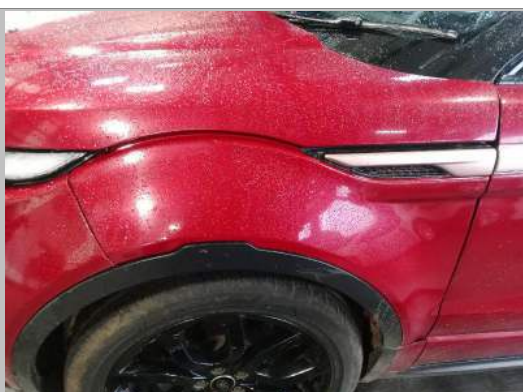
| Front Fender Left Damaged | Repair |

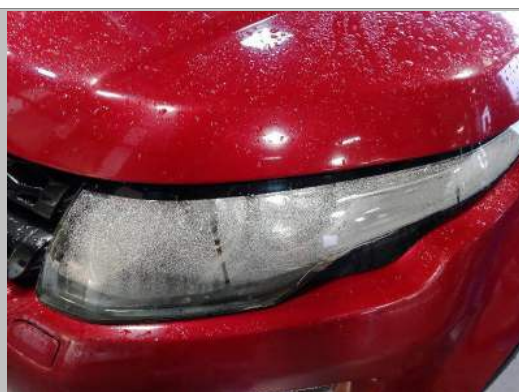
| Headlight Left Damaged | Replace |

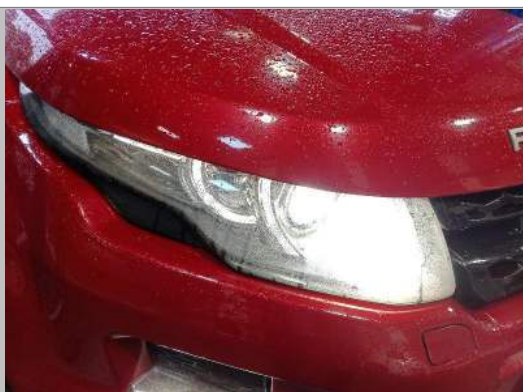
| Headlight Right Defective | Repair |

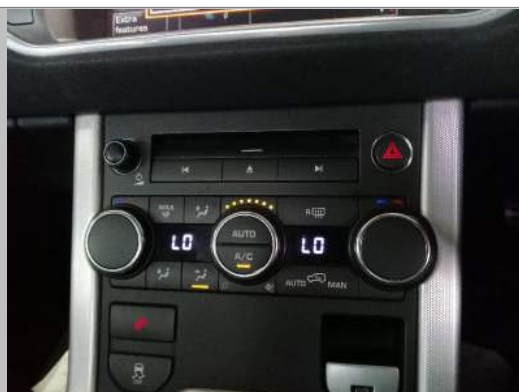
| Air Conditioner Insufficient | Replace |

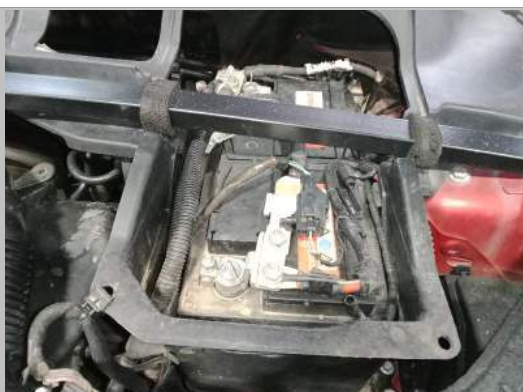
| Battery box Damaged | Replace |

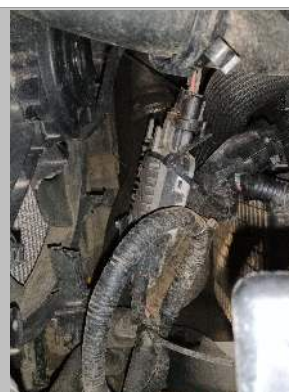
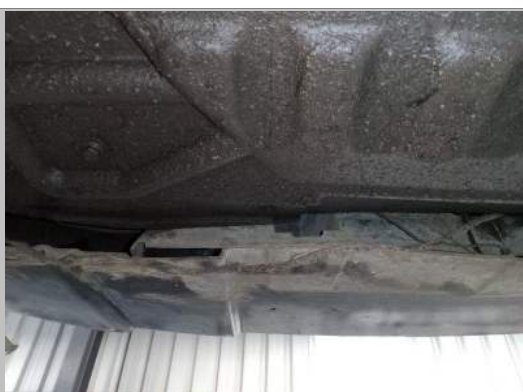
| Engine Wiring Defective | Repair |

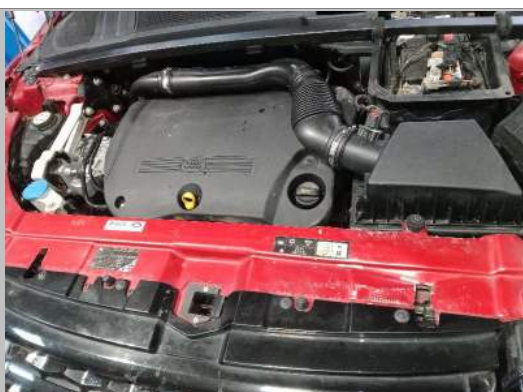
| Bonnet slam plate (Shock tower/ Inner tray) Damaged | Repair |

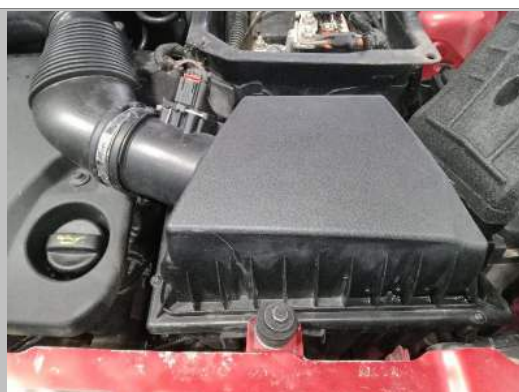
| Air cleaner Damaged | Replace |

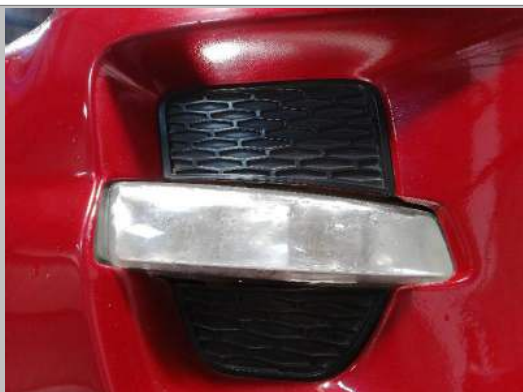
| Fog Light Front Right Damaged | Replace |

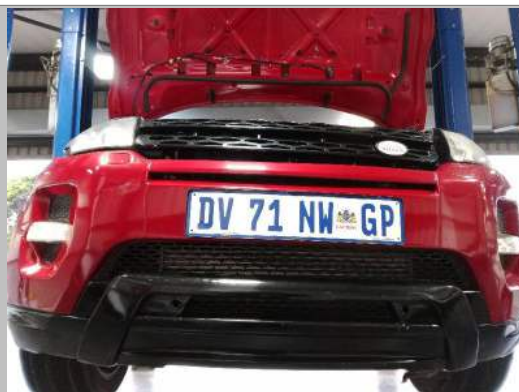
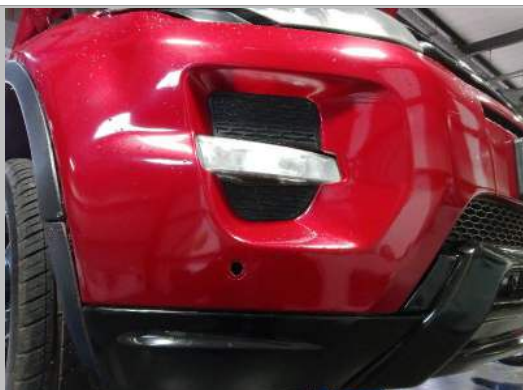
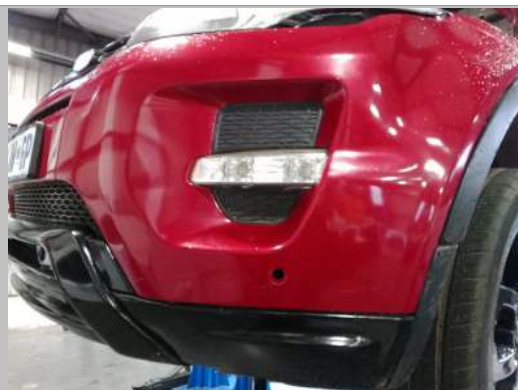
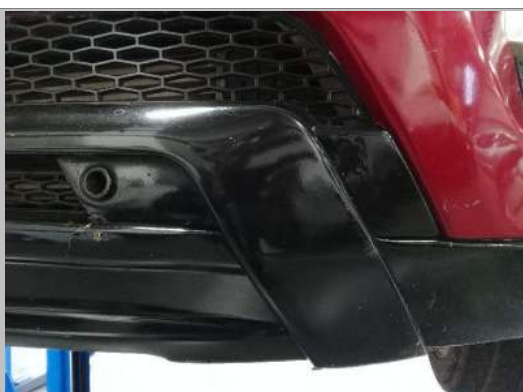
| Front Bumper Damaged | Repair |

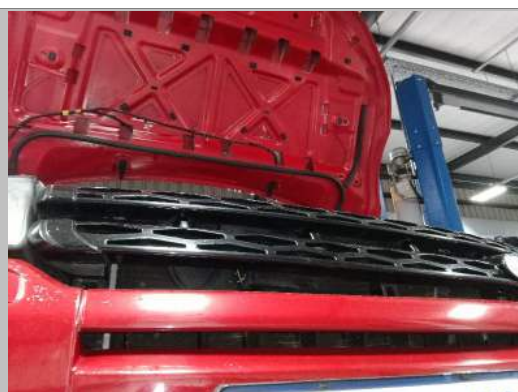
| Grill Damaged | Replace |

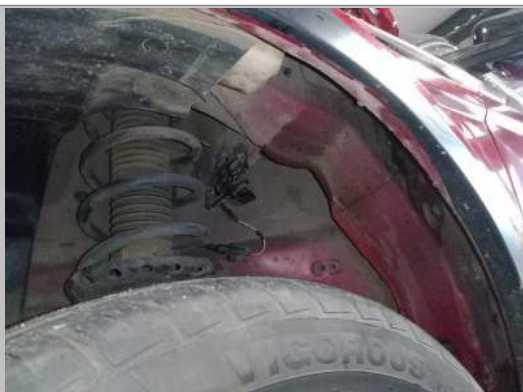
| Front Fender Left / Inner Tray Damaged | Replace |

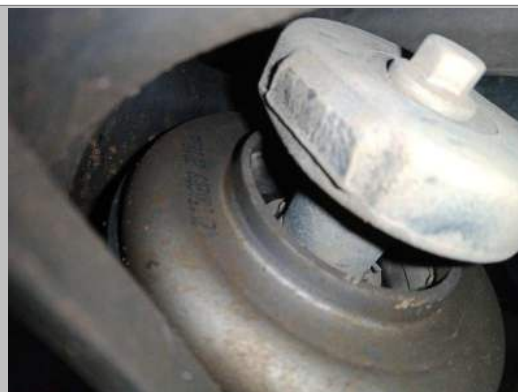
| Control Arm Bush(es) Front Axle Right Cracked | Replace |

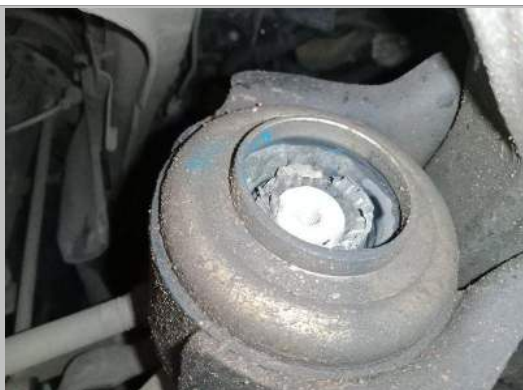
| Control Arm Bush(es) Front Axle Left Cracked | Replace |

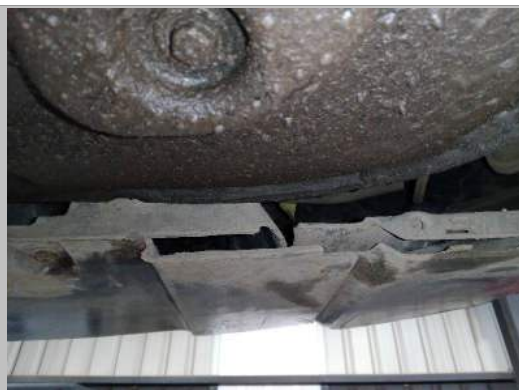
| Radiator Cradle Damaged | Replace |

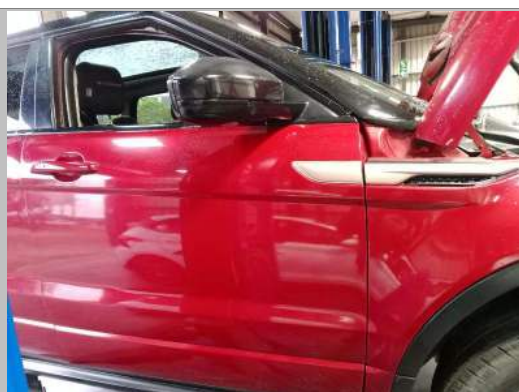
| Door Front Right Residual Traces of Repair | Repair |

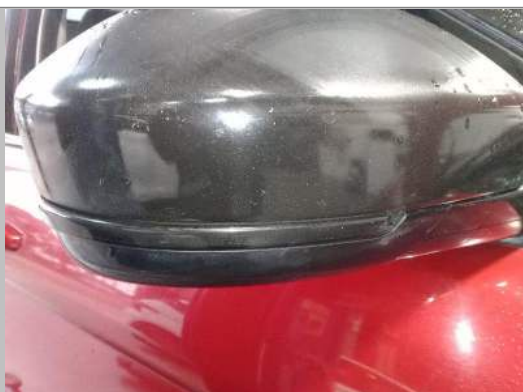
| Indicator Light Front Right Damaged | Replace |
