MFC Auction House
M57 Pretoria Rd, Glenmarais, KEMPTON PARK
Gauteng

DEKRA MFC
M57 Pretoria Rd - 1619
KEMPTON PARK - GT
08610 33572

VEHICLE INSPECTION

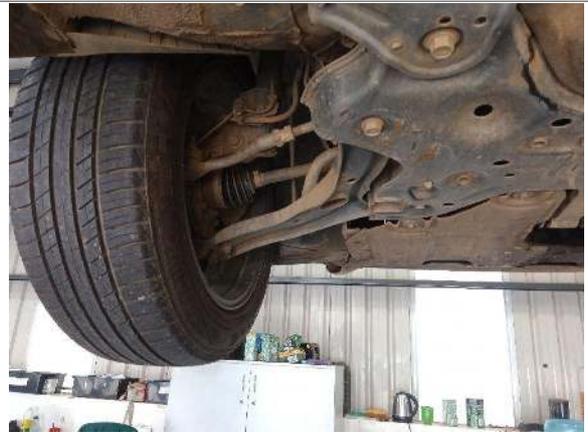
LF TYRE TREAD

Size	Load/Speed Index	Manufacture	Model	Type*	Production Date	Tread Depth (mm)
Front Left	225/55 R18	102W	Blackhawk	Radial	V	1523	5 mm
Front Right	225/55 R18	98V	Fortune	All Season	V	1823	3 mm
Rear Left	225/55 R18	98V	Fortune	All Season	V	1823	3 mm
Rear Right	225/55 R18	98H	Lanvigator	Performax	V	1621	1 mm
Spare	225/60 R17	99V	Voyager	Radial	V	4419	0 mm

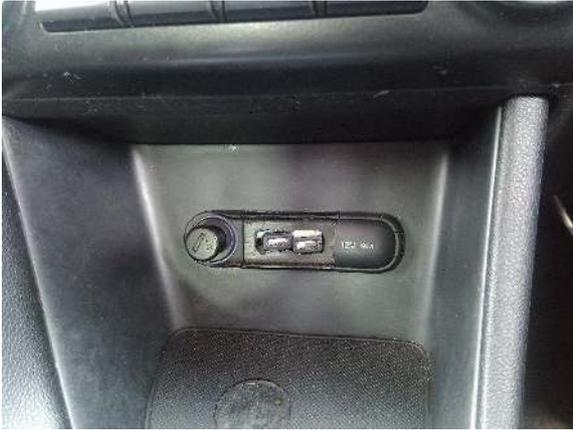
Damage	Repair Way
Engine Oil Leak	Repair
Air cleaner Defective	Repair
Center Console / Cubbyhole + Lid Defective	Repair
Brake Light Centre Damaged	Replace
Number Plate Light Left Damaged	Replace
Headlight Left Scratched	Replace
Seat Front Right Defective	Repair
Seat Rear Dirty	Repair
Hood Lining Dirty	Repair
Door Handle Front Right Defective	Repair
Door Sealing Rubber Front Left Damaged	Replace
Door Sealing Rubber Front Right Torn / Cut	Repair
Door Sealing Rubber Rear Left Damaged	Replace
Door Sealing Rubber Rear Right Torn / Cut	Repair
Steering Wheel Trim Defective	Repair
Side Mirror Left Paintwork • Scratched	Repair
Side Mirror Right Paintwork • Scratched	Repair
Front Bumper Paintwork • Scratched	Repair
Bonnet Dented	Repair
Front Fender Left Paintwork • Chipmarks	Repair
Rear Fender Left Residual Traces of Repair	Repair
Rear Fender Right Dented	Repair
Door Front Left Dented	Repair
Door Front Right Damaged	Repair

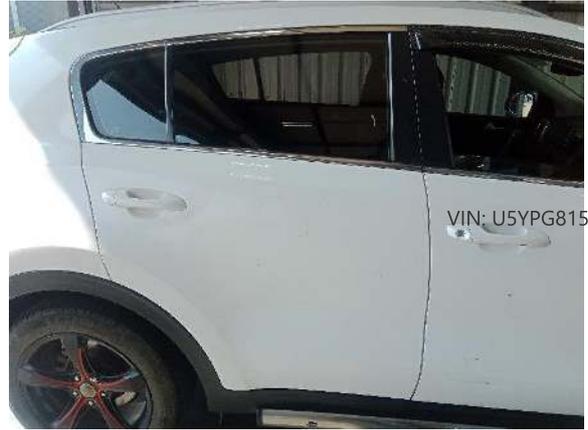
Door Rear Left Paintwork • Scratched	Repair
Door Rear Right Paintwork • Scratched	Repair
Boot Lid / Hatch door Paintwork • Scratched	Repair
Rear bumper Paintwork • Scratched	Repair
Sill Panel Left Defective	Repair

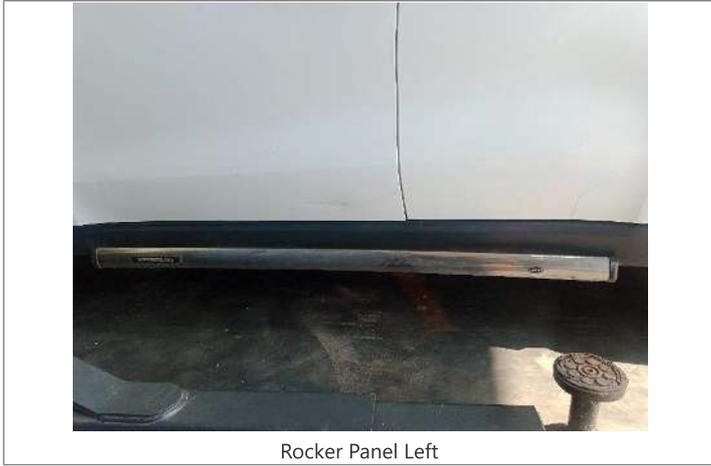
Damage	Repair Way
Rocker Panel Left Dented	Repair
Roof Dented	Repair
Windscreen Cracked	Replace
Parking Brake Performance Left / Right Difference out of legal range	Repair
Control Arm Bush(es) Front Axle Left Cracked	Replace
Control Arm Bush(es) Front Axle Right Cracked	Replace
Mounting Rubber(s) Rear Axle Left Cracked	Replace
Mounting Rubber(s) Rear Axle Right Cracked	Replace
Spare Tyre Worn	Replace
Rim Rear Left Welded	Replace
Rim Rear Right Welded	Replace
Bolt(s) / Nut(s) Front Wheel Left Missing	Replace
Chassis Dented	Repair
Sub Frame Dented	Repair
Belly plates Damaged	Replace
Gearbox Oil Leak	Repair
Fuel Tank Damaged	Replace
Engine Noise Excessive	Repair
Warning lights illuminated on dashboard	Repair
