MFC Auction House  
M57 Pretoria Rd, Glenmarais, KEMPTON PARK  
Gauteng

| Manufacturer | RENAULT | Registration Number | JD59JHGP |

## CONDITION REPORT

Report No: 2016213150

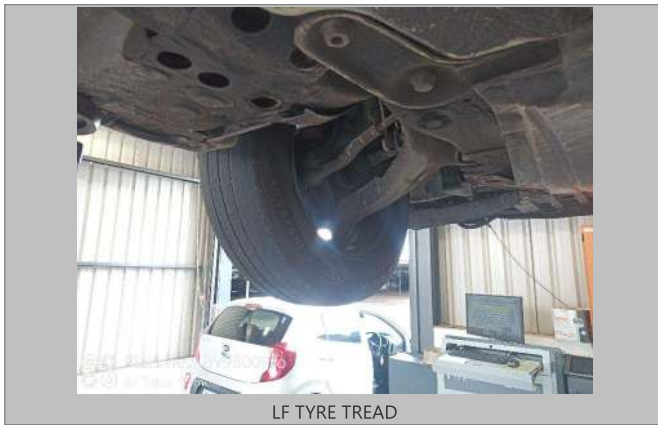
LF TYRE TREAD

| | Size | Load/Speed Index | Manufacture | Model | Type* | Production Date | Tread Depth (mm) |
|---|---|---|---|---|---|---|---|
| Front Left | 185/65R15 | 88H | Tracmax | X-privilo | V | 3122 | 0 mm |

| Damage | Repair Way |
|---|---|
| Tyre Front Left Smooth | Replace |

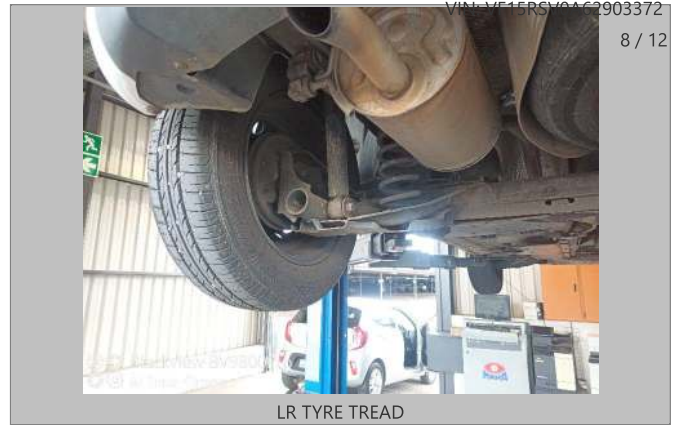
LR TYRE TREAD

| | Size | Load/Speed Index | Manufacture | Model | Type* | Production Date | Tread Depth (mm) |
|---|---|---|---|---|---|---|---|
| Rear Left | 185/65R15 | 88T | Bridgestone | Ecopia | V | 1219 | 3 mm |

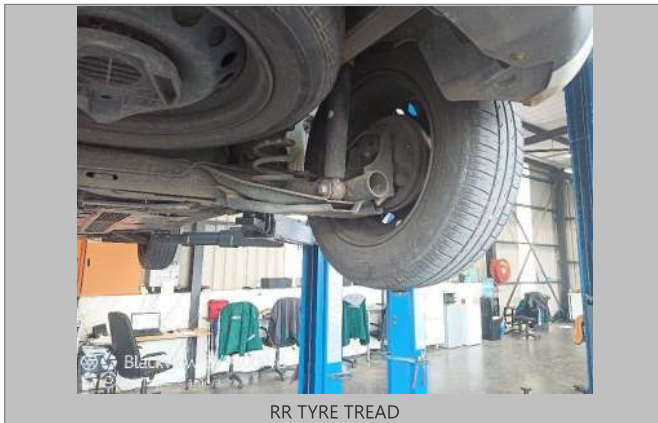
RR TYRE TREAD

| | Size | Load/Speed Index | Manufacture | Model | Type* | Production Date | Tread Depth (mm) |
|---|---|---|---|---|---|---|---|
| Rear Right | 185/65R15 | 88T | Bridgestone | Ecopia | V | 1219 | 3 mm |

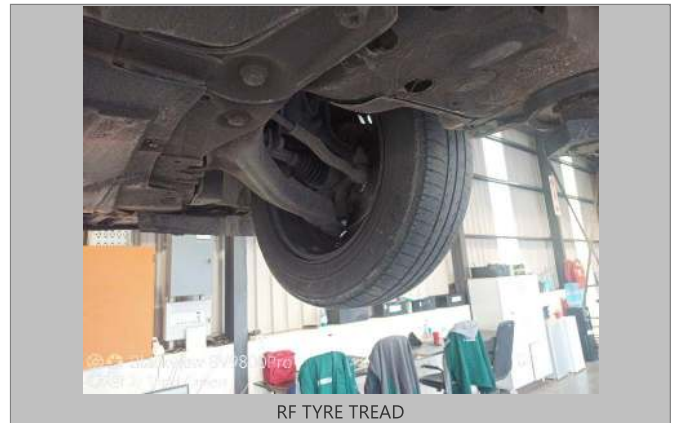
RF TYRE TREAD

| | Size | Load/Speed Index | Manufacture | Model | Type* | Production Date | Tread Depth (mm) |
|---|---|---|---|---|---|---|---|
| Front Right | 185/65R15 | 88T | Bridgestone | Ecopia | V | 1119 | 1 mm |

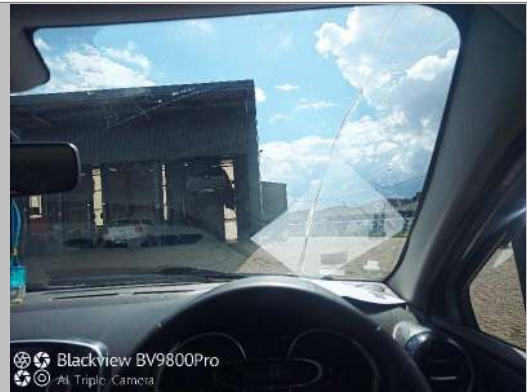
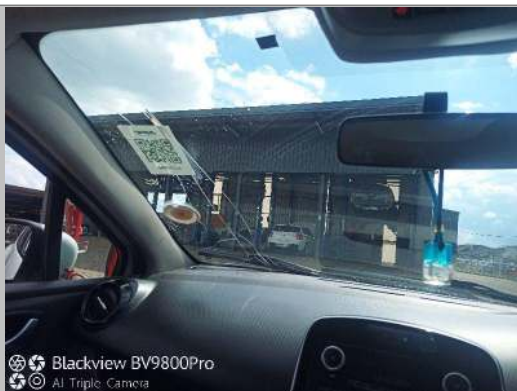
| Damage | Repair Way |
|---|---|
| Windscreen Cracked | Replace |

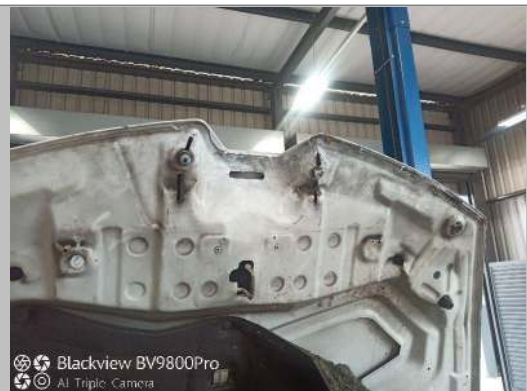
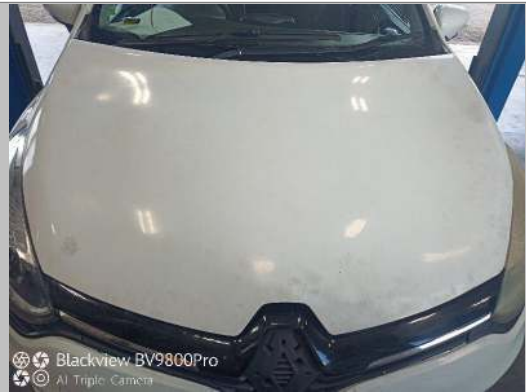
| Damage | Repair Way |
|---|---|
| Bonnet Residual Traces of Repair | Repair |

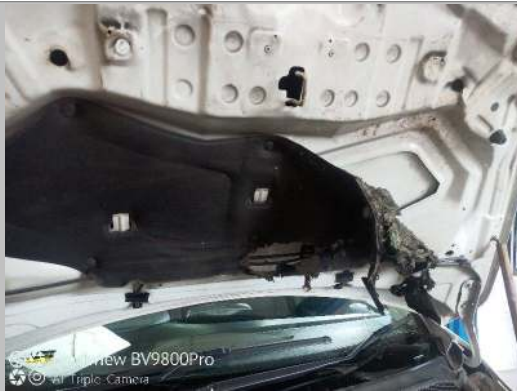
| Damage | Repair Way |
|---|---|
| Under bonnet insulation cover Damaged | Replace |

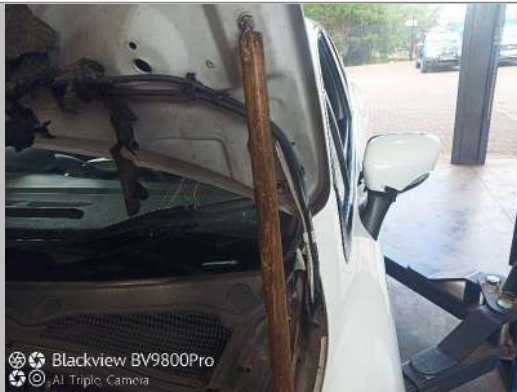
| Damage | Repair Way |
|---|---|
| Bonnet stay and shocks Missing | Replace |

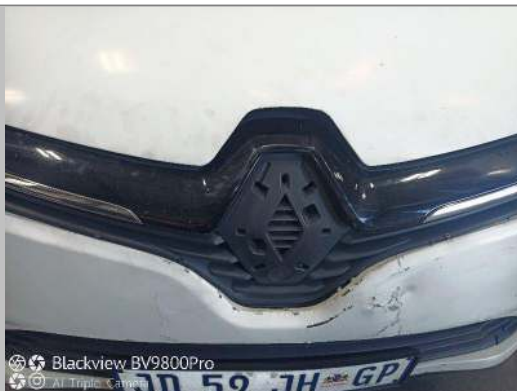
| Damage | Repair Way |
|---|---|
| Grill Damaged | Replace |

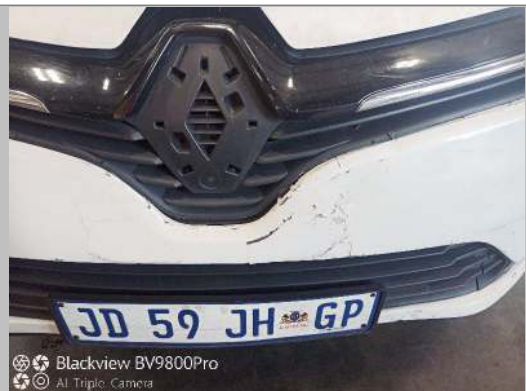
| Damage | Repair Way |
|---|---|
| Front Bumper Paintwork • Flaking | Repair |

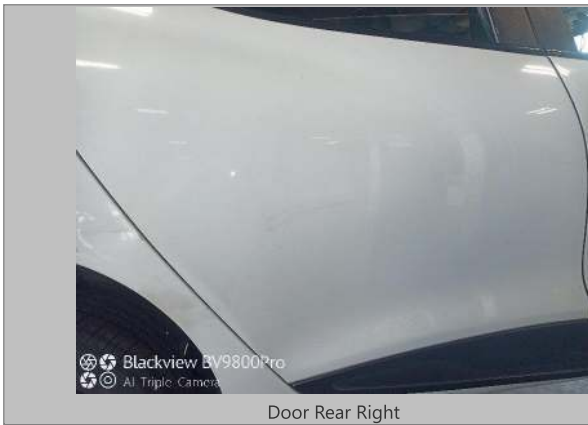
| Damage | Repair Way |
|---|---|
| Door Rear Right Paintwork • Scratched | Repair |

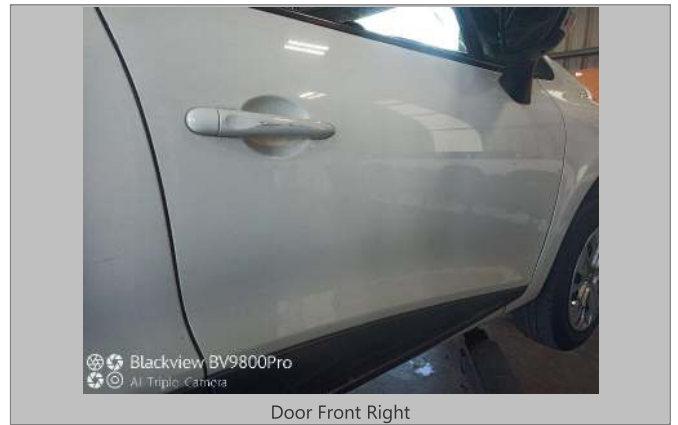
| Damage | Repair Way |
|---|---|
| Door Front Right Paintwork • Scratched | Repair |
